Strengthening of Structures Damaged by the Azores Earthquake of 1988

Aníbal COSTA
Associate Professor
FEUP
Porto

António Arêde
Assistant Professor
FEUP
Porto

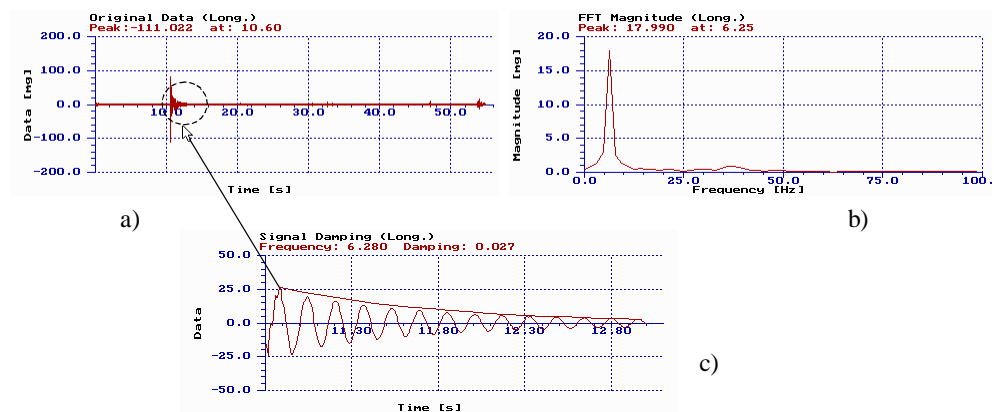
Fig. 8 – Response records due to impacts in the normal direction to the wall. a) acceleration; b) estimated frequency through the FFT and c) estimated damping

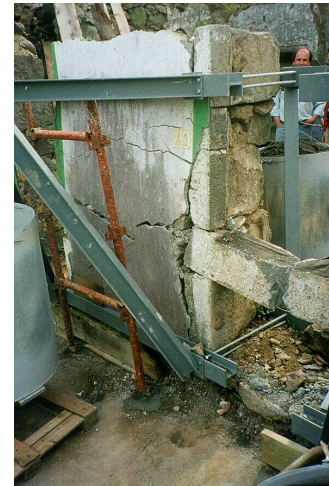
The non-strengthened panel (A1) wall was the only one that collapsed when subject to a load much lower than those applied to walls A2 and A3. In fact, after the load of 5.40 kN was reached, pronounced oscillation of panel A1 started occurring as a consequence of the bucket forced oscillating movement. This oscillation was followed by the panel wall collapse as shown in fig. 9.

Fig. 9 – Collapse of panel A1

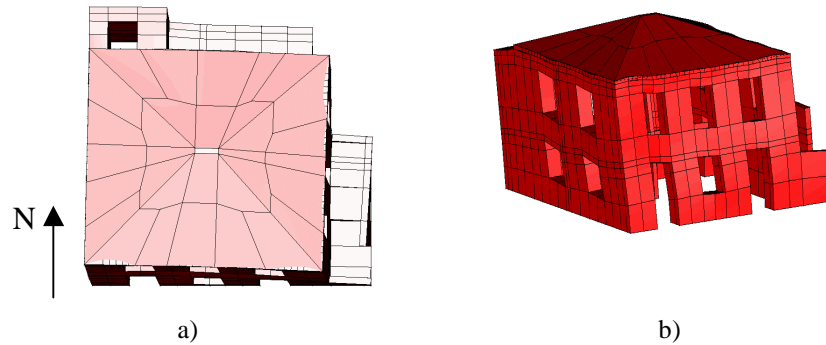
Figures 10 and 11 show the two first vibration modal configurations obtained by numeric calculation, where the north-south component is dominant in the 1st mode, whilst the east-west direction is preponderant in the 2nd mode. Note, however, that these are not pure translations due to the presence of substantially stiff and local elements (stairs and chimney) responsible for some rotation. The third vibration mode (not illustrated) is essentially a rotational mode with 8.05 Hz frequency.

Fig. 10 – Plan view (a) and perspective (b) of the 1st vibration mode (5.7 Hz)

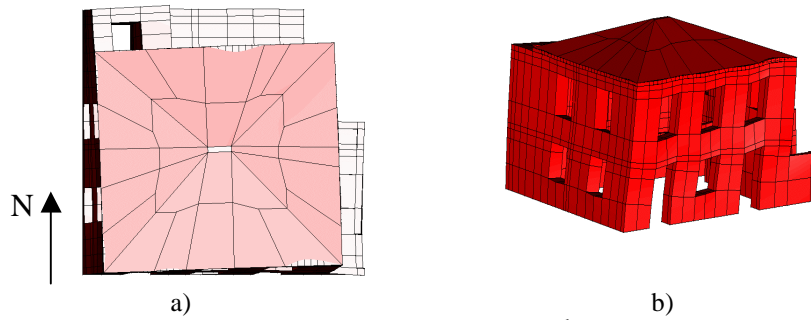
Fig. 11 – Plan view (a) and perspective (b) of the 2nd vibration mode (5.8 Hz)
