Survey of the Facade Walls of Existing Adobe Buildings

Dora Silveira, Humberto Varum, Aníbal Costa & Célia Neto

Adobe construction was very common in Aveiro district, Portugal, until the middle of the 20th century. At present, there are still many adobe buildings in use, a significant percentage of which have social, cultural, and architectural value. Many of these buildings, however, are in a poor state of conservation. The existing problems are partially the result of a lack of knowledge about the materials and building systems traditionally used. To contribute to this knowledge, a visual and dimensional inspection of the facade walls of twenty one adobe buildings located in Anadia, Murtoosa, and Aveiro municipalities, in Aveiro district, was conducted. This article presents a description and analysis of the construction details, common defects, and state of conservation of the facade walls studied. This work aims to contribute with preliminary information that may help support the preservation and rehabilitation of existing adobe buildings.

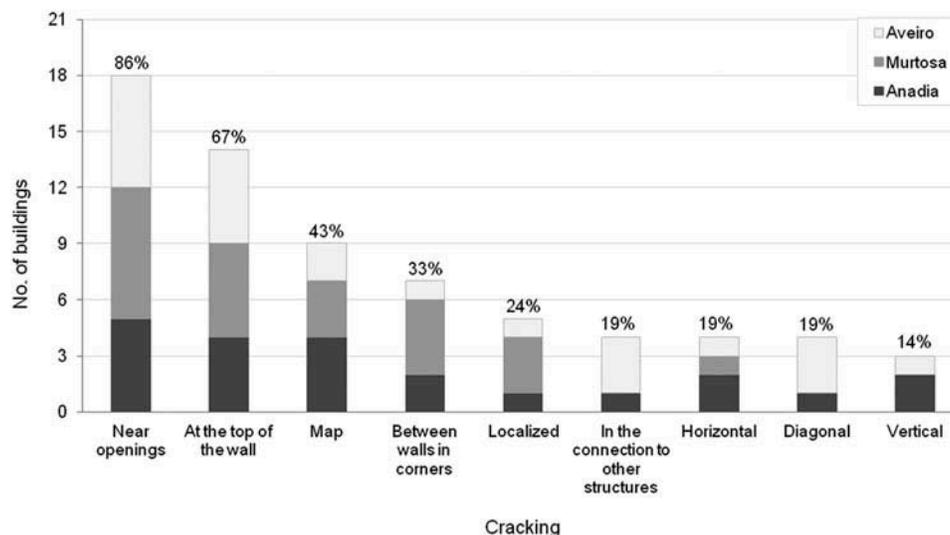
Figure 7. Types of cracking observed in facade walls.

The cracks near openings observed in the buildings studied are mainly located above or below the openings, frequently near the corners, and generally have vertical or diagonal orientation (Figure 6). In some cases, cracking is thin and superficial, affecting only the coating, but it is more frequently thick and deep, affecting also the support structure. In one building (“H21”), intense cracking led to the partial disintegration of masonry above two openings. Common causes for cracking near openings are: excessive load (Thomaz 2003), generally imposed by the roof or floor structures; insufficient support of the masonry above the openings; stress concentration in the corners; and excessive percentage of wall area with openings. In some of the cases, differential foundation settlement is also a possible cause for the existing cracking (Richardson 2001; Thomaz 2003).

The cracking observed at the top of the facade walls of the buildings studied is mainly vertical or diagonal (Figure 6). In some cases the cracks are light and superficial, but in other cases the cracks are thick and affect the support structure. This type of cracking is generally caused by excessive load or deformation imposed by the roof structure (Thomaz 2003).

Structural cracking between perpendicular facade walls, in corners, was observed in some of the buildings under study (Figure 6). This type of cracking is generally vertical, following along the area of connection between walls. In some of the cases observed, vertical cracking is combined with diagonal or scattered cracking along the corner. Possible causes for this type of cracking are: deformation of the walls due to variations in temperature or moisture content (Thomaz 2003); differential foundation settlement (Pagaimo 2004); and horizontal thrust imposed by the roof which leads to the rotation of one or both perpendicular walls (Pagaimo 2004). These factors can lead to cracking or even separation between facade walls, especially when combined with a weak connection between walls.

Long diagonal cracking was also observed in the facade walls of some of the buildings studied (Figure 6). In all the cases, the cracks are thick and appear to affect the support structure. In building “H39”, one diagonal crack is located near an opening, extending diagonally and downward towards a corner of the building, and seems to be caused by excessive load imposed by the roof structure. In the other cases where this type of cracking is observed, cracks appear to be caused by differential foundation settlement—in these cases, the diagonal cracks lean towards the point where the largest settlement occurred (Richardson 2001; Thomaz 2003). In building “H39”, one diagonal crack of this

Vertical structural cracking in the central area of the facade walls was observed in a few of the buildings under study (Figure 6). The vertical cracks are long, sometimes extending from the bottom to the top of the walls. Possible causes for this type of cracking are (Thomaz 2003): deformation of the walls due to variations in temperature or moisture content; differential foundation settlement; and excessive concentrated load imposed by the roof structure.

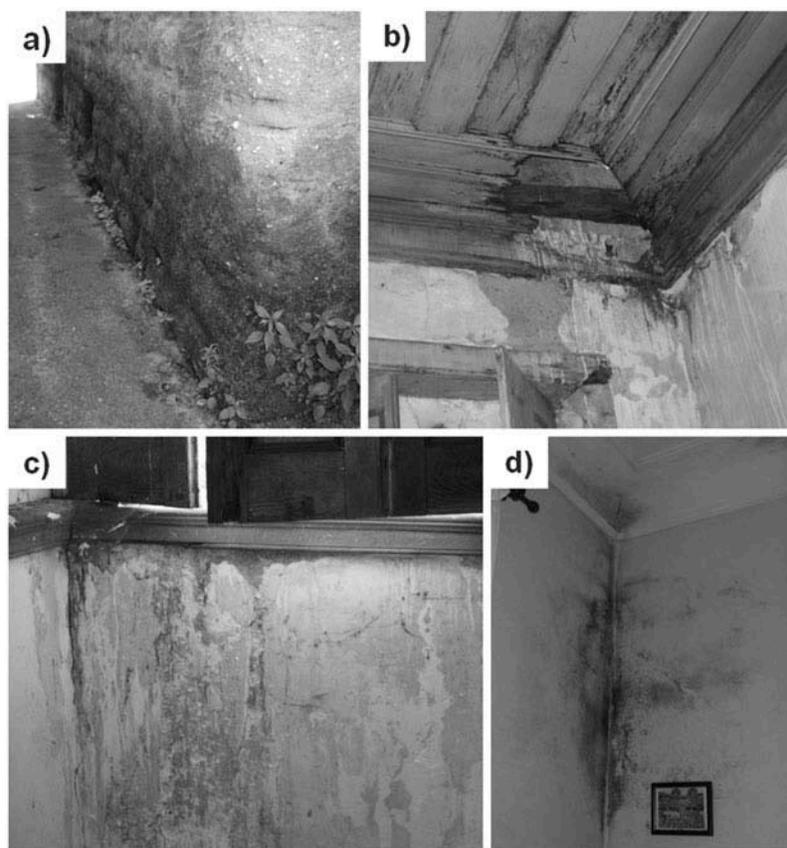
Rising dampness is a very common defect (Figure 8a), observed both in the buildings with adobe foundations and in the buildings with stone foundations. The signs of rising dampness generally consist of damp patches, mold, moss, mortar detachment, and paint peeling located at the bottom of the facade walls. In some buildings, these signs are only visible on the outer surface of walls. In these cases, surface water may be the main cause of rising dampness (Freitas, Torres, and Guimarães 2008). In other buildings, the signs of rising dampness are also visible on the inner surface of walls and are of equal or even higher intensity in these surfaces. In these cases, groundwater may be the main cause of rising dampness (Freitas, Torres, and Guimarães 2008).

Figure 8. (a) Rising dampness; (b) dampness at the top of walls; (c) leakage through window openings; and (d) surface condensation.

Two main factors appear to contribute to the problem of rising dampness observed in the buildings studied: on the one hand, adobe is a material with high capillarity (Coroado et al. 2010; Martins 2009) and thus adobe walls are very susceptible to this phenomenon; on the other hand, many of the buildings studied don't have a rainwater drainage system or have a malfunctioning drainage system, which causes the accumulation of water near the base of the buildings.

Dampness at the top of walls is usually the result of water leakage through the roof. This problem is generally observed on the inner surface (Figure 8b) and sometimes on the outer surface of walls. On the inner surface, damp patches, frequently combined with dripping water stains, are more intense at the top of the walls and often extend to the bottom. In some buildings, the formation of mold in these areas can be observed. On the outer surface of walls, the signs of

Leakage through window openings is also a common cause of dampness in the facade walls of the buildings studied (Figure 8c). Rainwater seeps through the connection between window frames and facade walls or through gaps in the window frames. This problem is generally manifested by the presence of damp patches, dripping water stains, and peeling paint on the area below the openings.

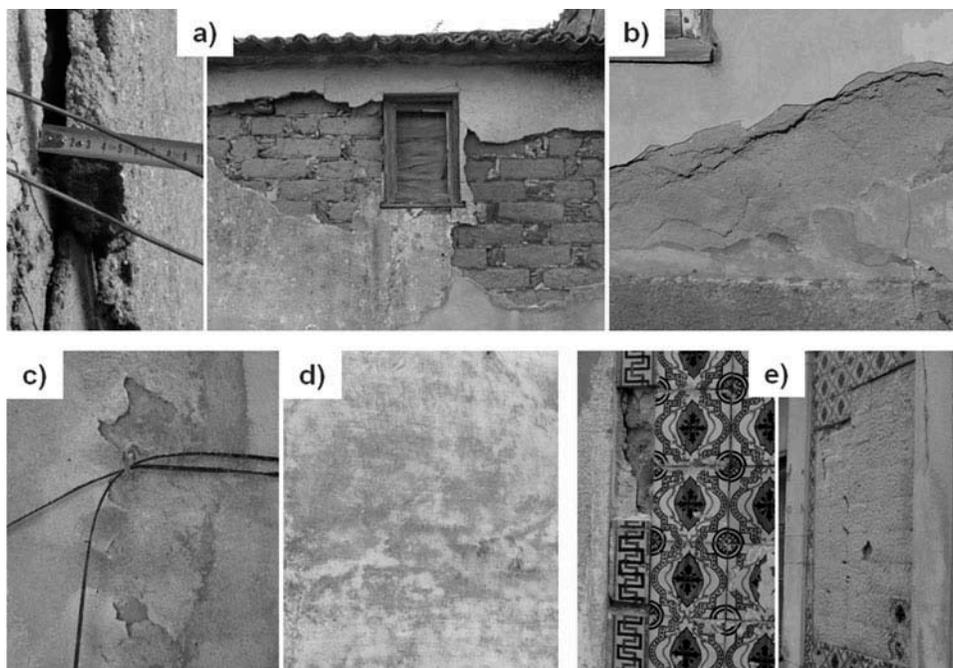
Figure 9. (a) Render detachment; (b) render erosion; (c) paint peeling; (d) paint erosion; and (e) ceramic tile deterioration.

Render deterioration was observed in 71% of the buildings studied. Two main forms of render deterioration were identified: detachment and erosion.
