# Diary of a historical building intervention in Oporto. The careful management of change.

The present contribution details an intervention in a 19<sup>th</sup> century building located in the Oporto Historical Centre buffer zone (UNESCO World Heritage since 1996). The building houses a bookseller and faced a series of problems stemming from structural overload and the lack of maintenance for over half a century. The first phase incorporated intervention on the roof.

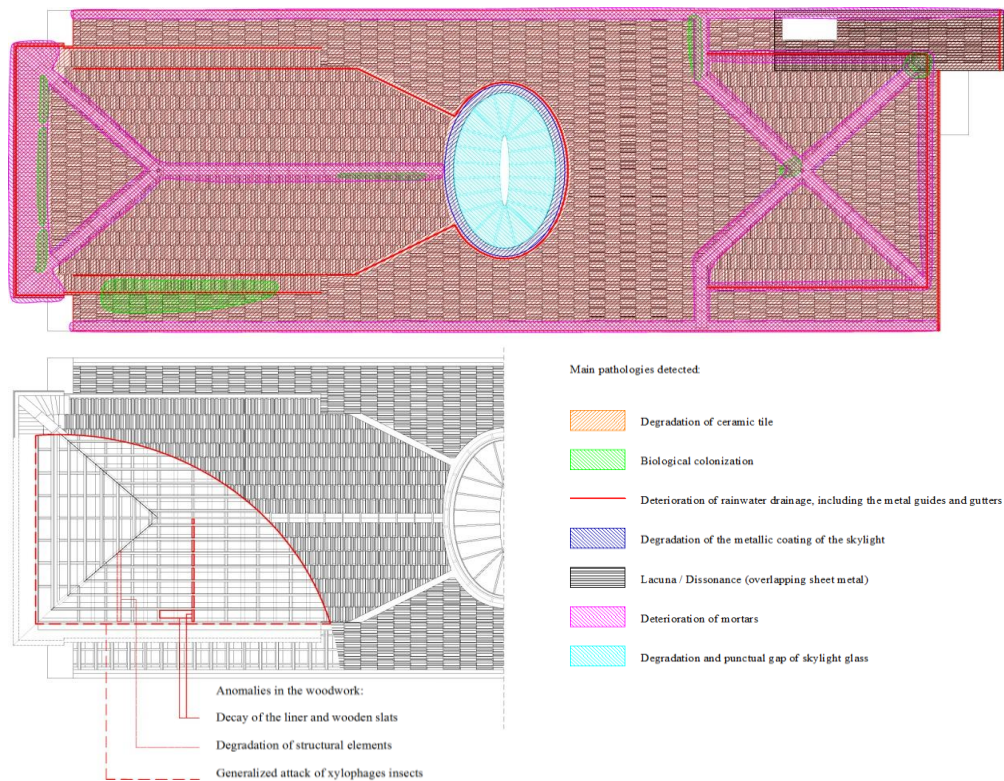
Figure 3. Decay mapping

The main problems identified generally involved the decay of ceramic tiles, the deterioration of the timber structures (due to the presence of water, insects and fungi), the decay of the mortars, the painted wooden and the metal features, among others problems such as:

- Advanced decay of the tiles with a considerable number of them either broken or with low levels of waterproofing;
- Advanced decay of the eave tiles due to the presence of biological colonization and the decay of the setting mortars;

- Gaps in the southwest corner roof tiles as well as over the bathroom area in the meanwhile remedied with metal sheeting;
- Decay of the gable end crowning tiles alongside the rotting of the mortar fixing;

- Advanced degradation of the recessed floor metal sheeting;
- Advanced degradation of the skylight cladding sheet and its drip tray (which caused water infiltration and the decay of the skylight support beam structure) and of the upper metallic edge;

- Deterioration of the rainwater drainage system, including the metal guides, gutters, the back downpipe and the capitals;
- Decay of some timber features due to rot or insect and fungal attack (beams, rods, upper skylight structure support beam, roof lining and slats);

- Detachment of the plasterwork along the upper face of the bathrooms;
- Wear of the painting on the recessed floor crowning wooden cornices;
- Oxidation of the metallic features and fissures in their outer facings.

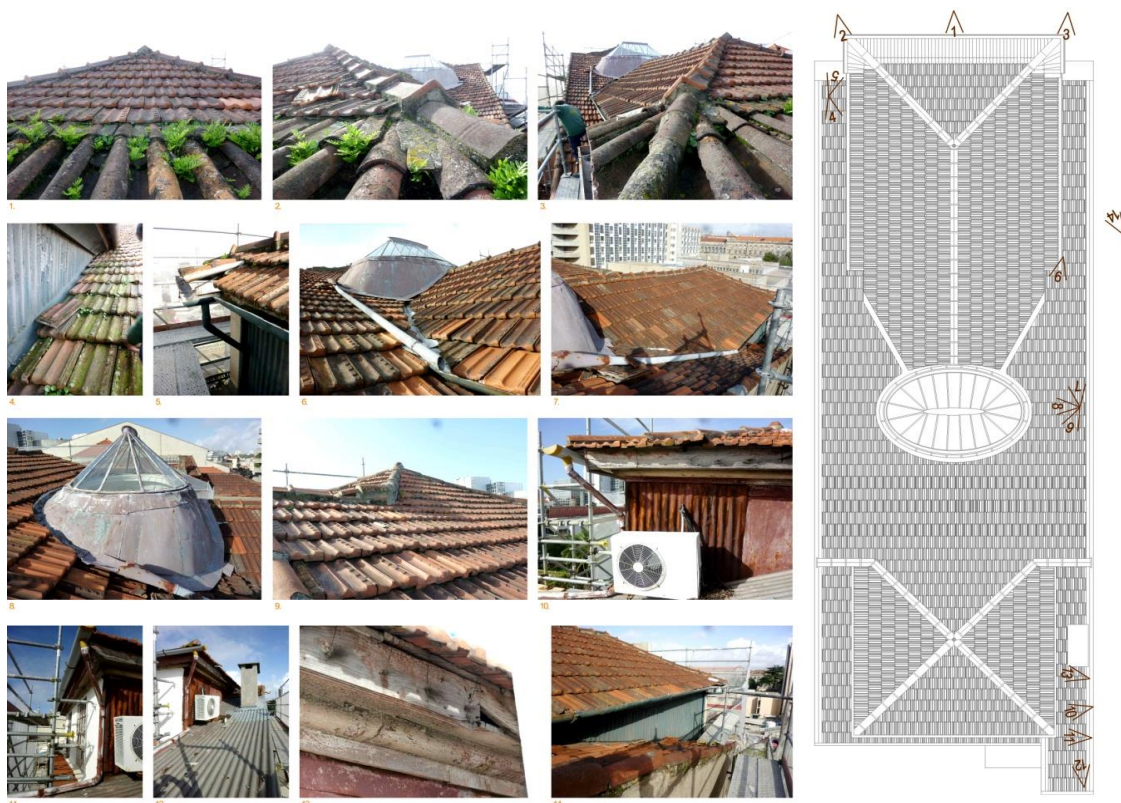
Figure 4. Photographic survey before the intervention

This intervention project focused on the conservation of the roof that was already in an advanced state of degradation due to the lack of maintenance throughout various decades (with no record of any consistent repairs to the roof since 1927<sup>4</sup>).

The project was motivated by interior gravitational infiltration in several points such as the base of the skylight and by some structural fissures as evaluated in the report made by the Instituto da Construção of the Oporto University Faculty of Engineering.
