Field observations of the structural performance of RC constructions in Nepal after 25th April 2015 earthquake

Abstract

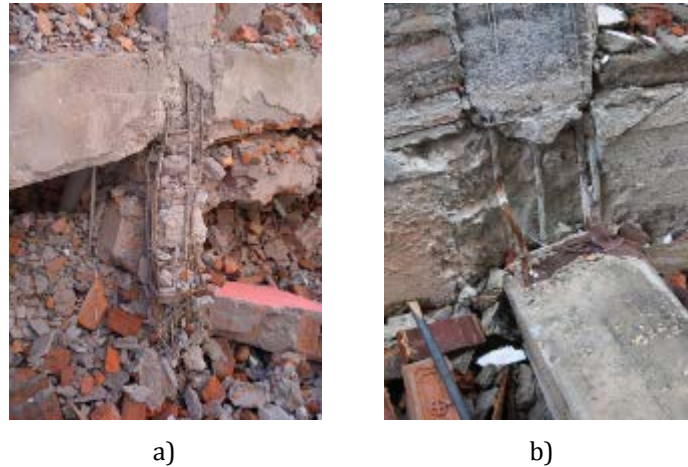
The main weaknesses are often linked to the quality control of materials (improper vibration of concrete, improper size of the aggregates and steel bars with insufficient ductility) and reduced construction quality (reinforcement detailing and insufficient percentage of reinforcement) which have a direct impact on the bearing capacity on the structural elements, as shown on Fig. 4.

Fig. 4 – Poor quality of materials and construction detailing on a) Columns and b) Joints, with shear failure.

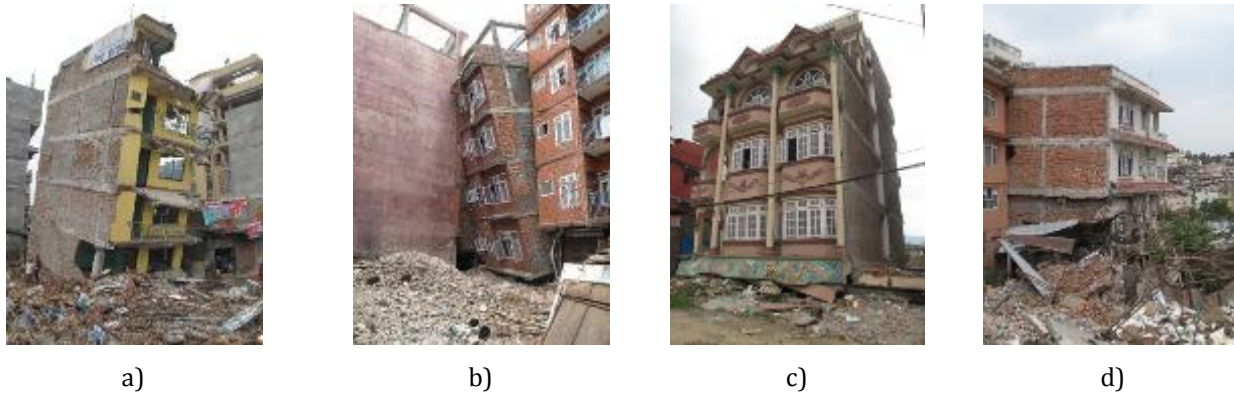
Another influential factor increasing its vulnerability was linked with the reduced amount of IM walls on the ground floor, leading to the formation of soft-storey mechanism, and subsequent partial/total collapse of some buildings, as illustrated in Fig. 5. The failures from soft-storeys are very destructive making these buildings irrecoverable from the retrofitting perspective and also creating damage to adjacent buildings.

Fig. 5 – Examples of buildings subject to soft-storey mechanism: a) Collapse at the ground floor level, b) Collapse at ground floor and pounding effect, c) Collapse at ground level with side turning, and d) Collapse at the 3rd storey.

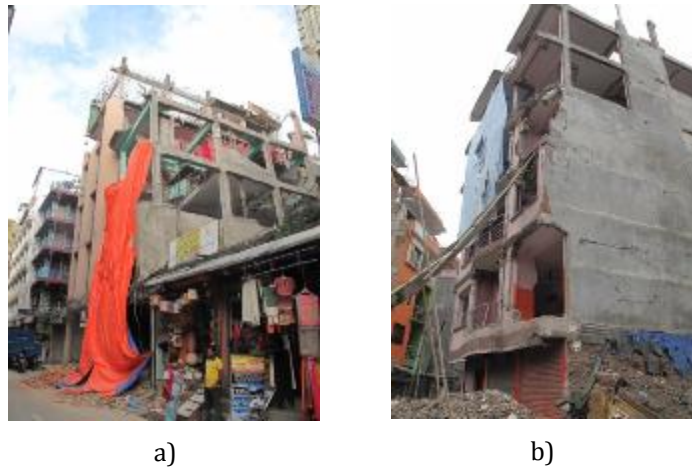
It is pointed out that engineered and pre-engineered buildings behaved substantially better compared with the non-engineered ones. However, this observation did not apply to every pre-engineered structure due to the fact that, even though the NBC-201 and NBC-205 limits the height to three storeys, a large number of owners decided to increase the height of the buildings without respecting the standard neither taking measures considering how extra storeys would affect the behaviour, shown on Fig. 6. These type of failures may not be connected to insufficient designing rules but to disregard and human errors. There were verified site-effects of high importance, connected with soil amplifications, that presumably has resulted in areas destroyed with the collapse of the majority of buildings.

Fig. 6 – Examples of pre-designed a) Adjacent and b) Isolated buildings that have grown in height for which the last storeys are being removed.

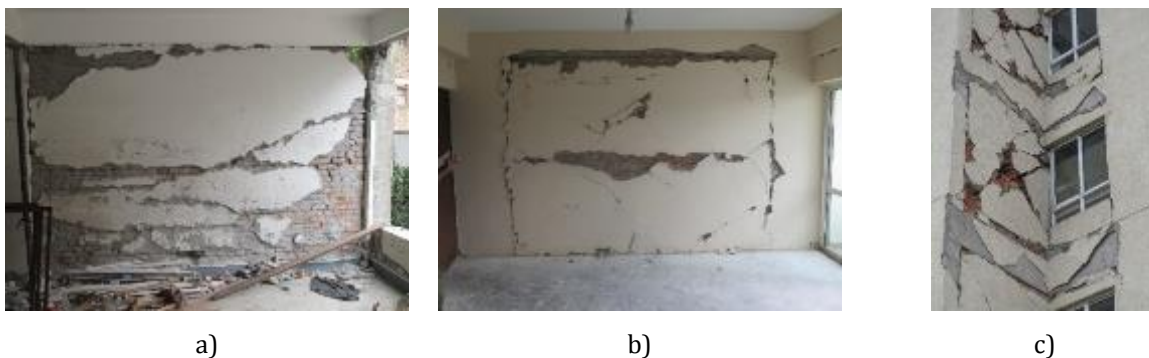
The majority of damages on IM walls (non-structural elements) were registered as shear-cracking at half height (Fig. 7a), detachment between wall and surrounding RC elements (Fig. 7b), and some with diagonal cracking (Fig. 7c). Given the characteristics of these walls – such as high stiffness provided by the interlock of double-leaf walls of solid bricks –, a reduced number of out-of-plane failures were registered, occurring mainly on the case of some non-confined walls.

Fig. 7 – Examples of damage in infill masonry walls: a) Shear cracking at half height, b) Detachment of the wall and surrounding RC elements, and c) Diagonal cracking.

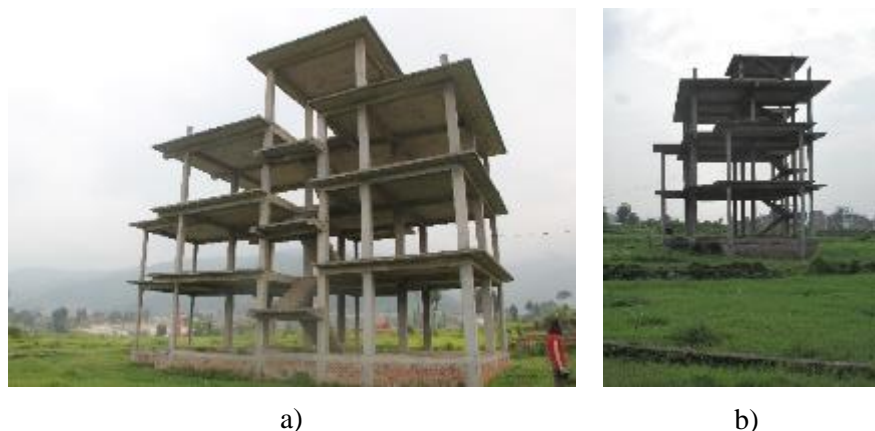
The studied building is a RC moment-resisting frame (RC-MRF) which is located at south east of Bhaktapur about 600 away from Araniko Highway. The building is bare framed with vertical and mass irregularities. Beam to beam connection without column at those joints causes more vulnerabilities to the building, as illustrated in Fig. 13. The structural irregularity such as structural circular column at ground floor changed to rectangular column in second and third floor, similarly short column in staircase landing are ill practice which are still practice in Nepal. This building in general represents the construction practice prevailed in Nepal before 25th April, 2015 earthquake. The structure is three storey building ageing more than 12 years. The height of each storey is 2.74 m and same for each storey. The maximum span between the columns is 3.5 m and 4.7 in X and Y direction respectively. The rectangular column section used are 300x300 mm, 300x230 mm, 230x230 mm and circular column section of 230x230 mm. The beam is uniform and its dimension is 230x355 mm excluding the slab thickness. The slab used is 125 mm thick throughout the building.

Fig. 13 – Building B: a) General view; and b) Lateral view.
