Access Viaducts to the Drawbridge of Leixões Harbour - Diagnosis of Concrete Deteriorations

ABSTRACT

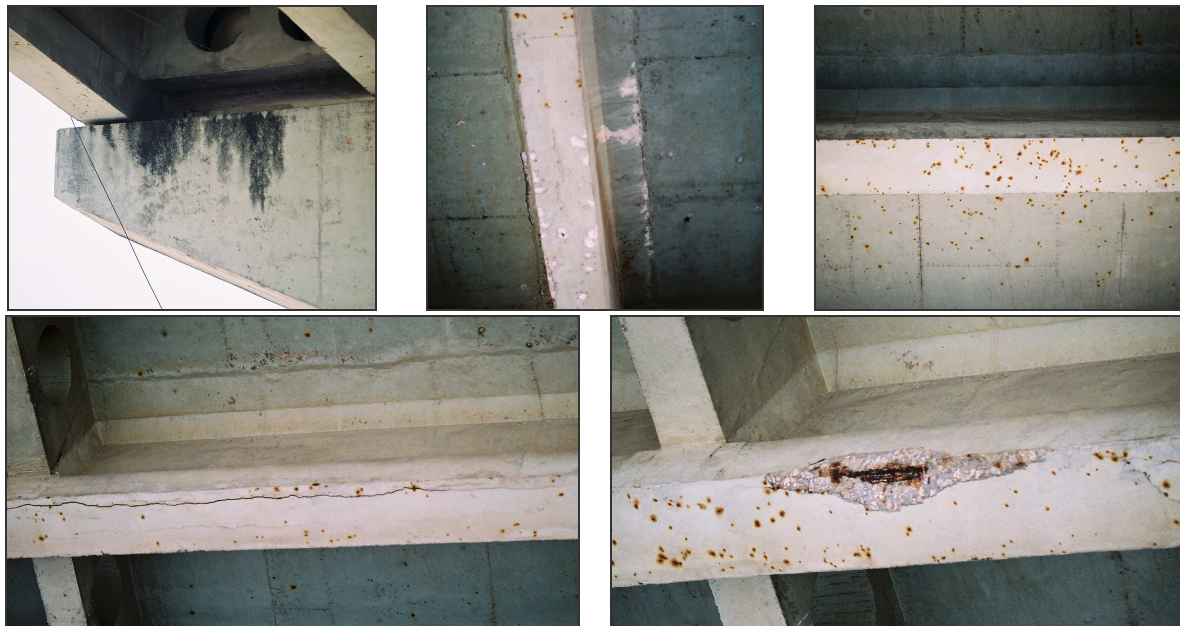
The visibly deteriorated concrete was obtained from locations near non-structural cracking at the base of one wall-column, at beams (along the reinforcement) and under stains and efflorescence ('Fig. 4').

Figure 4. Visually deteriorated concrete, stains and efflorescence.

These concretes show corrosion due to carbonation. The results of the chloride content analysis show that the corrosion of the reinforcement are caused by carbonation and not by high chloride content. The stains on these concretes consisted totally of iron oxides, and are caused by steel corrosion. The non-structural cracking along the reinforcement and the concrete spalling or delamination are due to the formation of expansive products of steel corrosion.

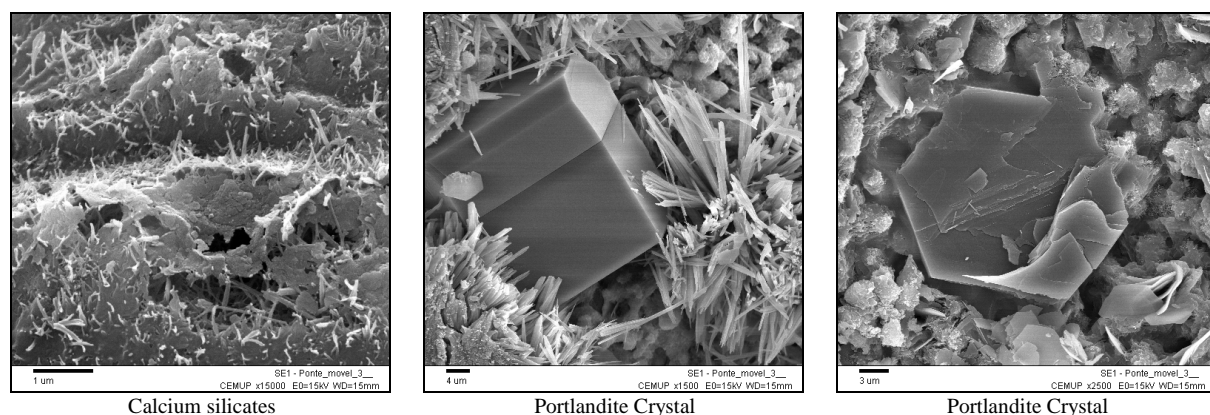
The observations and analysis of apparently non-deteriorated concrete of the two access viaducts showed good quality concrete, compact and with a well hydrated cement paste, showing hydrated calcium silicates and portlandite, calcium hydroxide, $(\text{Ca}(\text{OH})_2)$ ('Fig. 5'). The neoformation products found were calcite, calcium carbonate (CO_3Ca), sylvite, potassium chloride (KCl), ettringite, calcium sulfo-aluminate hydrated ($3\text{CaO} \cdot \text{Al}_2\text{O}_3 \cdot 3\text{CaSO}_4 \cdot 32\text{H}_2\text{O}$) and gypsum, calcium sulphate bi-hydrated ($\text{CaSO}_4 \cdot 2\text{H}_2\text{O}$) ('Fig. 6'). Large quantities of calcite were found even at 5mm depth, very small quantities at 8mm and at 100mm depth no neoformation calcite was identified. This concrete also showed potassium chloride crystals next to the surface. Beyond 5mm the concrete showed an incipient sulphate attack with the development of ettringite and gypsum.

Figure 5. Calcium silicates and crystals of portlandite.

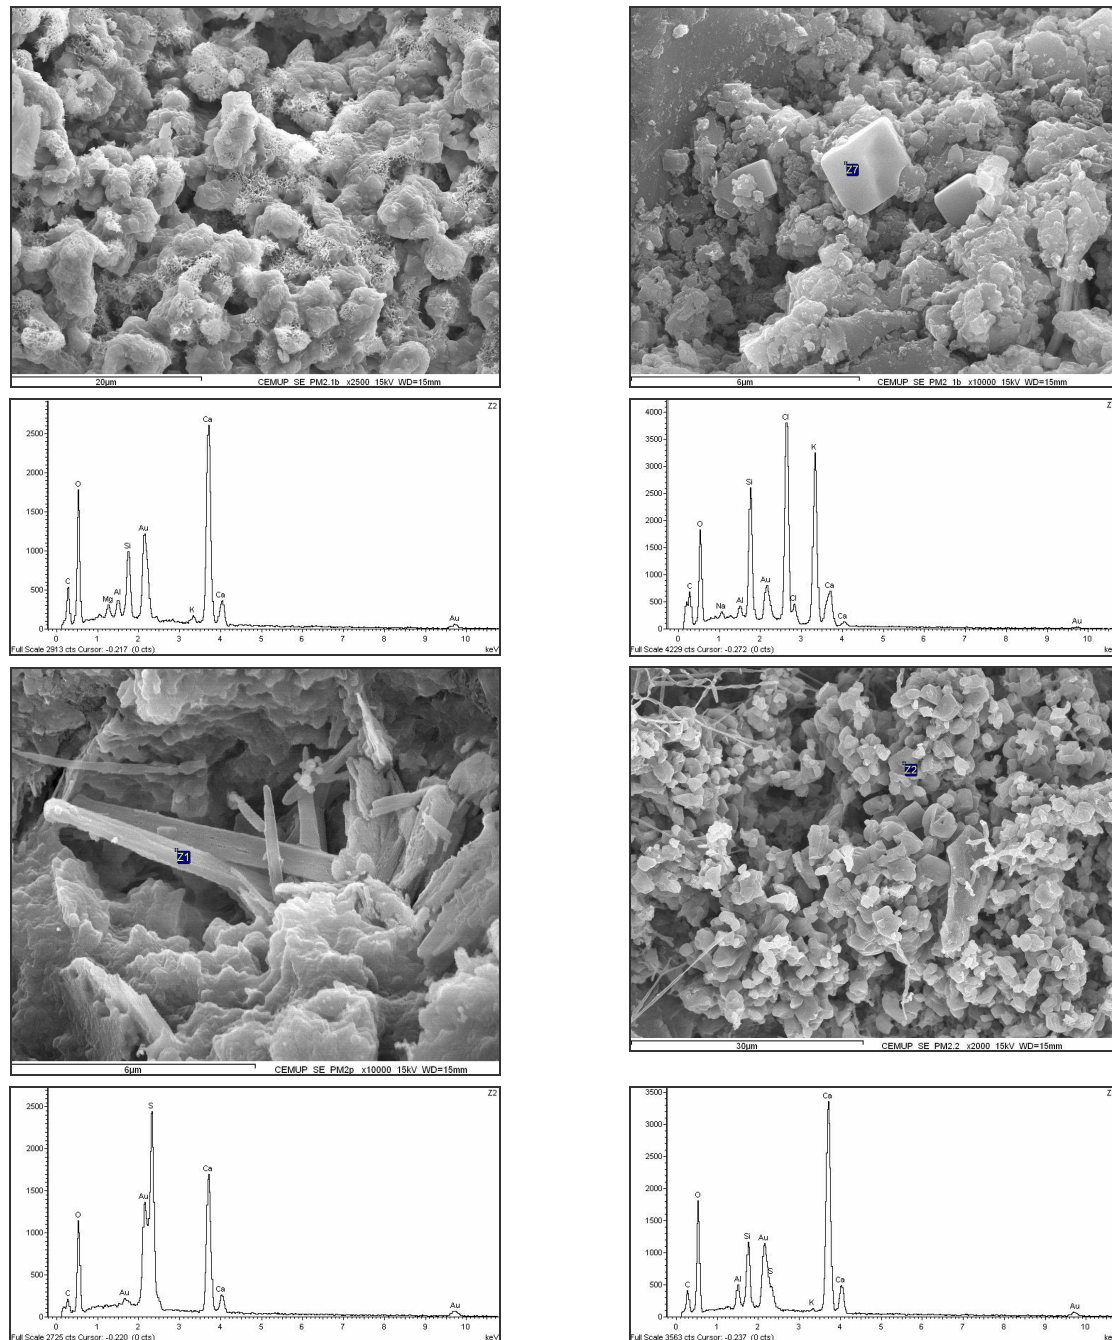
The cement paste showed hydrated calcium silicates, which are mainly responsible for the resistance and binding properties of cement paste, and portlandite crystals, responsible for long-term stability of the silicates. The observations of calcite are coherent with the carbonation test. The sylvite crystals next to the surface are probably due to the contamination of the repair mortar that had chloride in its' composition [Mota-Miranda 2006]. The sulphate attack with formation of gypsum and ettringite is an

external attack due to the water from the “Leça” river. Analysis of this water showed a very high sulphate content [Mota-Miranda 2006].

Figure 6. Calcite (dissolution forms), sylvite, ettringite and gypsum images and spectra.

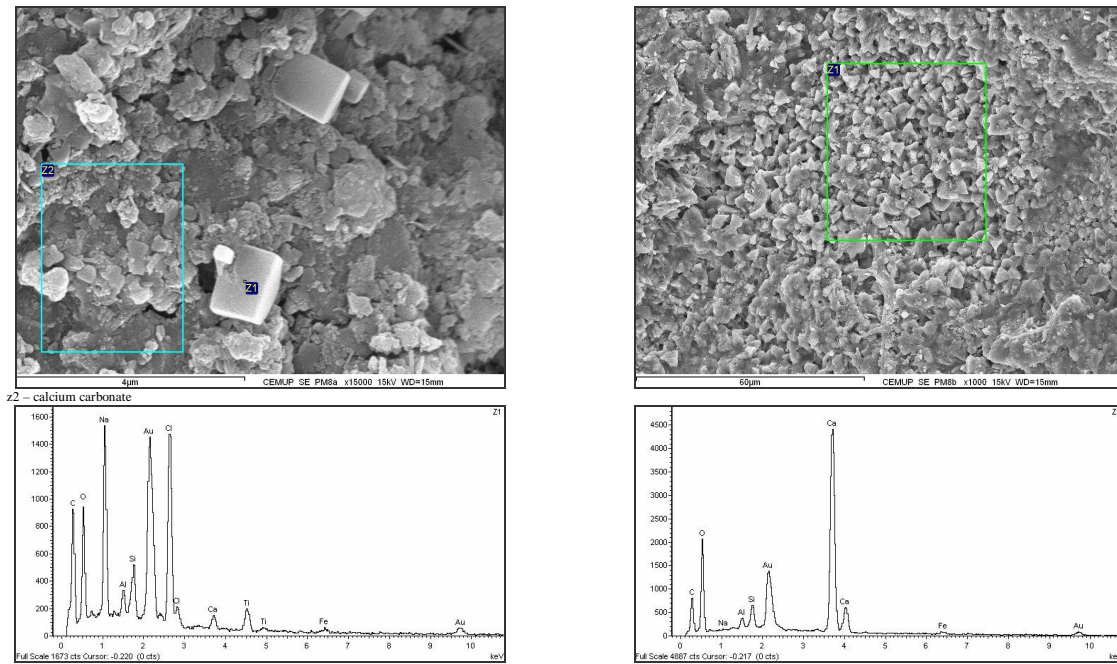
The concrete of the base of one wall-column with a non-structural crack, showed calcium silicates and aluminates, along with large quantities of calcium carbonate and halite, sodium chloride, (NaCl) (‘Fig.7’).

Figure 7. Images and spectra of sodium chloride and calcium carbonate.

The concrete facing south showed many crystals of calcium carbonate and of sodium chloride. This is the original concrete, without treatment, so, the origin of chloride is associated with environmental contamination; it rapidly develops in areas exposed to rainwater. Calcite is due to the penetration of carbonation which is easier when you have crack openings.

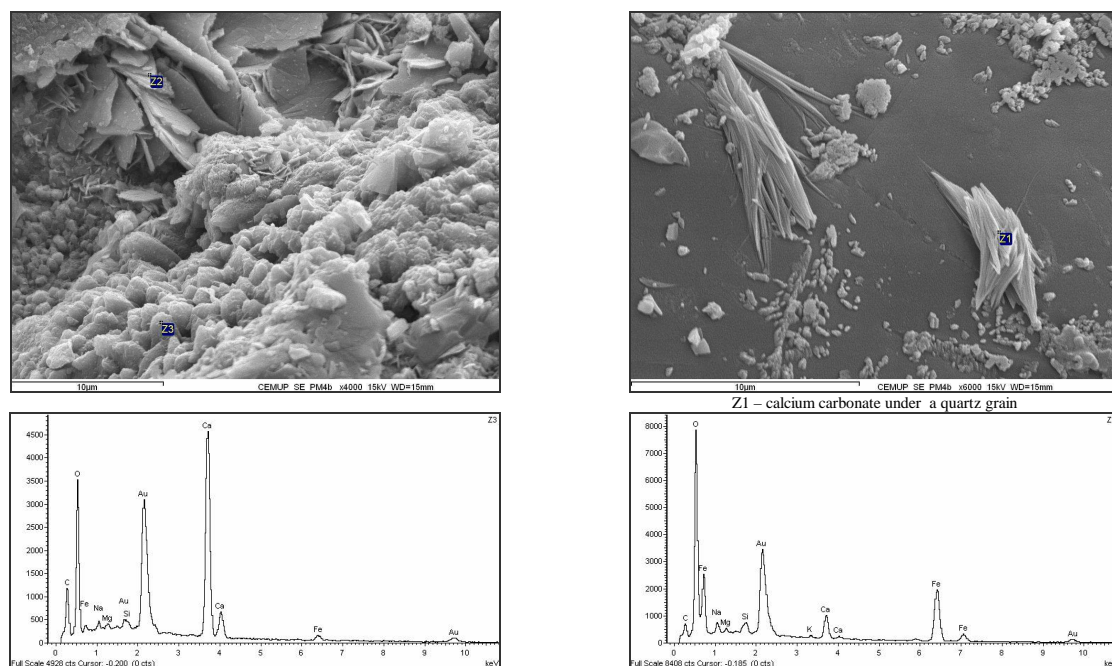
The observations and analysis of the concretes that are partially detached from the structures, near non-structural cracking along the reinforcement, showed that these concretes are very rich in calcite. The brownish stains found, on these concretes, were all of iron oxides ('Fig.8').

Figure 8. Calcite and iron oxides images and spectra.

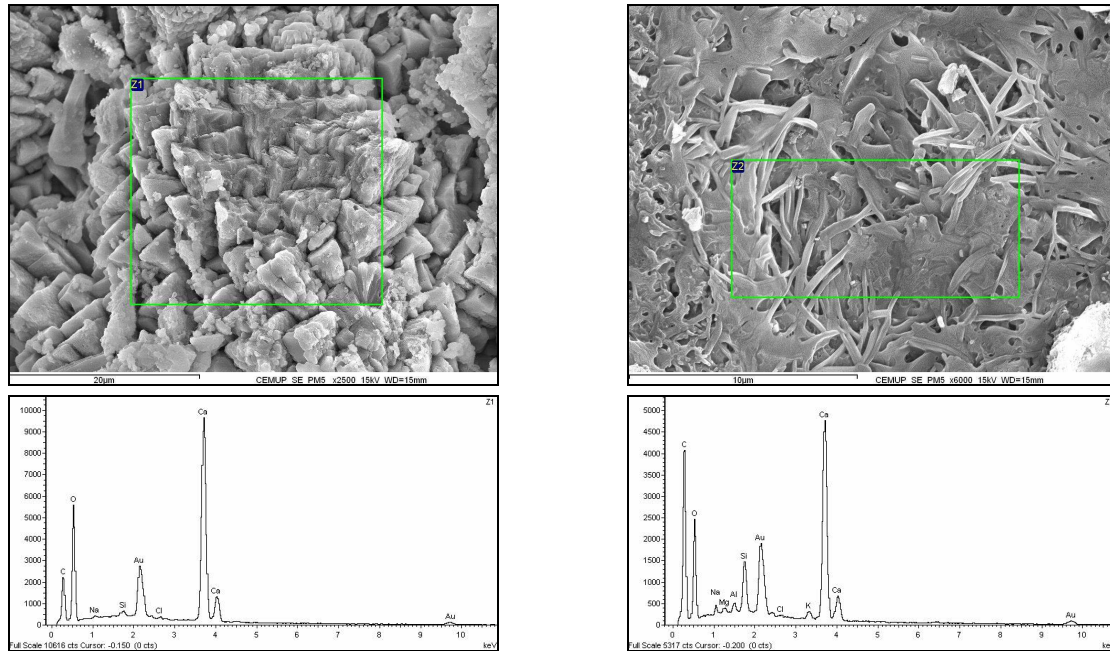
White and dark efflorescence were also analyzed. The white efflorescence consisted essentially of calcium carbonate ('Fig. 9'). The black efflorescence was organic substances ('Fig. 10').

Figure 9. White efflorescence images and spectrum.

The white efflorescence has its genesis in the leaching of lime compounds in the concrete and its carbonation at the surface. The dark efflorescence is an organic substance caused by moisture.

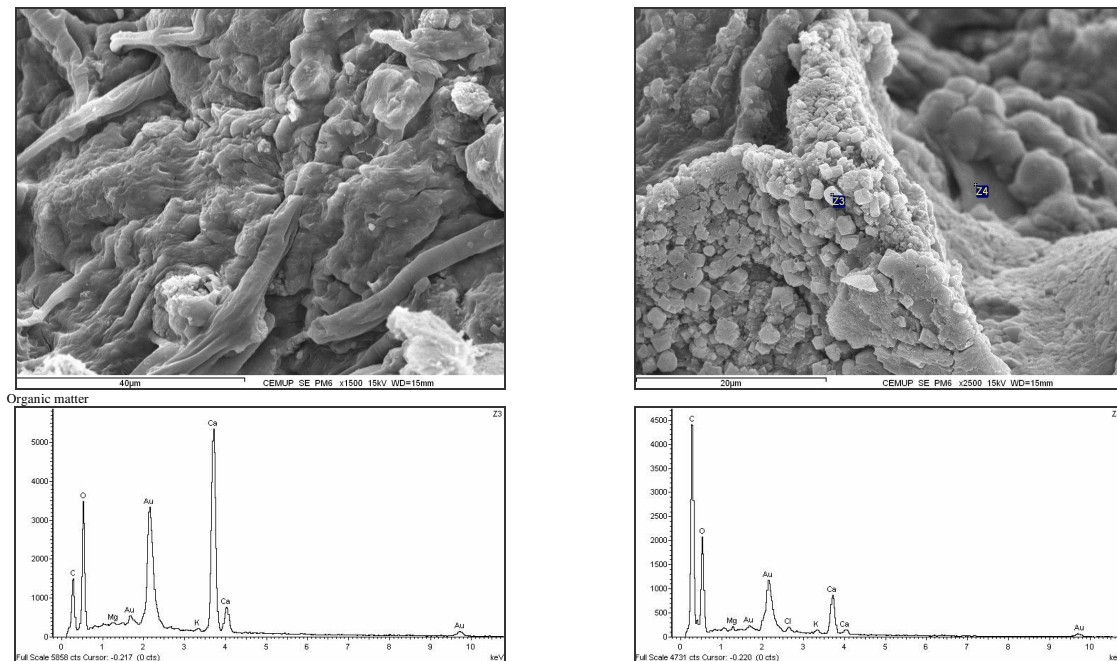
Figure 10. Black efflorescence images and spectra.
