Review

A Review of the Performance of Infilled RC Structures in Recent Earthquakes

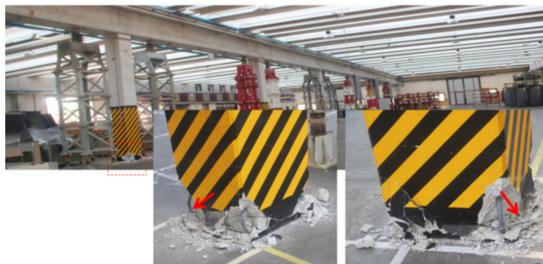
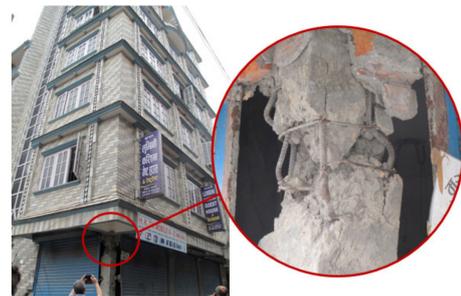
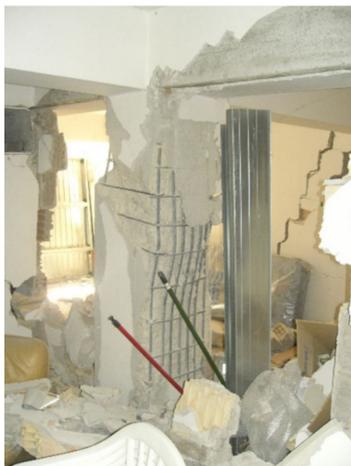
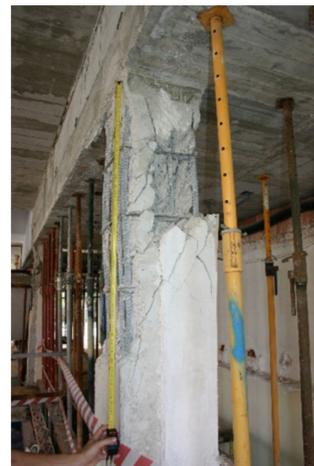
It is possible to find some examples of RC building structures that, during an earthquake, suffered damage in their RC columns due to inadequate transverse reinforcement, namely poor detailing and designing. Figure 4 shows examples of damage observed following the Gorkha, Emilia-Romagna and L'Aquila earthquakes [9,14,15].

Figure 4. Damage type 1—example of post-earthquake damage in RC columns: (a) absence of transverse reinforcement, (b) hoops' poor detailing, (c) large spacing between stirrups and (d) insufficient transverse reinforcement.

It is recommended adequate confinement of the concrete core of the columns and beams in the plastic hinge regions to prevent strength degradation or fragile failure due to shear and flexural demands and increased ductility. This need for confinement is even higher when the column is subjected to high axial and shear loadings. During an earthquake, the failure of beams and beam-column joints is usually related to the inadequate use of transverse reinforcement and confinement. These failures are commonly observed at a local level and may not result in the total collapse of the building structure. A ductile behaviour can be achieved if a proper and adequate seismic design is carried out, with appropriate transverse reinforcement and detailing. Without a refined design and detailing of the transverse reinforcement, a fragile behaviour can occur during an earthquake, and the probability of occurring columns' failure is higher.

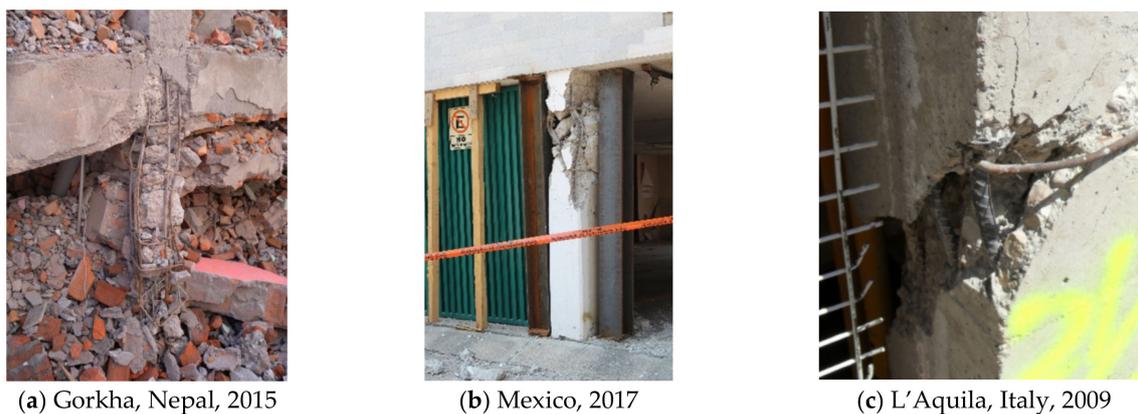
Some examples of this type of damage are shown in Figure 5. They are reported due to poor and inadequate detailing of the longitudinal and transverse reinforcement and to the use of smooth bars.

Figure 5. Damage type 2—example of post-earthquake damage in RC columns: (a) Bond and inadequate spacing of the bars and stirrups; (b) inadequate stirrup detailing and spacing; and (c) inadequate stirrup detailing and use of plain smooth bars.

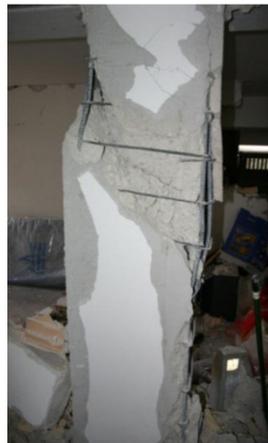
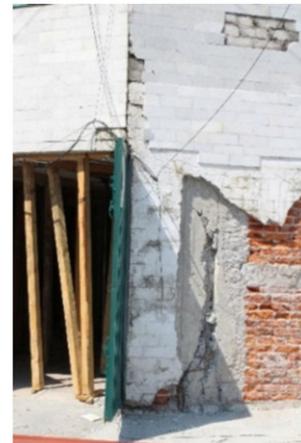
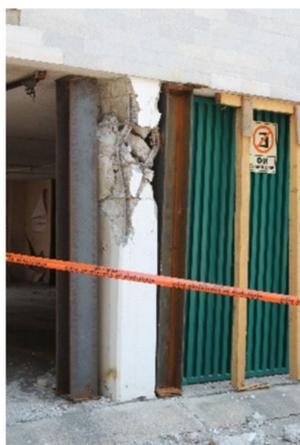
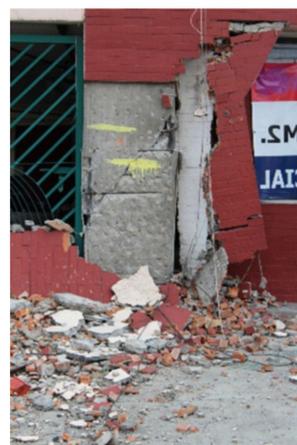
The shear strength and confinement problems are prevalent in corner columns, especially if the building structure has eccentricity between the mass and stiffness centres. The corner columns should be designed with the highest confinement requirements. Figure 6a,b shows examples of damaged columns after the L'Aquila and Chiapas earthquakes, respectively.

Figure 6. Damage Type 3—Example of post-earthquake damage in RC columns: (a) insufficient transverse reinforcement and longitudinal reinforcement in two faces only; (b) shear failure due to inadequate transverse reinforcement; (c) poor detailing and transverse reinforcement; and (d) inadequate stirrups spacing.

Traditionally, the focus of the designers was related to the structural elements strength and rarely with their ductility. Therefore some of these principles have not been adequately understood and applied. Due to that, some fragile failures were observed in elements subjected to flexural loadings (particularly parts from old existent buildings), as shown in Figure 6c,d.

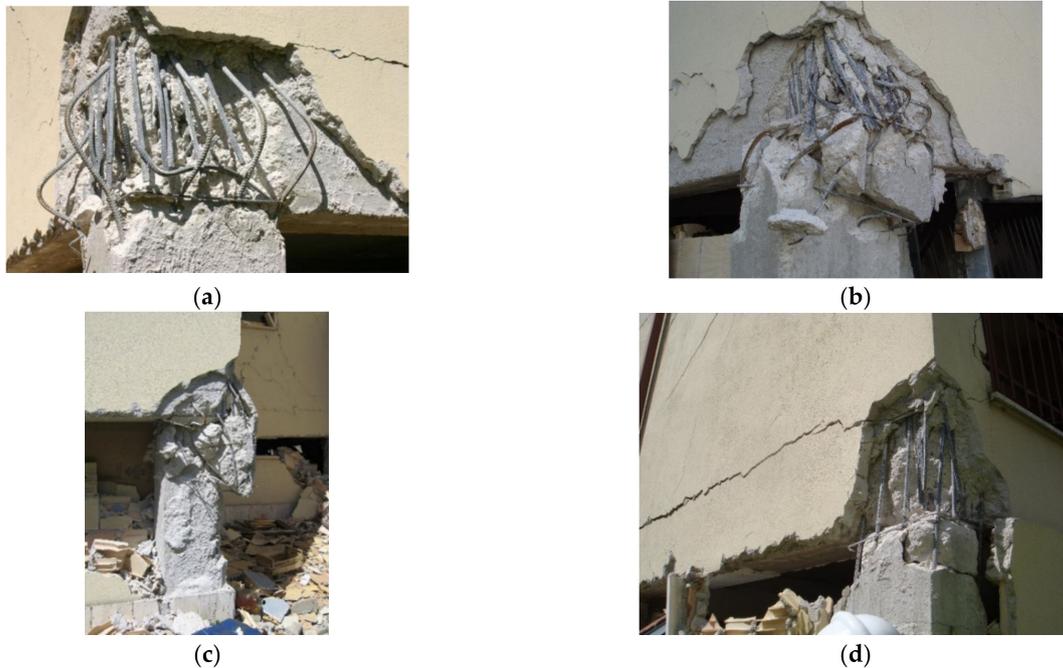
The beam-column joints can be subjected to a significant stiffness reduction due to the insufficient shear strength, poor and inadequate reinforcement anchorage. Both types of failure are related to the deficient use of transverse reinforcement and the poor detailing of the reinforcement anchorage through the joint. The collapse or extensive damage observed in buildings' structures due to the absence of good beam-column joints is widespread during an earthquake event. For example, Figure 7 presents beam-column joints with poor detailing that resulted in the building's collapse during the L'Aquila earthquake in 2009.

Figure 7. Damage type 4—example of post-earthquake damage in beam-column RC joints: (a) absence of transverse reinforcement; (b) bond-split of the reinforcement and inadequate reinforcement anchorage; (c) shear failure of the column due to insufficient transverse reinforcement; and (d) poor detailing and design of the beam-column joints.

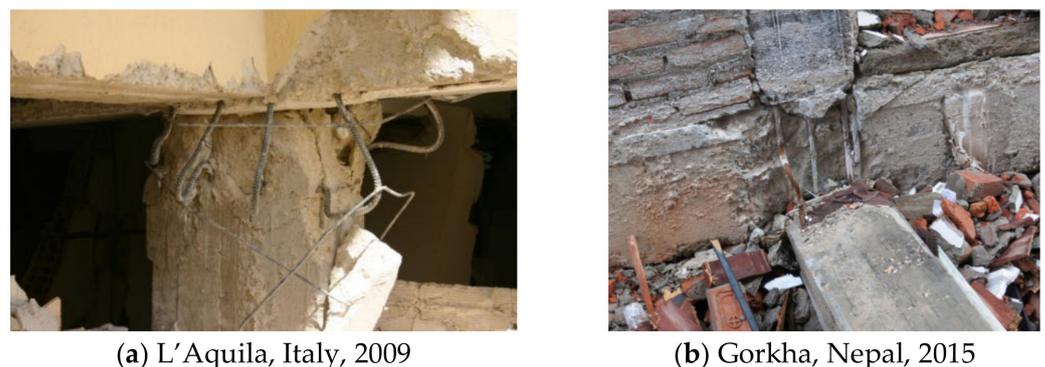
Many RC structures collapsed or were severely damaged due to the development of the strong beam–weak column mechanism, confirming the importance of the recommendation of the actual codes. Figure 8 shows examples of buildings severely damaged due to strong beam–weak column mechanism after the L’Aquila and Gorkha earthquakes.

Figure 8. Damage type 5—example of post-earthquake damage in beam-column RC joints: (a) strong beam–weak column mechanism and (b) absence of transverse reinforcement in the beam-column joints.

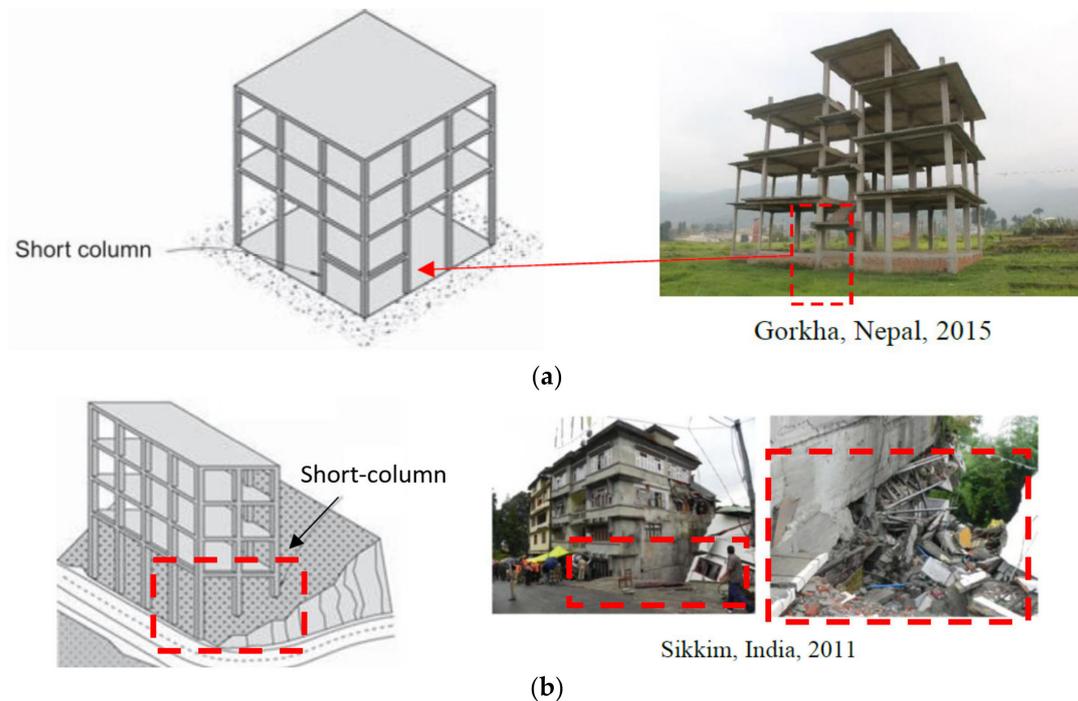
- Situation 1: Existence of columns shorter than others in a moment-resistant frame system. It is well-known that the stiffness of shorter columns is inversely proportional to their length. Examples of this situation are beams for stairs support linked to the surrounding columns and, subsequently, reduce the columns' length. This situation is quite commonly observed in Nepal, as shown in Figure 9a. Some examples of short-column mechanism due to this structural configuration have resulted in the collapse of the columns;
- Situation 2: Building structures located in inclined plans, which lead to columns at the same building level with different length, as shown in Figure 9b. It is possible to observe an RC structure severely damaged after the India Earthquake in 2011 [28];

Figure 9. Damage type 6—example of post-earthquake damage in RC structures: short-column mechanism (a) due to the presence of beam (situation 1) and (b) due to a sloping site (situation 2).

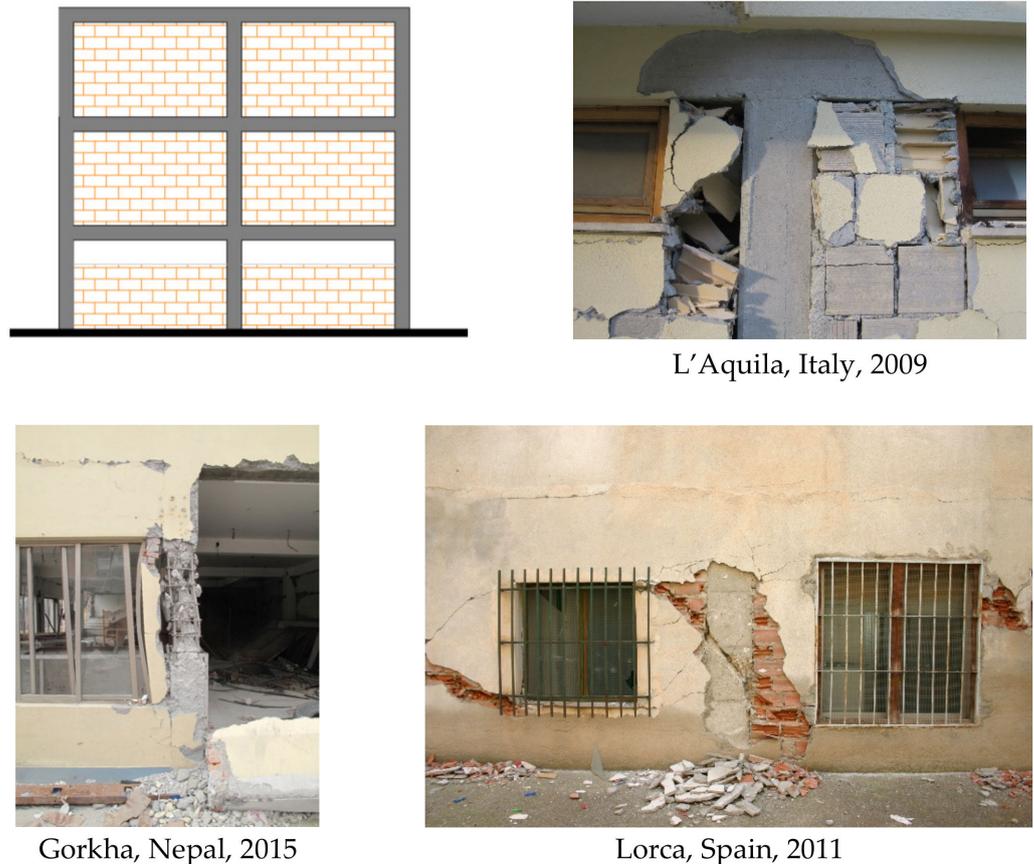
- Situation 3: The third situation in which the short-column mechanism can occur is when the column is adjacent to infill panels that do not fill the total column height. As mentioned before, the infill panels are not considered in the structural and seismic design. However, they have an essential contribution in terms of strength and stiffness, leading to different behaviour than what was initially predicted. In addition, many infill panels do not fill the total floor height in the construction, such as openings such as doors or windows, leaving a short part of the column exposed to higher shear demands. This situation is not considered in the structural design and is likely to potentiate the shear failure mechanism of those columns (Figure 10). The column failure can redistribute additional loadings to the remaining structural elements, thus increment their vulnerability and, consequently, the building structure vulnerability.

Figure 10. Damage type 6—example of post-earthquake damage in RC structures: short-column mechanism due to adjacent infill panels with openings.

The short-column mechanism can be minimised or prevented through a previous study that combines architectural and structural projects. In other words, the columns' and shear walls' design and/or assessment must be carried out after defining the disposition of the infill panels and the corresponding openings. With this easy strategy, it will be possible to improve the potentially vulnerable zones of the columns subjected to higher shear loadings.

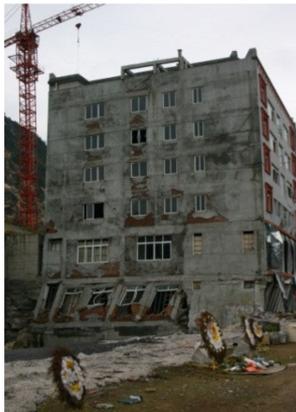
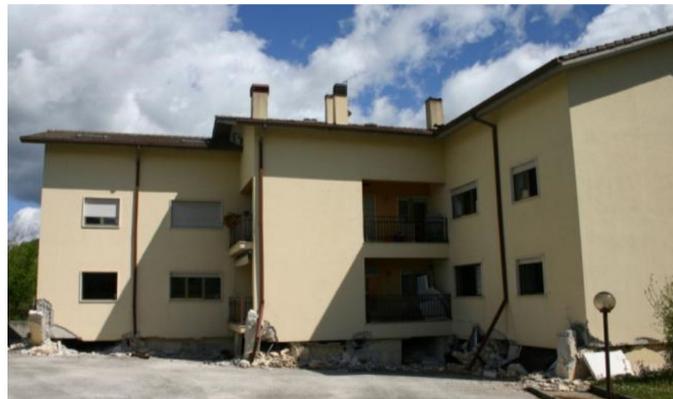
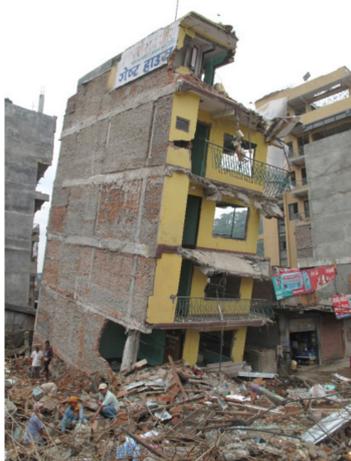
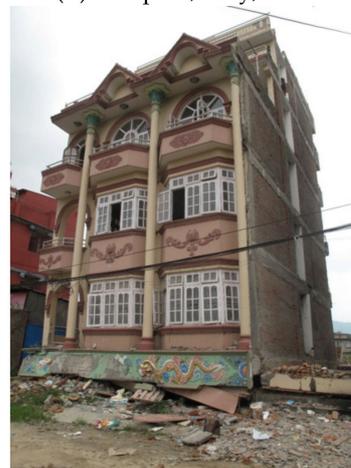
Figure 12 shows two residential buildings that partially collapsed due to the soft-storey mechanism. Figure 12a shows the front view of a six-storey building with a commercial storey on the ground-floor. Figure 12b shows a residential building, 4-storeys' high, with a garage on the ground floor that collapsed during the L'Aquila earthquake. This type of damage can be prevented by ensuring a uniform in-elevation distribution of the infill panels and structural elements (columns and shear walls).

Figure 12. Damage type 7—example of buildings collapsed due to the soft-storey mechanism.

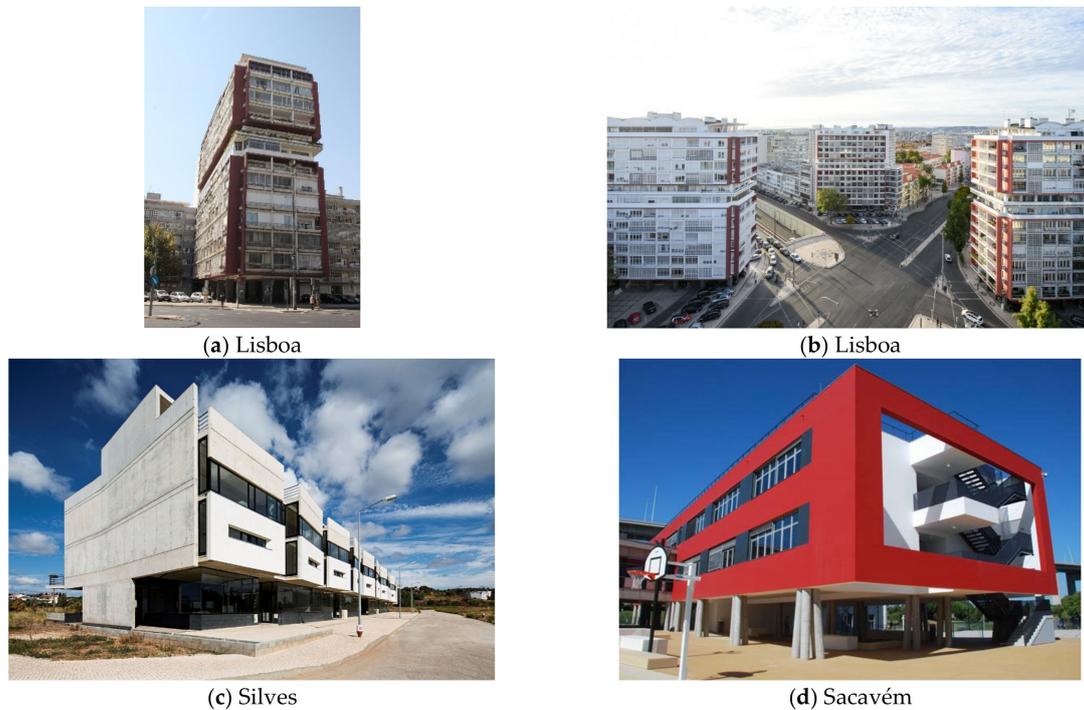
In Portugal, particularly in the Lisboa region, several infilled RC structures built in the 1950s decade were designed with this structural configuration, inspired by Le Corbusier, where the primary system is supported by pilotis to allow the circulation of the people, garage and commerce, as shown in Figure 13. Residential buildings with vertical irregularities, located in Lisboa and Silves, are shown in Figure 13a–c. Additionally, Figure 13d presents a school with the same structural irregularity.

Figure 13. Examples of buildings with soft-storey configuration in Portugal: (a) 11-storey building; (b) general view of 11-storey structures with soft-storey configuration; (c) 4-storey building; and (d) school building.

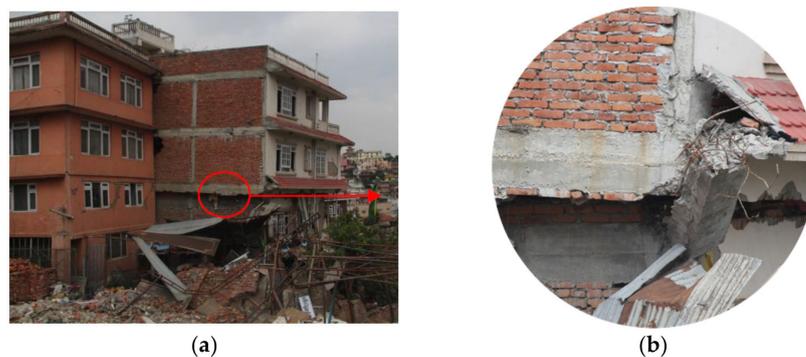
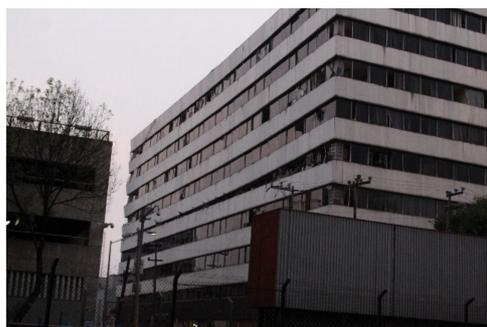
Other examples of stiffness irregularities were found at the upper-storeys, which resulted in their collapse without leading to the total failure of the building structure. For example, Figure 14a,b shows a 5-storey building severely damaged due to aftershock following the Gorkha (Nepal) earthquake in 2015. The collapsed storey corresponded in the past to a restaurant with a lower number of infill panels when compared with the remaining storeys. This irregularity resulted in the deformation concentration and high shear demands and thus the collapse of this level. In 2017, the same phenomenon was observed in Mexico, where the partial collapse of the fourth storey of an 8-storey building occurred (Figure 14c).

Figure 14. Damage type 7—example of a partial collapse of the upper-storeys: (a) general view; (b) detail of the column shear failure; (c) detail of an 8-storey building with soft-storey collapse at 4th storey.

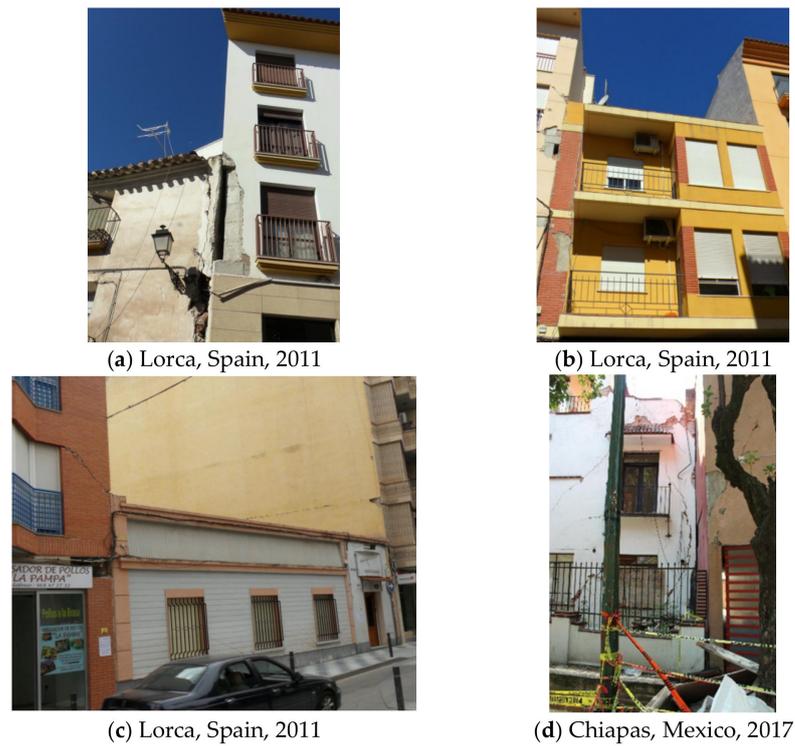
Several damages were reported due to the pounding effect during earthquakes (i.e., Lorca in 2011): adjacent buildings with different height and/or structural configurations and materials (Figure 16a), the urban centre, facing the different dynamic responses, results in shocks between the buildings (pounding) and thus accumulate stresses in specific common points between adjacent buildings (Figure 16b–d).

Figure 16. Damage type 8—example of pounding effect after the Lorca, Spain 2011 earthquake: (a) adjacent buildings with different heights; (b–d) cumulative stresses and cracking in common points among adjacent buildings.

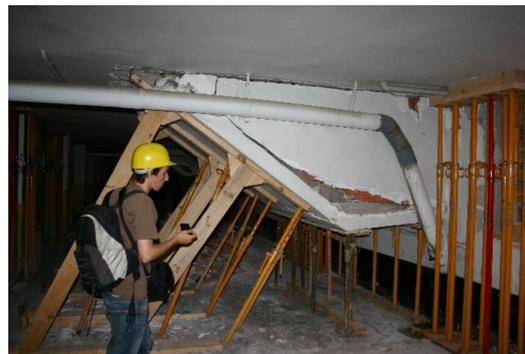
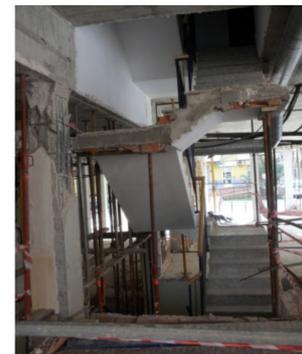
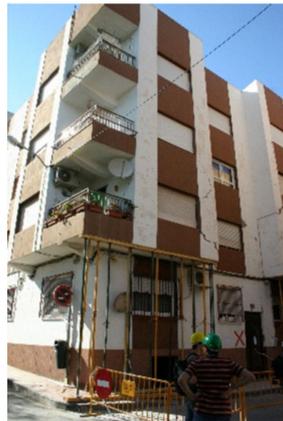
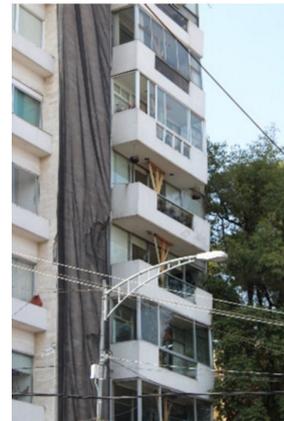
After the last major earthquakes, the damage observed in the infilled RC structures was also reported and linked to secondary elements such as stairs and/or cantilevers. In the case of stairs, some partial collapses were observed and were related to the absence of proper design and/or poor detailing combined with constructive errors and no connection of the stairs to the primary structural system. Examples of this type of damage are shown in Figure 17a,b. Concerning the balconies and cantilevers, some collapses and excessive deformation were caused by the vertical accelerations (Figure 17c,d).

Figure 17. Damage type 9—damage in secondary elements: (a) partial collapse of the stairs; (b) absence of proper connection between the stairs and the primary structural-resistant system; (c) excessive deformation of the cantilever—general view (d) use of props to support the cantilevers with excessive deformation.

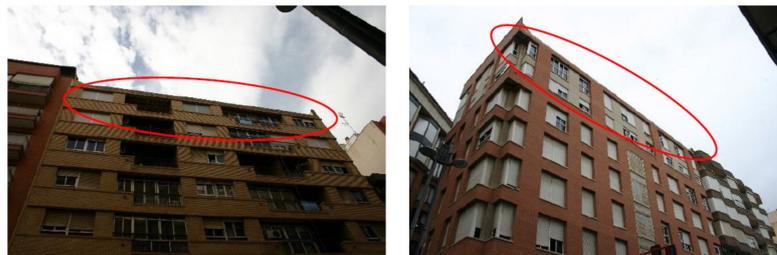
Finally, it is vital to highlight the poor performance and collapse of masonry parapets, as shown in Figure 18. Romão et al. [15] reported that the failure of these elements was the primary cause of fatalities in the Lorca (Spain) earthquake, since the parapets fell from the top of the buildings during the quake, hitting people that were in the streets. It was pretty common to observe parapets not linked to the structure, which resulted in their high out-of-plane (OOP) collapse vulnerability. This problem could be mitigated by designing an effective parapet connection to the structure and preventing its collapse.

Figure 18. Examples of masonry parapets collapses in the Lorca (Spain) earthquake (adapted from Romão et al. [15]).

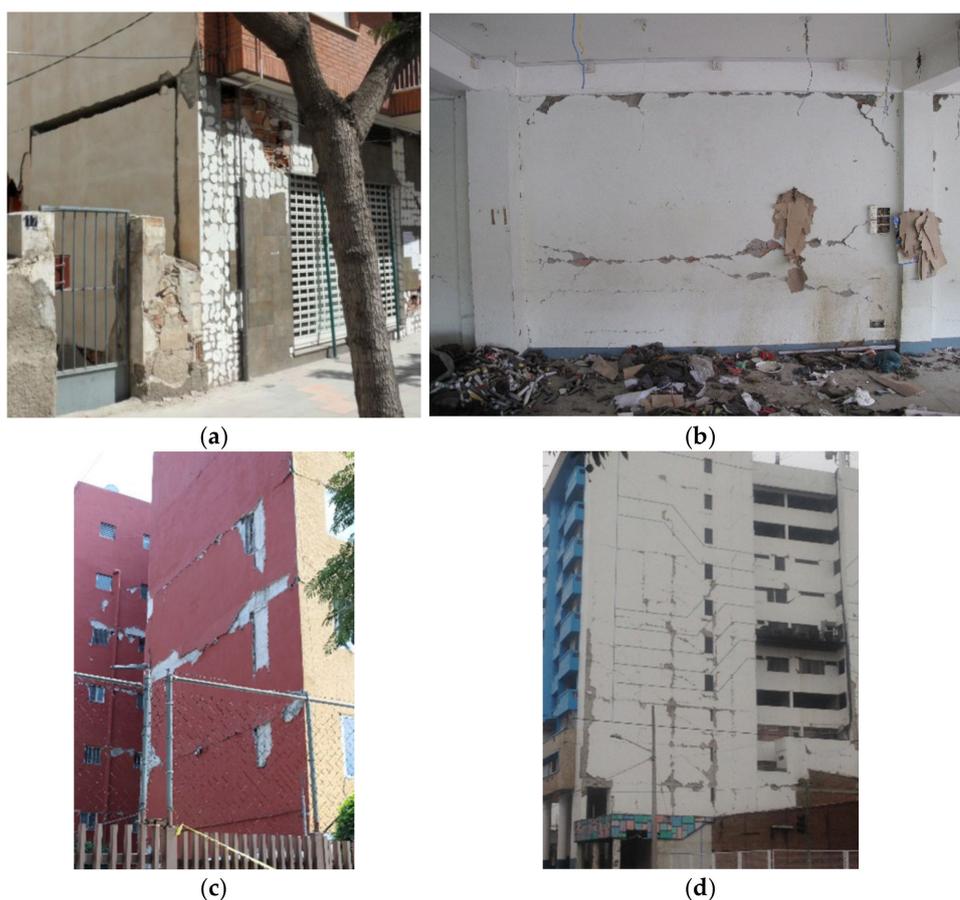
The infill masonry walls tend to detach from the envelope frame for low seismic demands, as proved by the cracking around the panel contours. Besides using different types of masonry units (solid or hollow bricks), the in-plane detachment of the panels tends to occur due to their incapacity to follow the frame deformation during the seismic event, as shown in Figure 19. Multiple examples are herein presented following the earthquakes in Spain in 2011 (Figure 19a), Nepal in 2015 (Figure 19b), Mexico in 2017 (Figure 19c) and Ecuador ((Figure 19d).

Figure 19. Damage type 10—damage in infill panels: detachment of the panel from the envelope frame: (a) Lorca, Spain 2011; (b) Gorkha, Nepal, 2015; (c) Chiapas, Mexico, 2017 and (d) Muisne, Ecuador, 2018.

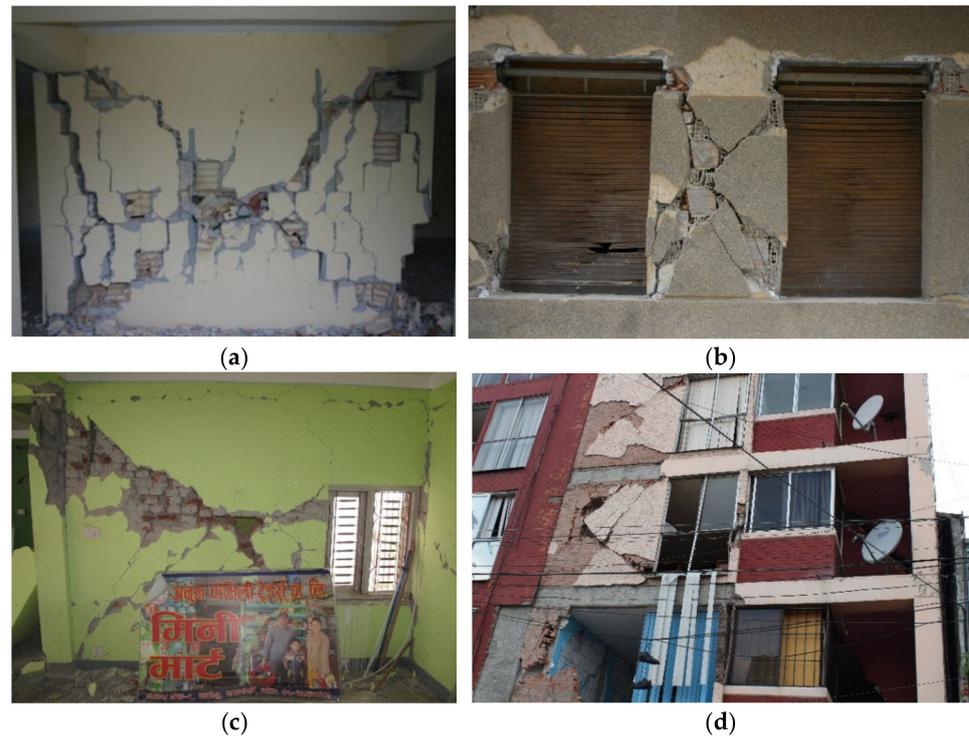
Moreover, it is well-known, infill panels generally exhibit a diagonal damage pattern due to the horizontal action parallel to their plane, as shown in Figure 20. Such damage can be more or less diffused across the building and generally concentrated at the lowest floors, where the relative displacement demand is typically higher. Such damage is clear evidence of the interaction of infills with the RC structure seismic response. Therefore, their typical definition of ‘non-structural’ components can be considered as not appropriate. Furthermore, the infill panels damage is often particularly severe under moderate seismic shaking, proved by the economic seismic losses reported in recent earthquakes [29], and casualties, thus reducing the seismic resilience of the communities in seismic-prone areas [5].

Figure 20. Damage type 10—damage in infill panels: diagonal cracking: (a) L’Aquila, Italy, 2009; (b) Lorca, Spain, 2011; (c) Gorkha, Nepal, 2015 and (d) Chiapas, Mexico, 2017.

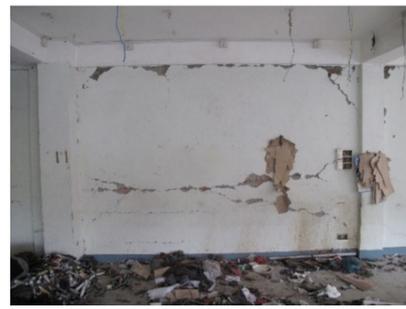
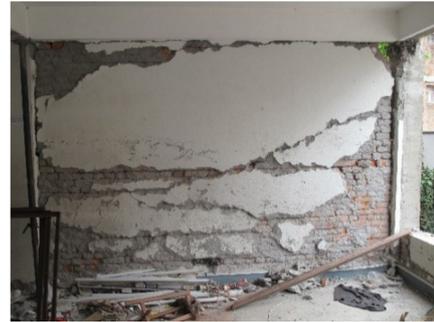
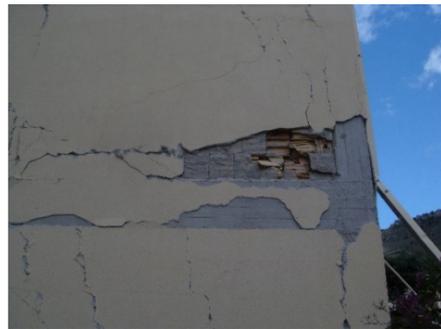
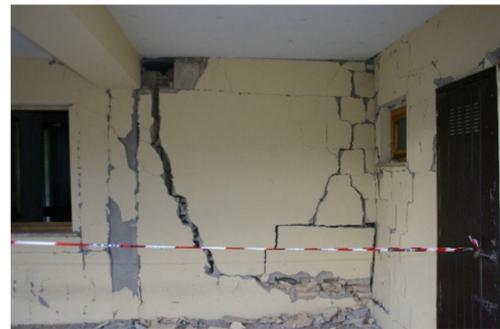
Some other damage mechanisms commonly found in the infill walls due to the in-plane seismic demands were the sliding cracking and the corner crushing. The sliding failure is typically characterised by a horizontal crack at the panel middle height. It is justified by its high in-plane stiffness, which reduces the capacity to deform and then develops the sliding along the horizontal bed joints. This type of damage was often observed in the Gorkha earthquake in Nepal due to the solid clay bricks commonly used there to build the infill walls. These type of bricks are combined with cementitious mortars resulting in panels with high in-plane stiffness. Some examples of this type of damage are shown in Figure 21a,b. In addition, the accumulation of the stresses transferred by the in-plane loading demand can result in the bricks crushing. This type of damage, shown in Figure 21c,d, is often combined with diagonal cracking or detachment of the panel.

Figure 21. Damage type 10—damage in infill panels: (a,b) sliding cracking; (c,d) corner crushing.

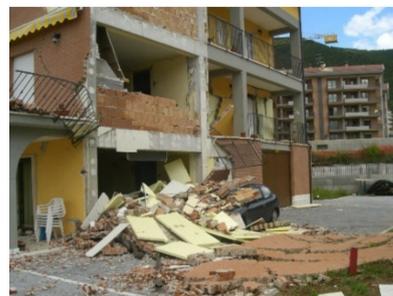
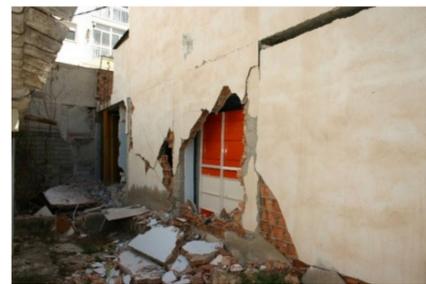
Figure 22. Damage type 10—damage in infill panels: OOP collapse in low-medium RC structures: (a) L'Aquila, Italy, 2009; (b) Lorca, Spain, 2011; (c) L'Aquila, Italy, 2009 and (d) L'Aquila, Italy, 2009.

Some authors pointed out that the inadequate support condition of the panel reduced the panel resistance capacity to OOP loadings. This solution is commonly adopted due to thermal concerns. However, the enormous in-plane demands subjected to the panels leads to higher damage levels, reducing the OOP-resistant capacity. Most often, the OOP collapse was observed in the intermediary storeys of the structures. Figure 22 shows examples of

OOP collapses in RC structures composed of 3–5 storeys. As shown in the Figure 22, the level of destruction caused by the panel collapse is high, representing a significant risk for human life safety and economic losses.

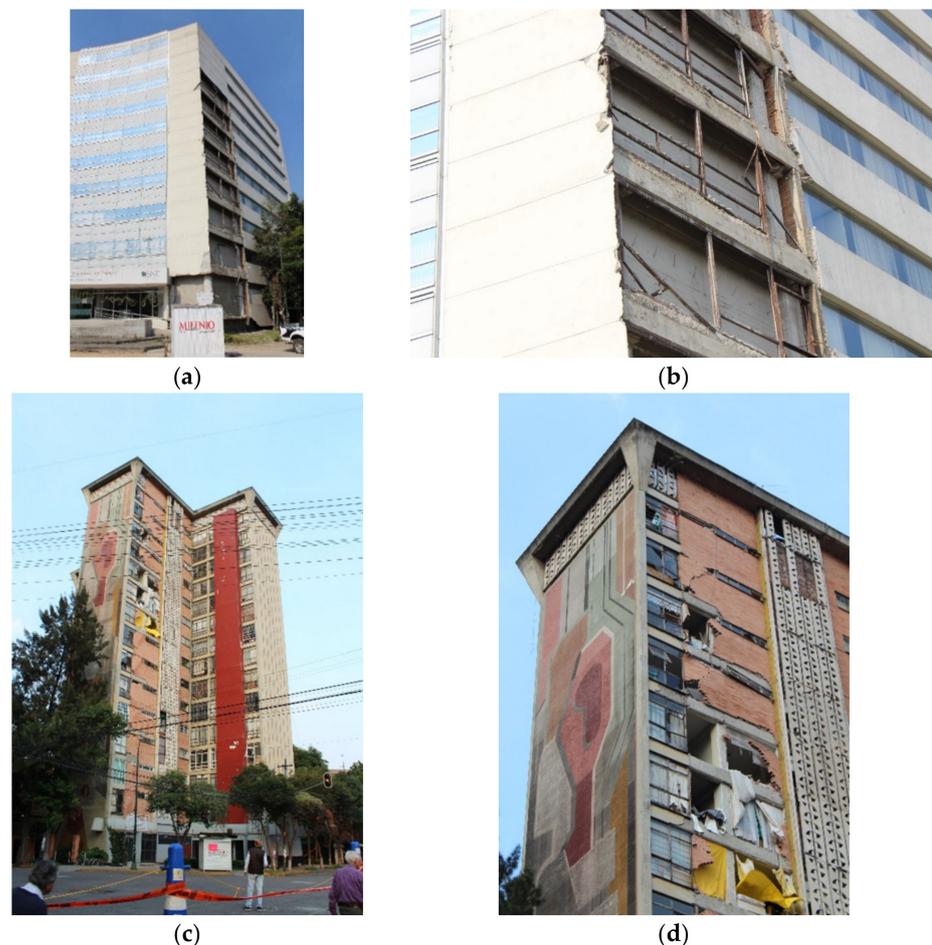
The OOP collapse was also observed in medium-high RC structures, Figure 23, in the intermediary levels comprised of the panels' total failure and consequent collapse. In addition, some other panels with openings, which suffered damage due to the in-plane seismic demands, partially collapsed.

Figure 23. Damage type 10—damage in infill panels: OOP collapse in medium-high RC structures (a) Chiapas, Mexico, 2017; (b) Chiapas, Mexico, 2017; (c) Chiapas, Mexico, 2017 and (d) Chiapas, Mexico, 2017.
