Survey of churches damaged by the May 2012 Emilia-Romagna earthquake sequence

This report presents an overview of the damage that was observed in fourteen churches that were hit by the May 2012 Emilia-Romagna earthquake sequence. The data was collected over the course of a two-day reconnaissance mission that took place on the 9th and 10th of July 2012, and that involved researchers from the Civil engineering Department of the Faculty of Engineering of the University of Porto and of the University of Aveiro, both institutions from Portugal.

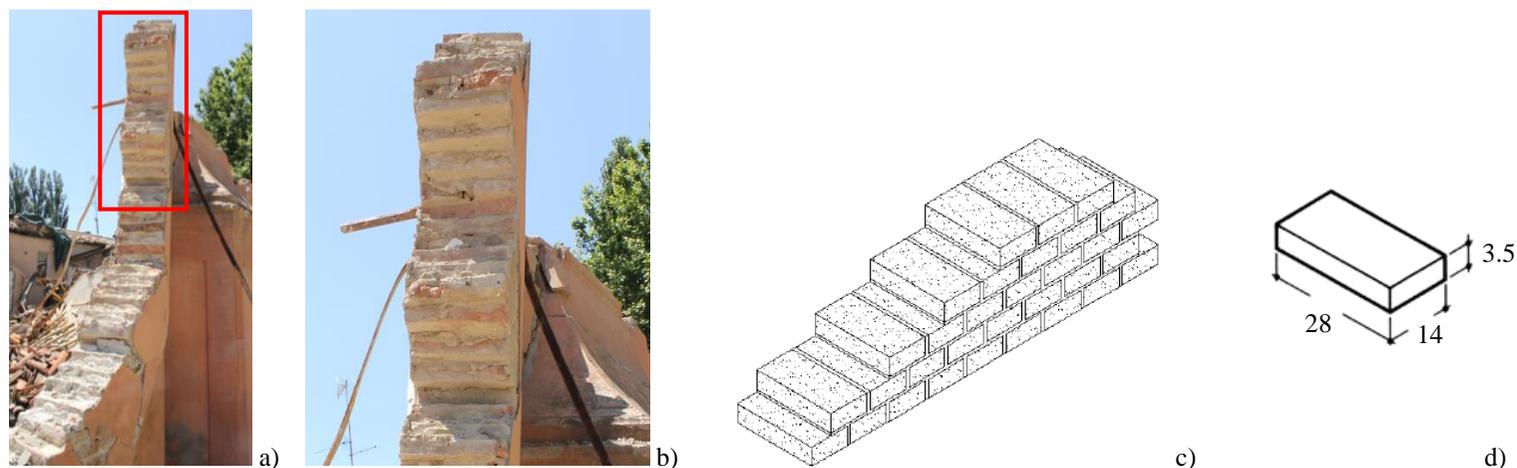
header bond masonry along with the corresponding sketch of the bond type according to Borri (2006). The block dimensions of this wall are $28 \times 14 \times 3.5$ cm according to *in situ* measurements.

Fig. 3 – Single header brick masonry bond in church I2: general view (a), detail (b) and sketch of the bond type adapted from Borri (2006) (c), brick dimensions in cm.

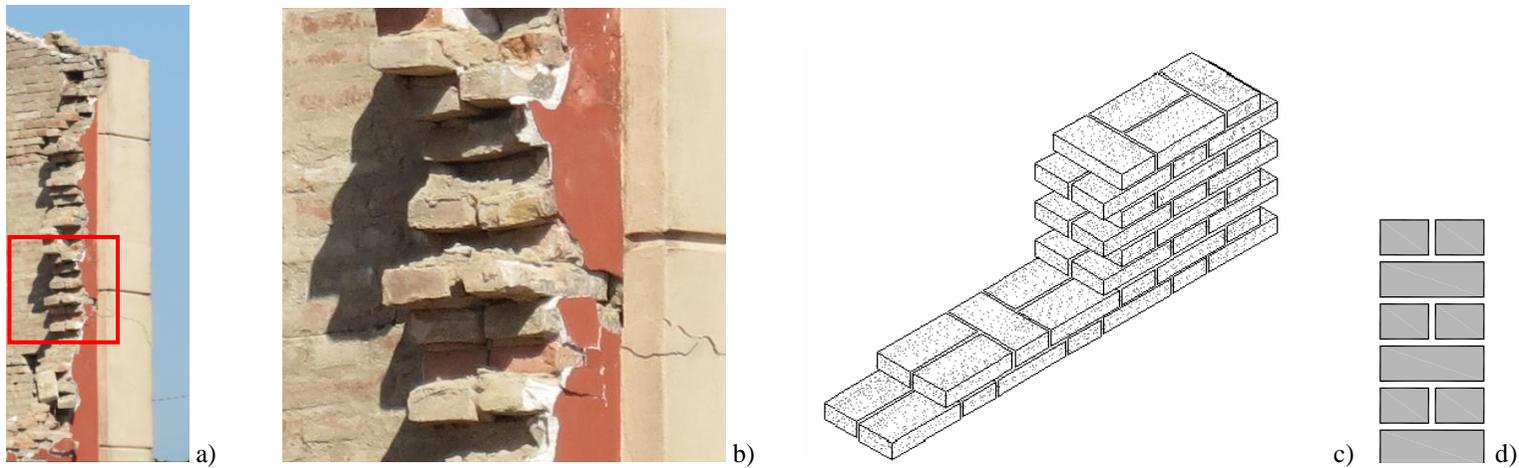
The bond type of Figs. 4 and 5 is a double header bond masonry similar to the Flemish bond and was observed in churches I1 and I3. Figure 4 also presents a sketch of the bond type according to Borri (2006) and a sketch of the cross section view of the wall. In this case, the brick dimensions were not able to be measured. In church I1, it was also observed that the region of the timber truss supports was reinforced by duplicating the wall, Figs. 5b) and c). Although it was not able to be observed, it is believed that both walls must be connected to the truss by timber or metallic elements.

Fig. 4 – Double header brick masonry bond in church I3: general view (a), detail (b), sketch of the bond type adapted from Borri (2006) (c) and sketch of the cross section view of the wall (d)

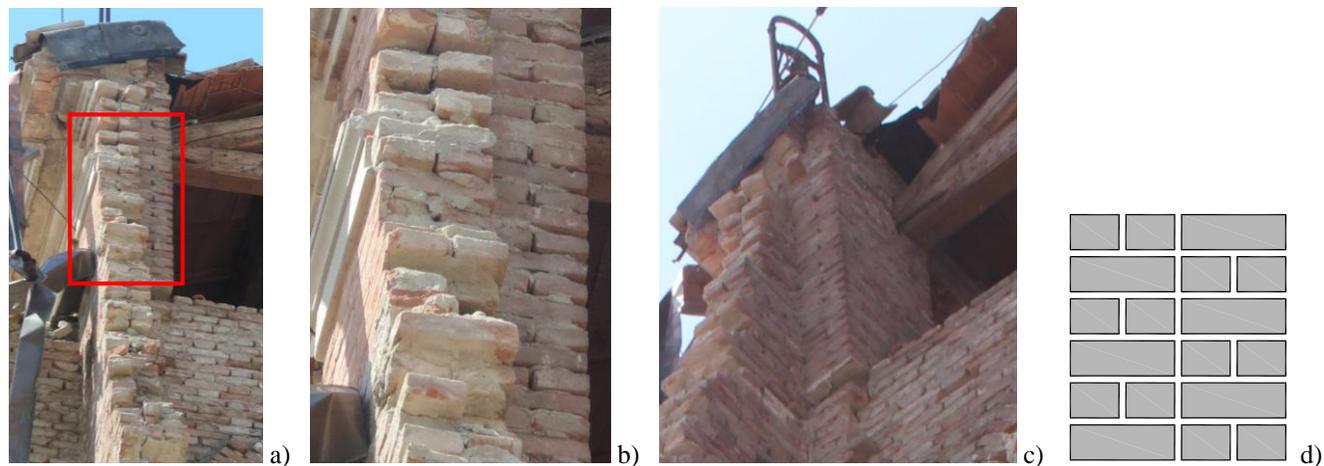
Fig. 5 – Double wall made of double header brick masonry bond in church I1: general view (a), detail (b), view from the back side which supports a timber truss (c) and sketch of the cross section of the duplicated wall in the region of the truss support (d).

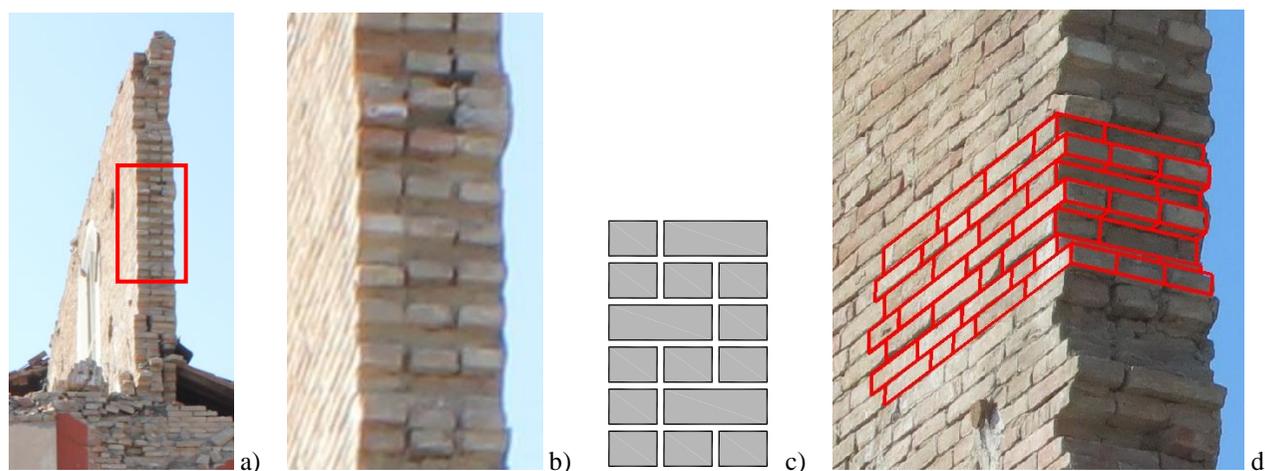
The bond types of Figs. 6 and 7 are examples of triple header masonry bonds. The several examples that were observed show the existence of different triple header bonds. Figure 6 presents an example of a more regular bond found in church I3, as can be seen from the pattern of the cross section view of Fig. 6c). However, the side view of Fig 6d) shows the inexistence of a regular pattern over the several courses of masonry. Figure 7 presents another example of this type of masonry bond also from church I3.

Fig. 6 – Example of a triple header brick masonry bond in church I3, general view (a), detail (b), sketch of the cross section view of the bond type (c) and highlighted detail of the side and the cross section view of the bond type (d).

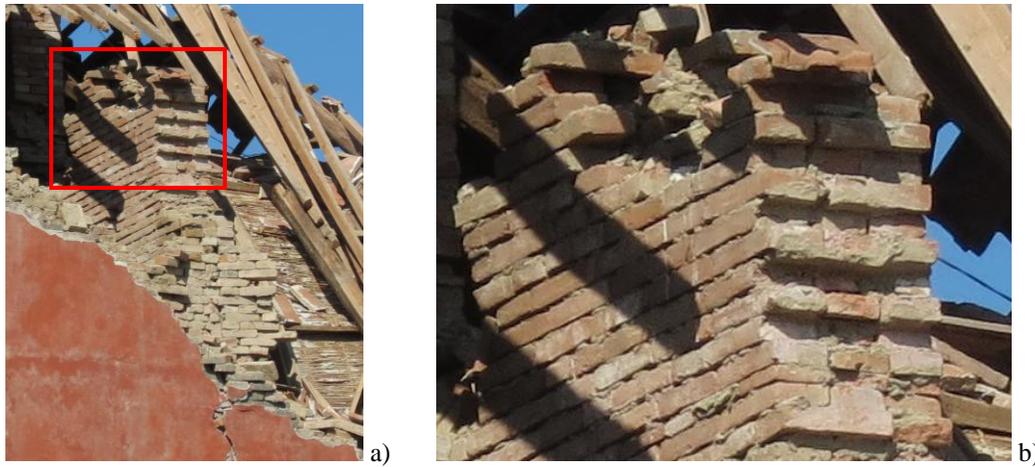
Fig. 7 – Example of regular triple header brick masonry bond in church I3, general view (a) and detail (b).

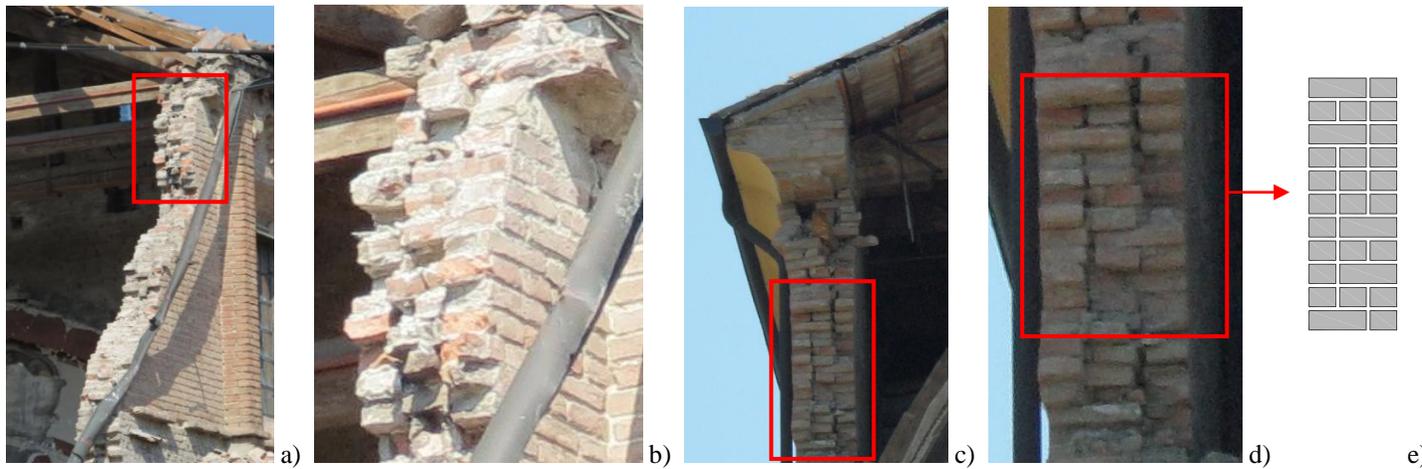
The examples of triple header masonry bonds presented in Fig. 8 were found in churches I9 and I10 and represent cases of a more irregular bond of this type. As can be seen, both the cross section views and the side views show the inexistence of a regular pattern. Furthermore, it is noted that, according to the detail of Fig. 8d), this irregularity promotes the detachment of the three leaves in some localized regions of the wall.

Fig. 8 – Irregular triple header brick masonry bond in church I9, general view (a) and detail (b), and in church I10, general view (c) and detail (d), and sketch of the highlighted part of the cross section bond (e).

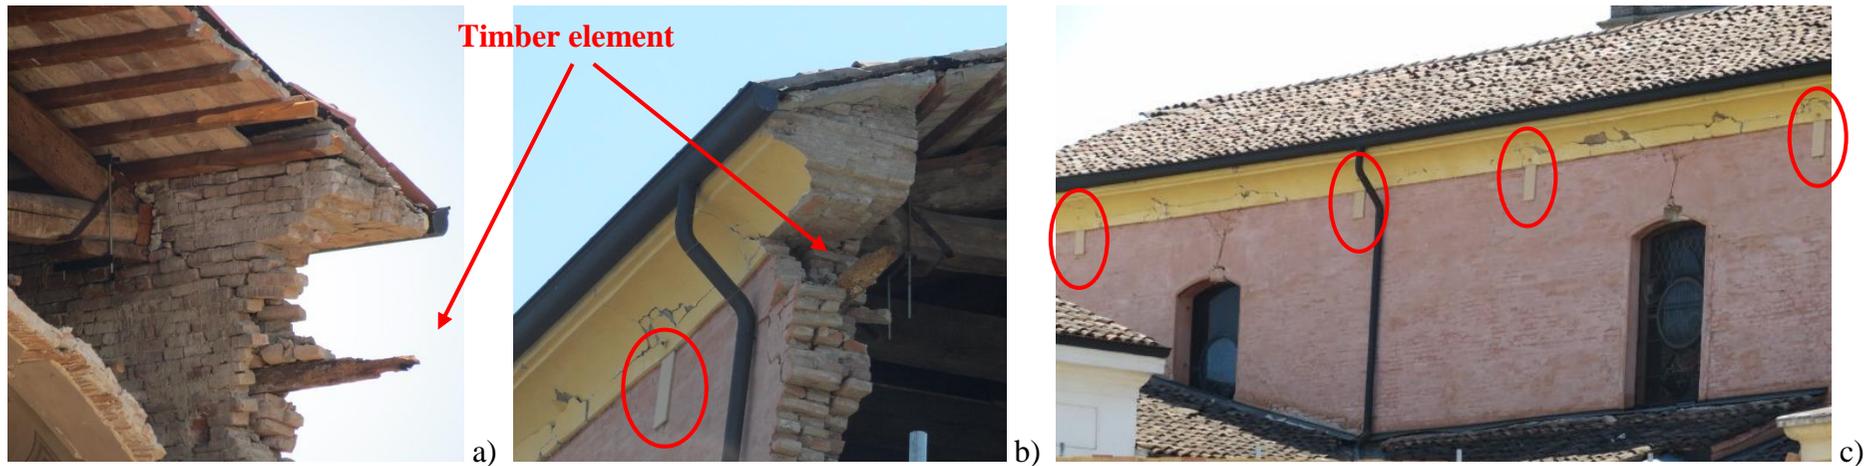
With respect to the walls, it is also referred that, in church I10, timber elements were found inside the triple header masonry lateral walls in the anchorage region of the tie rods with the purpose of enhancing their efficiency (Fig. 9).

Fig. 9 – Timber elements inside the walls of church I10 to enhance the efficiency of the tie rods, (a) and (b), and exterior view showing the tie rod anchoring plates (c).

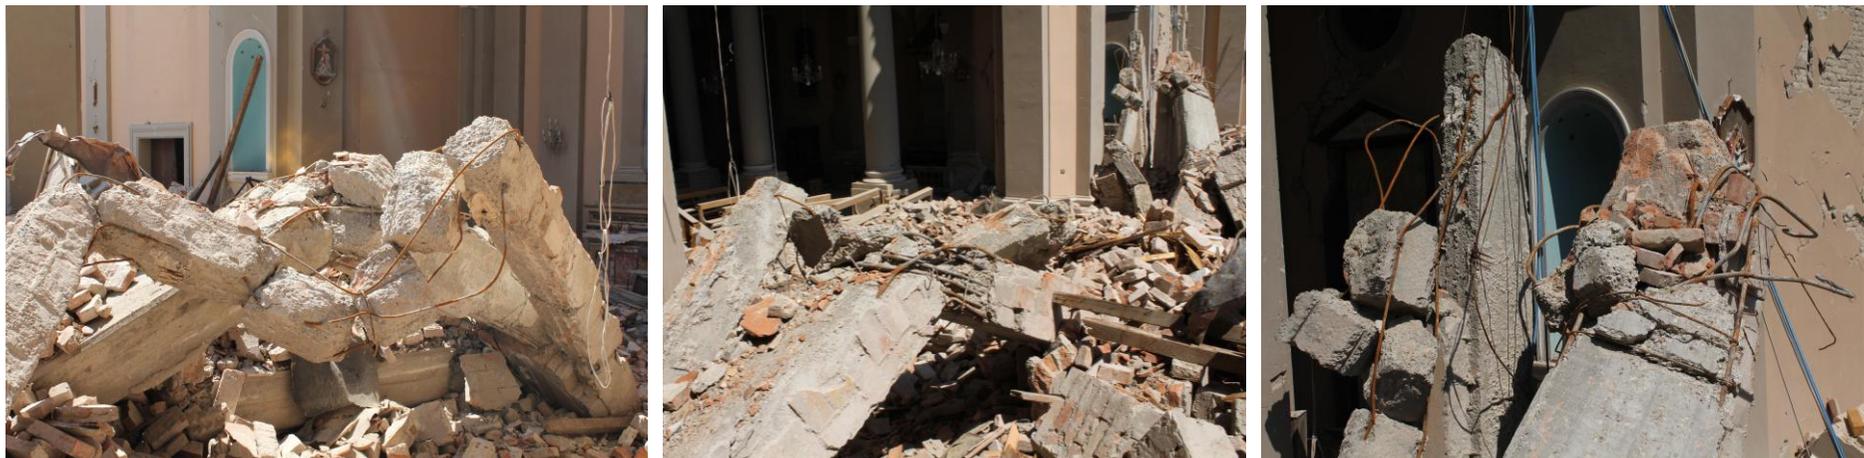
Finally, it is also referred that in church I1, the debris of a collapsed reinforced concrete element were found. The debris are believed to be part of a large reinforced concrete beam that existed over the transept area (Fig. 17). As can be seen, the beam reinforcement was made of smooth rebars and the transverse reinforcement was almost inexistent. It is also noted that the beam appeared to be supported by the brick masonry walls.

Fig. 17 – Collapsed reinforced concrete beam in church I1.
