**Damage suffered by  
Hanuman Dhoka after the  
2015 Nepal Earthquakes**

26 May 2015

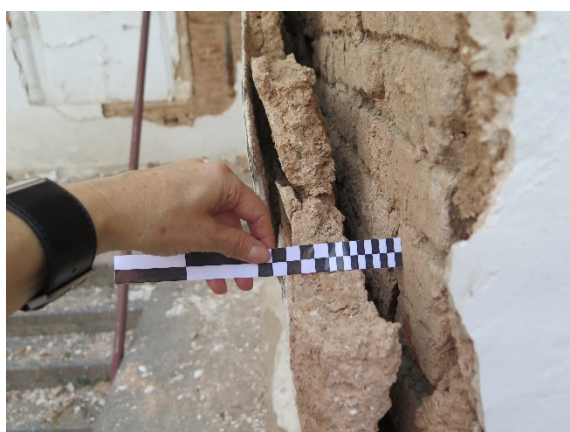
The assessment was essentially based on engineering judgment and visual/qualitative assessment of the damage to the exterior walls. From this analysis, it was seen that the mortar layer that covers the walls has a large thickness, 4 to 4.5 cm, and that many of the visible cracks on the walls do not reflect structural damage. Instead, these cracks only reflect damage to the exterior mortar layer which is also detached from the actual wall structure in many places. It was also seen in many parts of the walls that the cracks in the mortar layer do not extend to the bricks of the wall structure. Figures 1 to 3 show different examples of the cracks in the exterior walls of Hanuman Dhoka that were analysed, while Figs. 4 to 8 show cases where the mortar layer cracks do not extend to the bricks of the wall structure.

Figure 1 – Mortar layer of the walls with 4.5 cm thickness currently detached 3 cm from its support

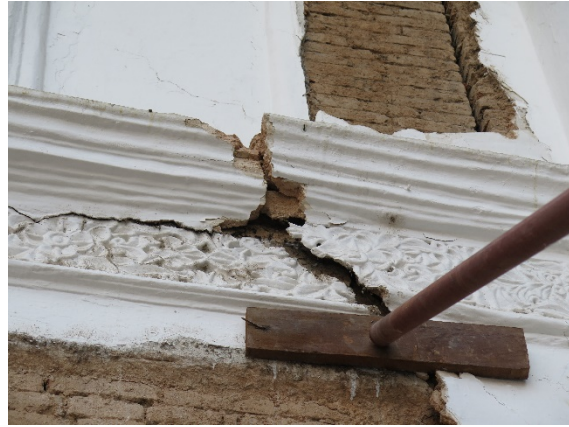
Figure 4 – Cracks in the decorative mortar layer

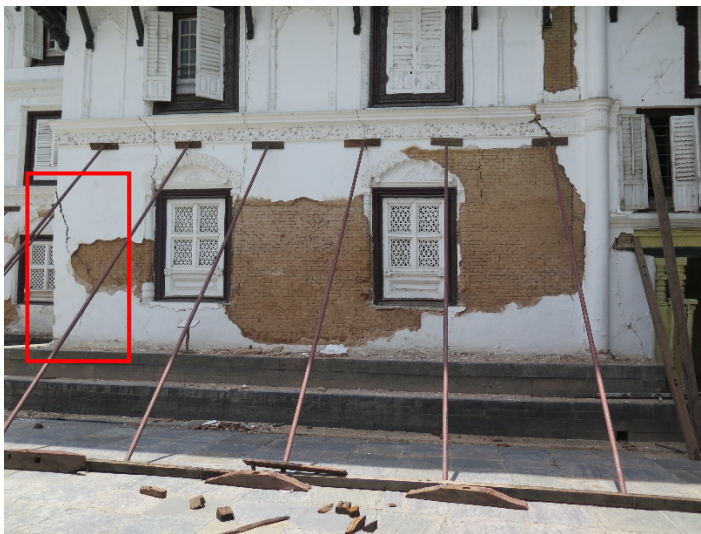
Figure 5 – Cracks and delamination in the mortar layer

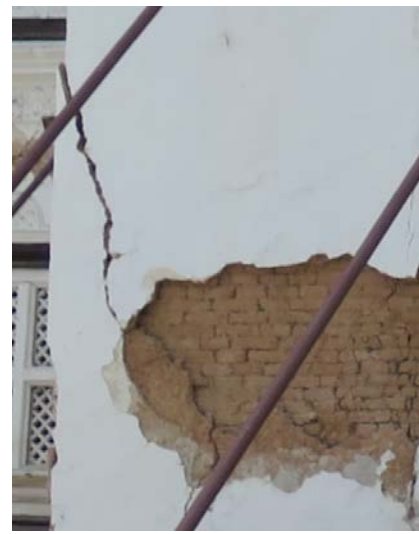
Figure 6 – Detail highlighted in the previous figure

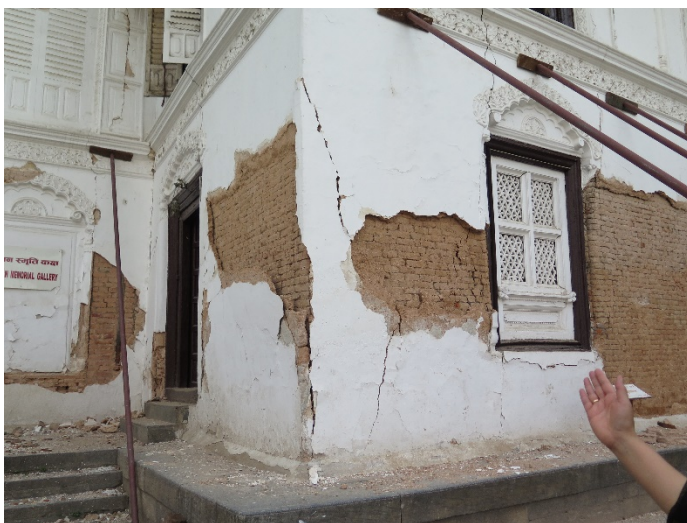
Figure 7 – Cracks and delamination in the mortar layer

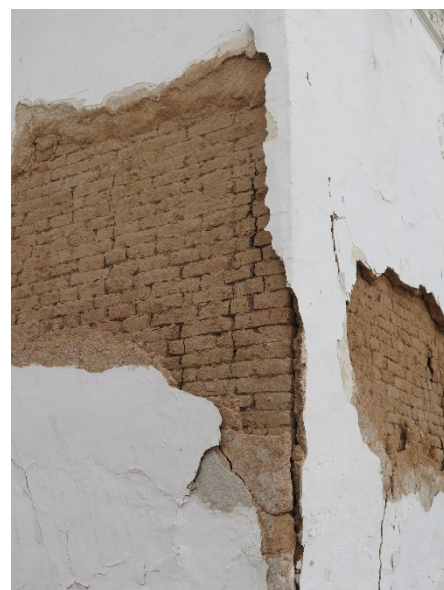
Figure 8 – Detail highlighted in the previous figure

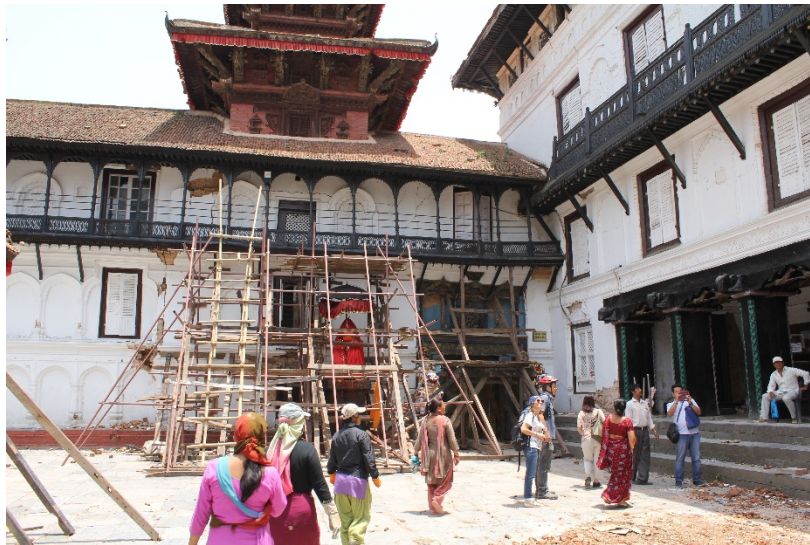
Figure 10 presents a global view of the entrance of Hanuman Dhoka where the temporary stabilization structure shoring some of its elements is in place due to the high level of damage that this section of the building suffered. With respect to façade 1, Fig. 11 presents an overall view where it can be seen that the level of damage due to the earthquake is minor. However, in the area where façade 1 is connected to the Deutaleju temple (Fig. 12), it can be seen that the damage is more intense due to the interaction between the 2 buildings and also due to the high level of damage in façade 9.

Figure 10 – View of the entrance of Hanuman Dhoka which is shored due to its level of damage

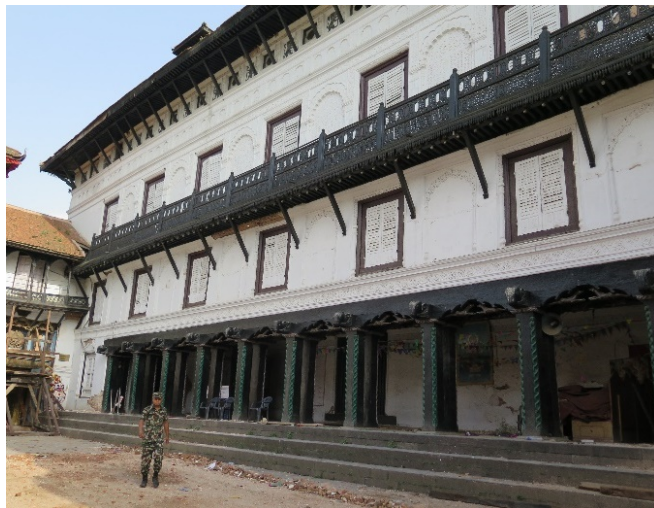
Figure 11 – View of the damages in façade 1 of Hanuman Dhoka

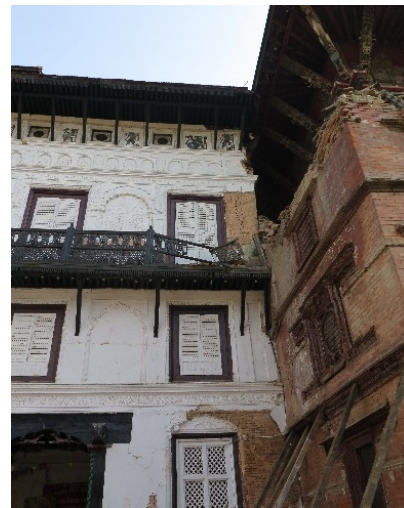
Figure 12 – View of the damages in façade 1 of Hanuman Dhoka and of the shoring of the Deutaleju temple

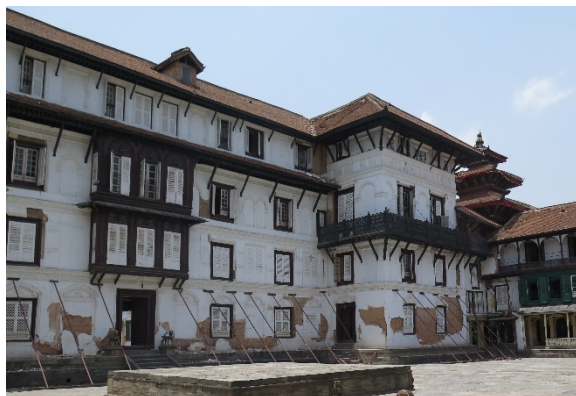
The damages that were observed in façade 2 are shown in Figs. 13 to 16 where it can be seen that a significant part of the damages is concentrated at the ground floor level. Although some of the damages are seen to be mostly non-structural, as previously referred, one section of the façade on the southern side exhibits significant structural damage (see left side of Fig. 15).

Figure 13 – View of the damages in façade 2 of Hanuman Dhoka and of the shoring structures

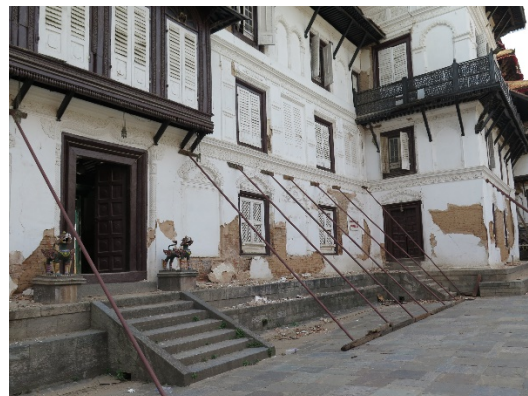
Figure 14 – View of the damages in façade 2 of Hanuman Dhoka and of the shoring structures

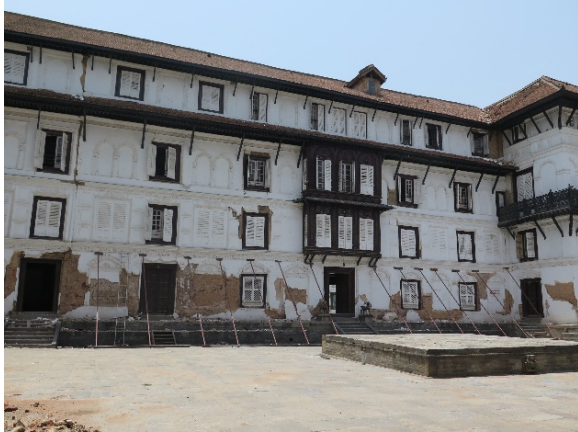
Figure 15 – View of the damages in façade 2 of Hanuman Dhoka and of the shoring structures

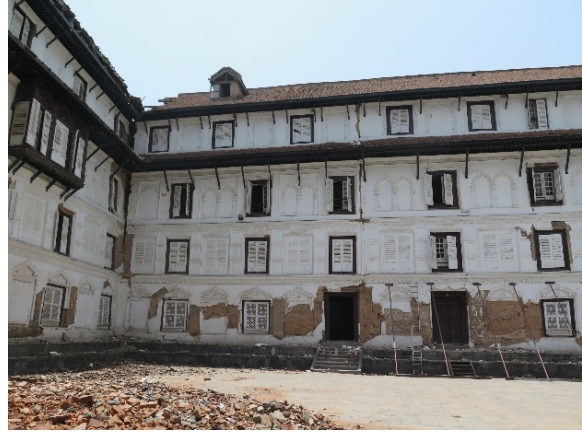
Figure 16 – View of the damages in façade 2 of Hanuman Dhoka and of the shoring structures

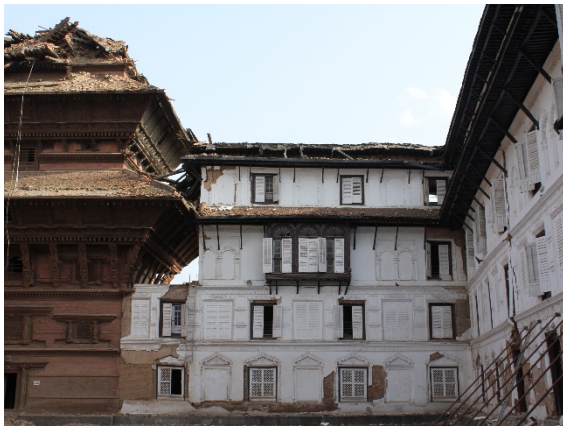
With respect to façade 3, Figs. 17 and 18 present a view of its damages where it can be seen that this façades exhibits a significant out-of-plane deformation making the whole section of the building unstable. Furthermore, it can also be seen that left lateral exterior wall of the building also exhibits out-of-plan damage and is, currently, partially supported by the Nautalle temple.

Figure 17 – View of the damages in façade 3 of Hanuman Dhoka

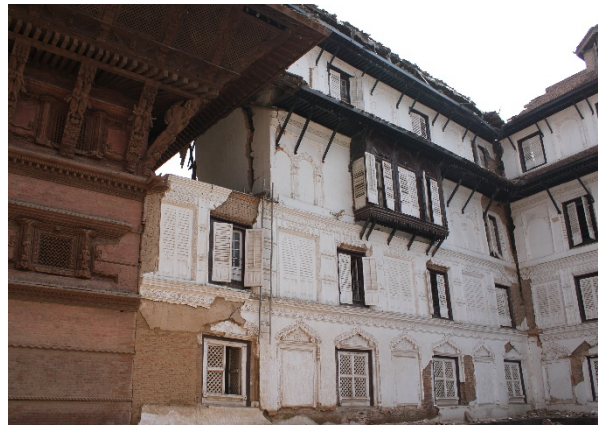
Figure 18 – View of the out-of-plane deformation of façade 3 of Hanuman Dhoka and view of the out-of-plan damage of the lateral exterior wall of the building that is currently partially supported by the Nautalle temple

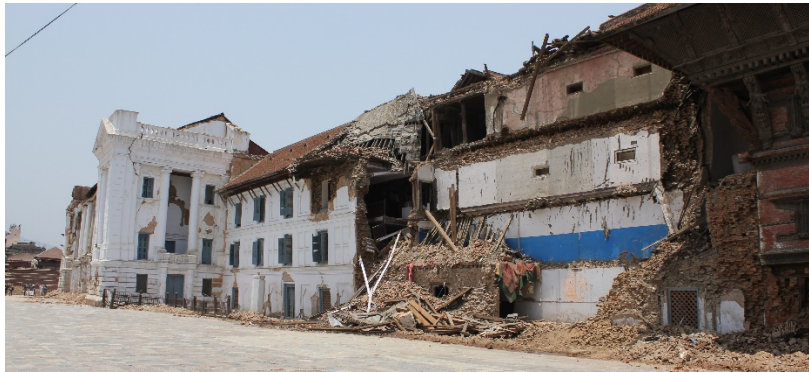
The significant damage of façade 3 is directly connected to some of the damages in façade 4 where the actual part of the façade opposite to façade 3 has collapsed during the earthquake. The remaining part of the façade also exhibits severe damage (Fig. 19).

Figure 19 – View of the damages in façade 4 of Hanuman Dhoka and view of the interior wall of the building in the section of the façade that collapsed during the earthquake

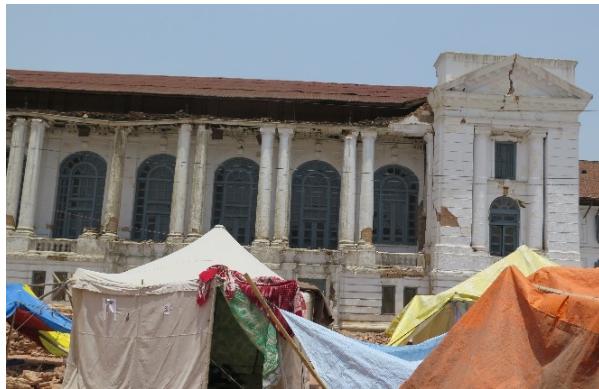
The damages in façade 5 were also seen to be severe. The right side of the façade can be seen to have sustained significant damage involving severe cracks in the frontispiece and the out-of-plane detachment of the top part of the portico (Figs. 20 and 21). In the centre part of the façade, it can be seen that the roof is also severely damaged and that the columns are heavily cracked (Figs. 20 and 21). Finally, on the left part of the façade, it can be seen that part of it has collapsed during the earthquake and that the remains are highly unstable (Figs. 22 and 23). Part of the damages in façade 6, which include severe cracking and the collapse of some elements, can be seen to be directly connected to those of façade 5 (Fig. 24).

Figure 20 – View of the damages in façade 5 of Hanuman Dhoka

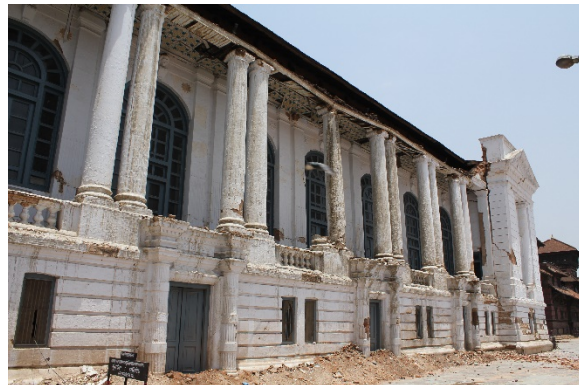
Figure 21 – View of the damages in façade 5 of Hanuman Dhoka

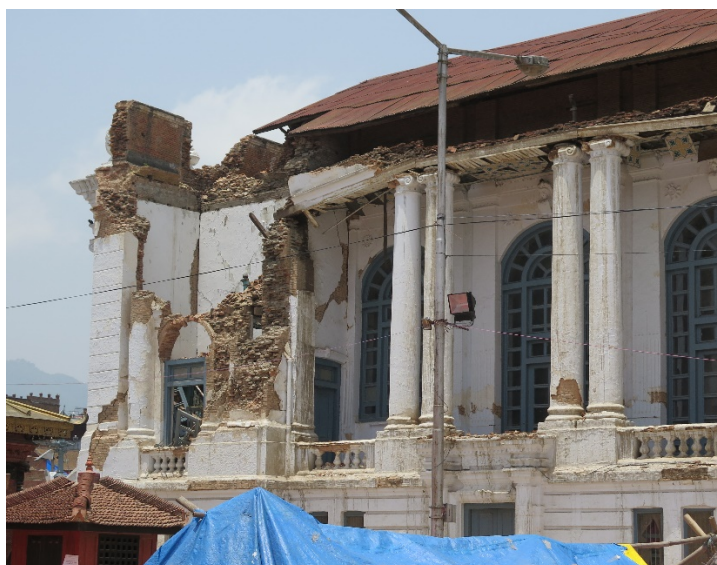
Figure 22 – View of the damages in façade 5 of Hanuman Dhoka

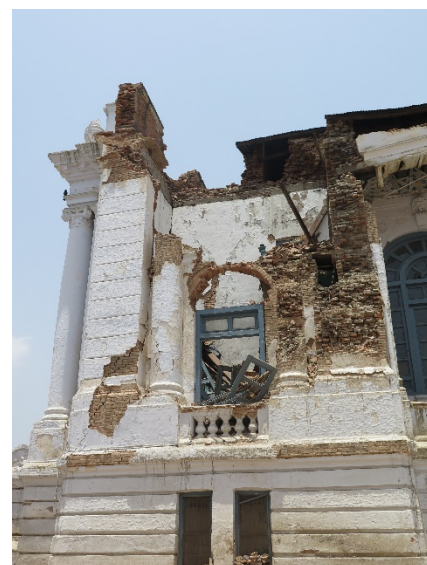
Figure 23 – View of the damages in façade 5 of Hanuman Dhoka

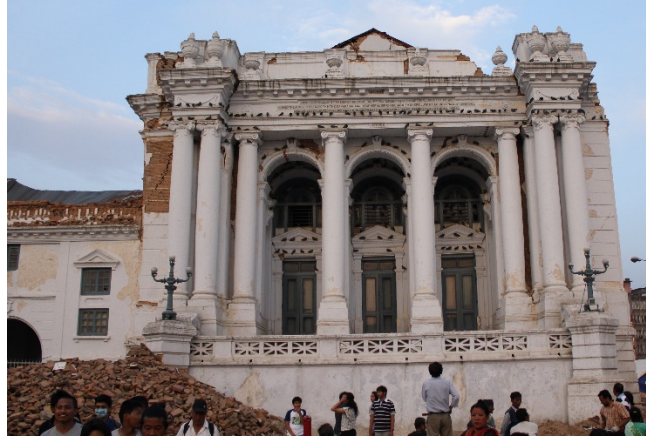
Figure 24 – View of the damages in façade 6 of Hanuman Dhoka

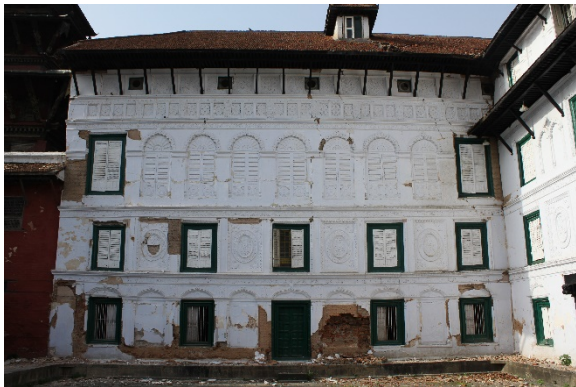
With respect to façade 7 (Fig. 25), it can be seen that a significant part of the damages is concentrated at the ground floor level and most of them appear to structural, involving in some cases the out-of-plane collapse of parts of the wall. On the other hand, the damages observed in façade 8 (Fig. 26) were seen to be minor. Finally, the damages that were observed in façade 9 were seen to involve severe cracking leading to the imminent out-of-plane failure of the top part of the

Figure 25 – View of the damages in façade 7 of Hanuman Dhoka

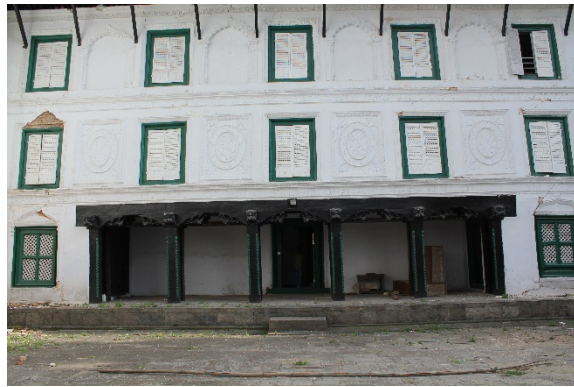
façade (the only visible part of the façade due to lack of access) which could potentially cause further damage to the Deutaleju temple.

Figure 26 – View of the damages in façade 8 of Hanuman Dhoka

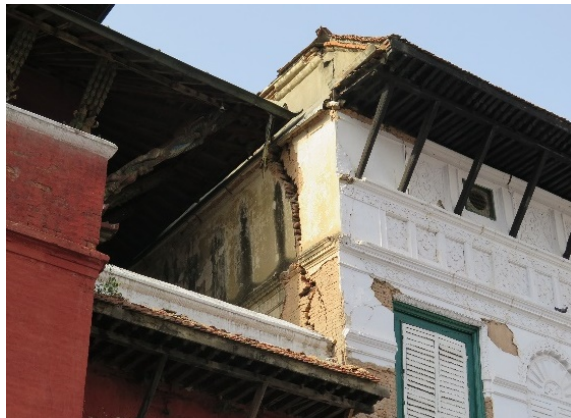
Figure 27 – View of the damages in façade 9 of Hanuman Dhoka

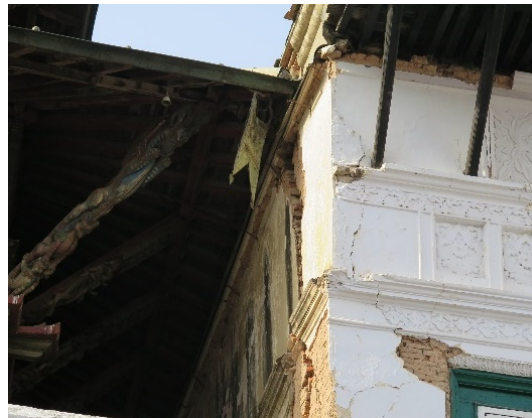
Figure 28 – View of the damages in façade 9 of Hanuman Dhoka

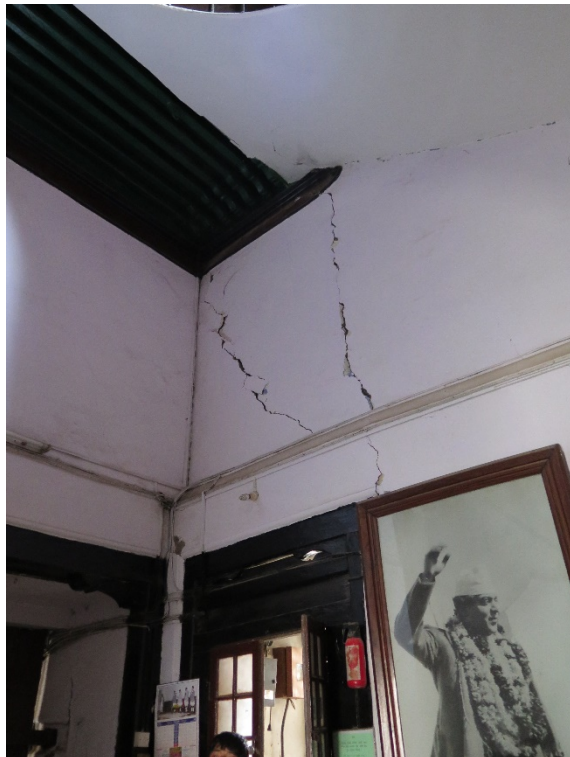
The area that was visited in the ground floor is only that of the entry hall (Fig. 33) and no particular movable heritage was observed in that area. In terms of the damage, some cracks with variable sizes were seen (Figs. 34 to 37). Based on visual assessment, the walls appear to be stable. The staircase did not appear to be unstable under the weight of people.

Figure 34 – Cracks visible in the top part of one of the ground floor wall

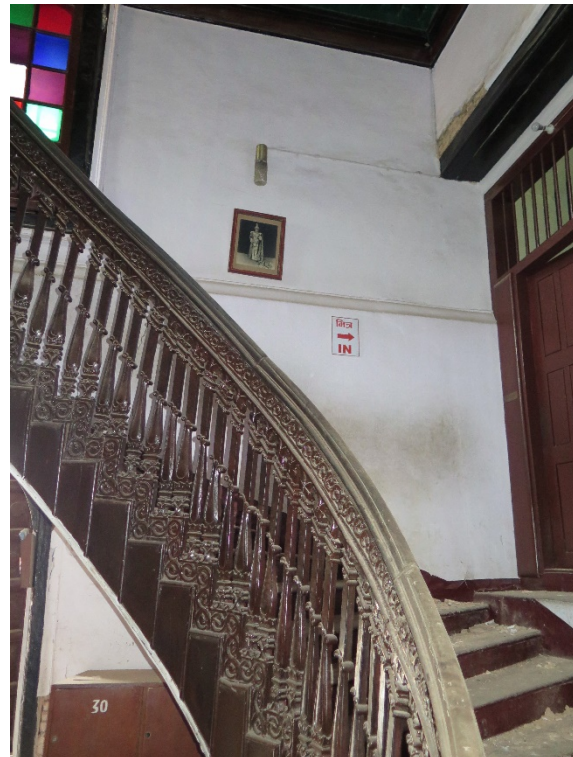
Figure 35 – Cracks visible in the ground floor wall behind the staircase

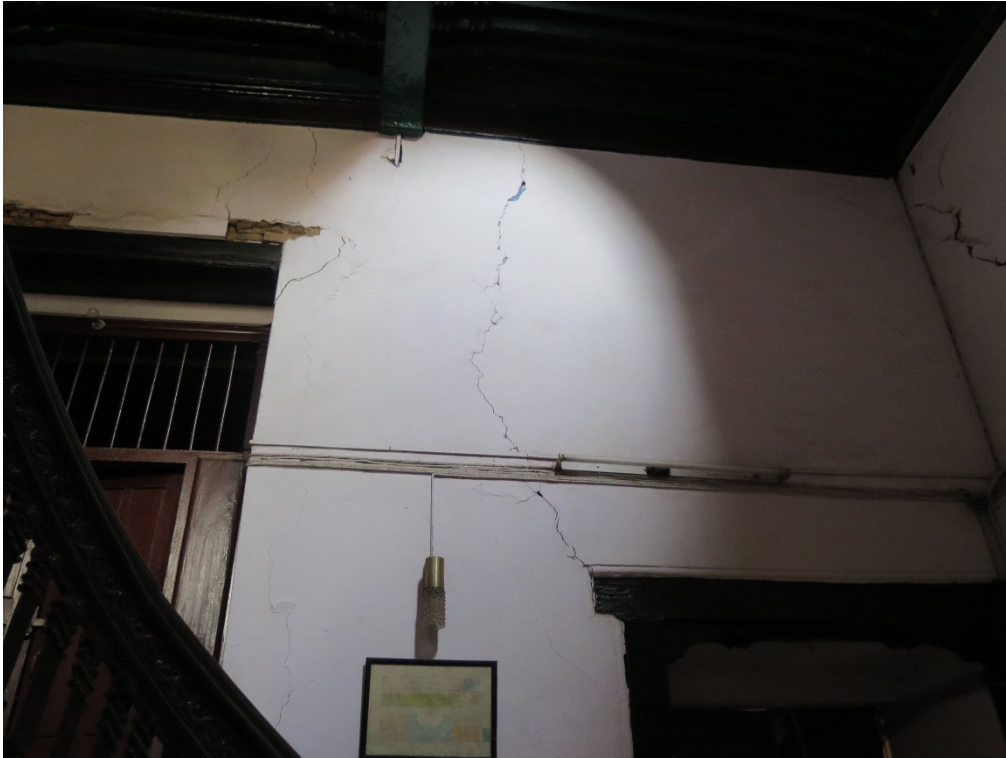
Figure 36 – Cracks visible in the top part of one of the ground floor wall

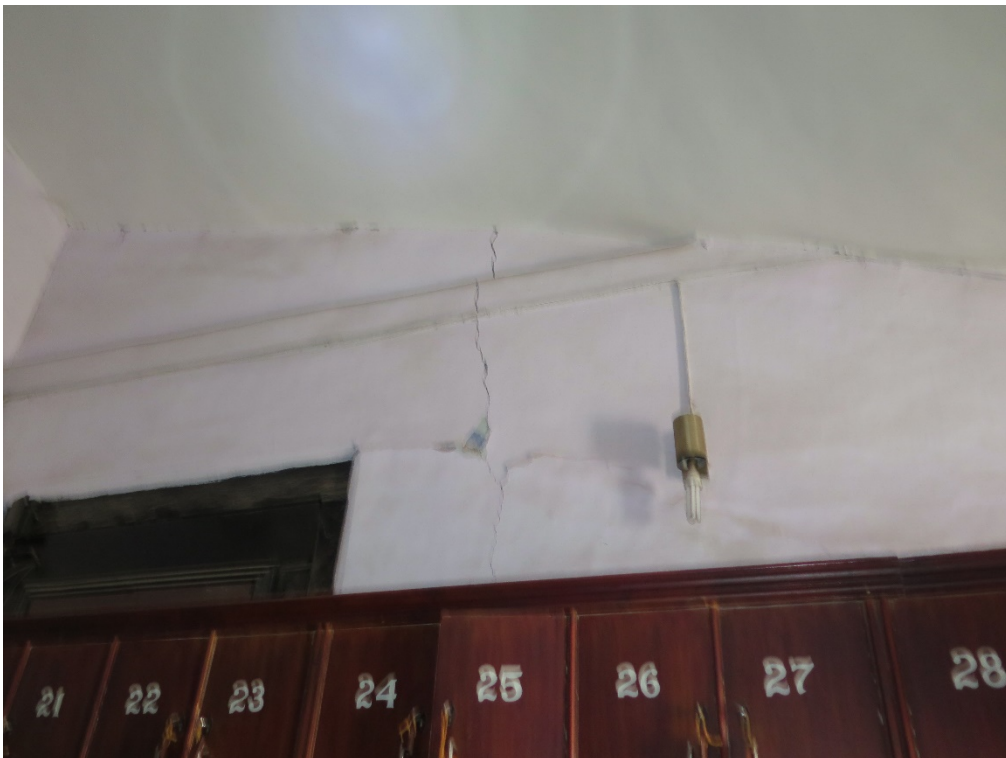
Figure 37 – Cracks visible in the top part of one of the ground floor wall

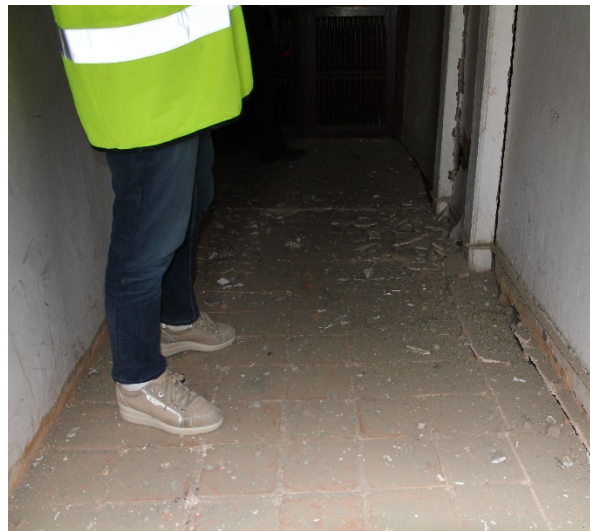
Figure 77 – 2<sup>nd</sup> floor plan from B1 area to B3 area

On the way to area B3, the corridor connecting areas B1 and B3 was seen to exhibit cracks on the floor, near the walls (Figs. 76 and 77). Area B3 corresponds to a lobby area giving access to an office and to staircase to the 3<sup>rd</sup> floor. From the safety point of view, the area close to the staircase (Figs.

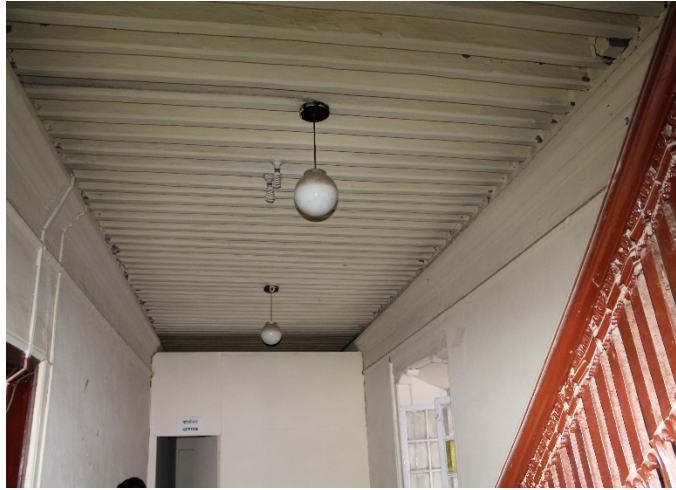
Figure 79 – 2<sup>nd</sup> floor plan B3 area

78 and 79) exhibited important cracks in the wall. Still, the floor did not appear to have unsafe deformations when people walked on top of it and the ceiling exhibited a few cracks whose severity was not possible to determine.

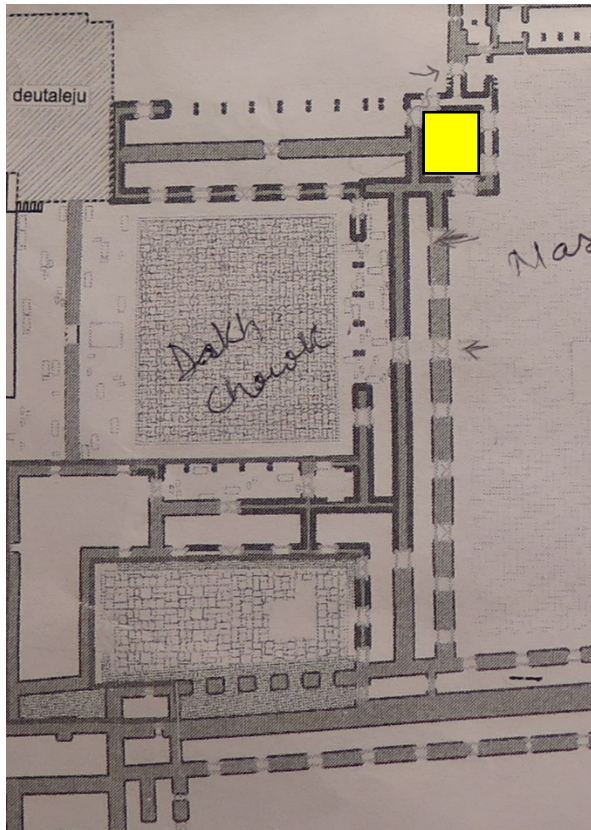
Figure 86 – Damages in the ground floor areas that were visited

- Most of the movable heritage seems to be undamaged.
- Based on the visual assessment that was carried out, some of the interior areas that were visited only exhibited light damage levels in walls and ceilings (see Figs. 86 to 88).
- Based on the visual assessment that was carried out, some of the interior areas that were visited exhibited medium/intense damage levels in walls and ceilings (see Fig. 88).

- The visual safety assessment carried out during the visit revealed that a part of the museum movable heritage can be safely retrieved before undertaking detailed stabilization work for the structure (see areas highlighted in yellow in Figs. 86 to 88). However, this should be done in coordination with structural engineers.

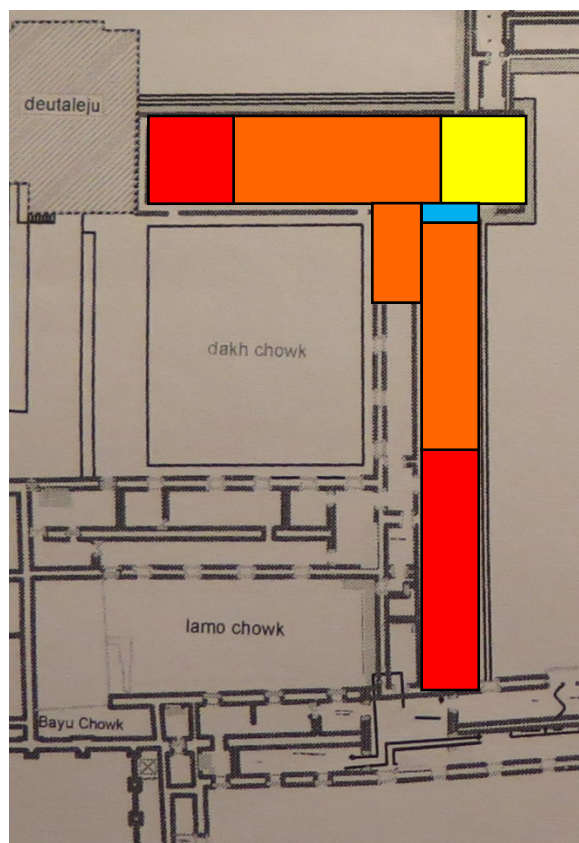
Figure 88 – Damages in the 2<sup>nd</sup> floor areas that were visited

- Parts of the building (see areas highlighted in orange in Fig. 88) have suffered medium/high structural damage and appear to be unstable. Some important artefacts are housed in these areas and their retrieval requires special operation that will need internal shoring before evacuation.

- Parts of the building that were not visited for safety reasons (see areas highlighted in red in Fig. 88) have suffered extensive structural damage and appear to be unstable. Some important artefacts are housed in these areas and their retrieval requires special operation that will need a detailed assessment of the safety conditions and internal shoring before evacuation.
