MILAN, ITALY 30<sup>th</sup> JUNE - 5<sup>th</sup> JULY 2024

# SEISMIC ANALYSIS IN CORNER BUILDINGS AND ITS RELATIONSHIP WITH THE DAMAGE OBSERVED IN BUILDINGS IN MEXICO CITY DUE TO THE EARTHQUAKE OF SEPTEMBER 19, 2017.

J.I. López<sup>1</sup>, A. Martínez<sup>1</sup>, J.M. Jara<sup>1</sup>, H. Varum<sup>2</sup> & B.A. Olmos<sup>1</sup>

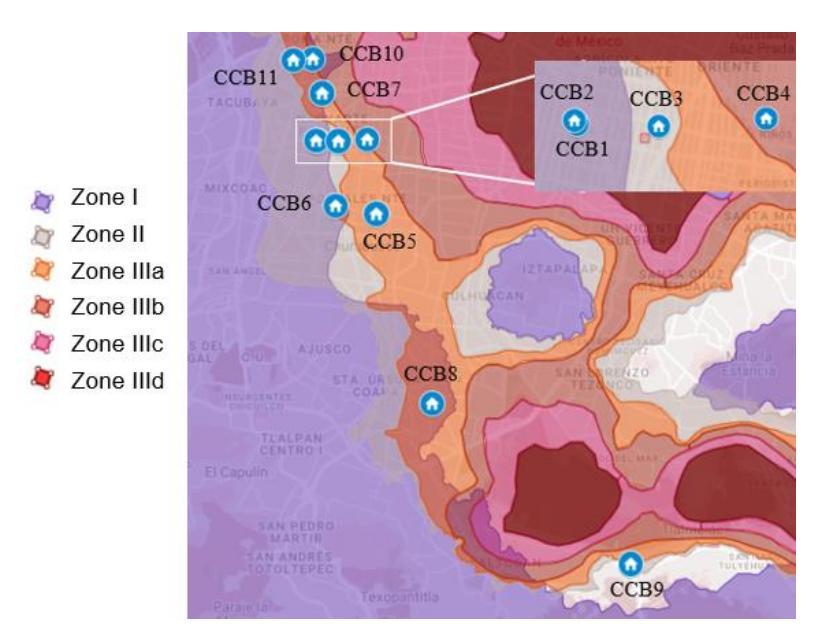
2019). In this study, the data obtained from post-seismic damage assessment surveys, conducted shortly after the seismic event, provided information of 40 collapsed structures. After filtering out structures that were not classified as buildings, the sample size was reduced to 31, with 11 structures identified as collapsed corner buildings (CCB).

Figure 1. Location of the collapsed corner buildings due to the 19S, 2017 earthquake and seismic zonation of Mexico City

Using data from visual inspections and satellite images, it was determined that the CCB buildings were in the range of three-eight stories, the use was predominantly residential or a combination of residential and commercial use. Regarding to the floor systems, detailed information was not available, but based on the images, it was estimated that the majority of these structures had solid slabs and lightweight flat slabs. Figure 2 shows a collapsed eight-story building. 73% of the buildings experienced complete collapse, whereas 27% suffered partial collapse. All of the collapses were in seismic zones II, IIIa, and IIIb.

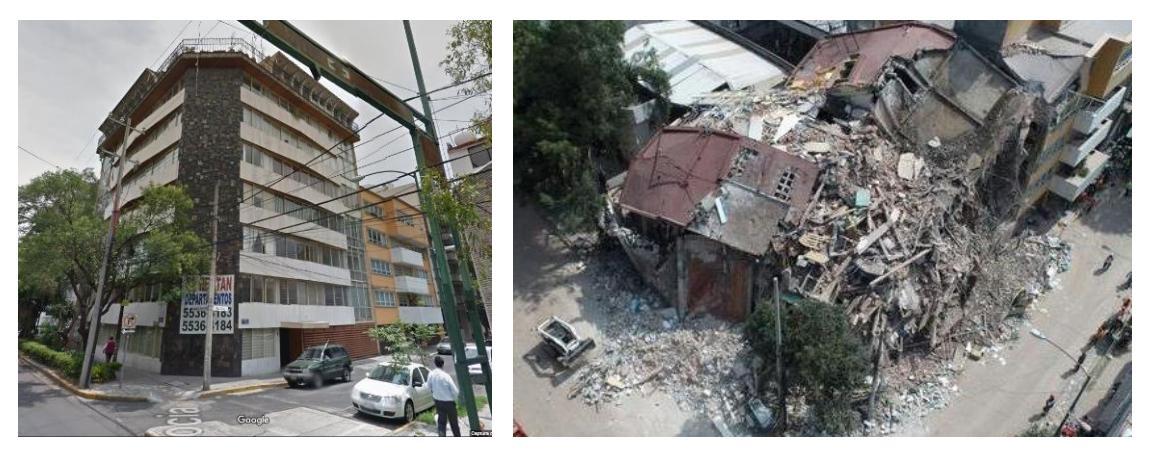
Figure 2. CCB2 building, before and after the 19S, 2017 earthquake

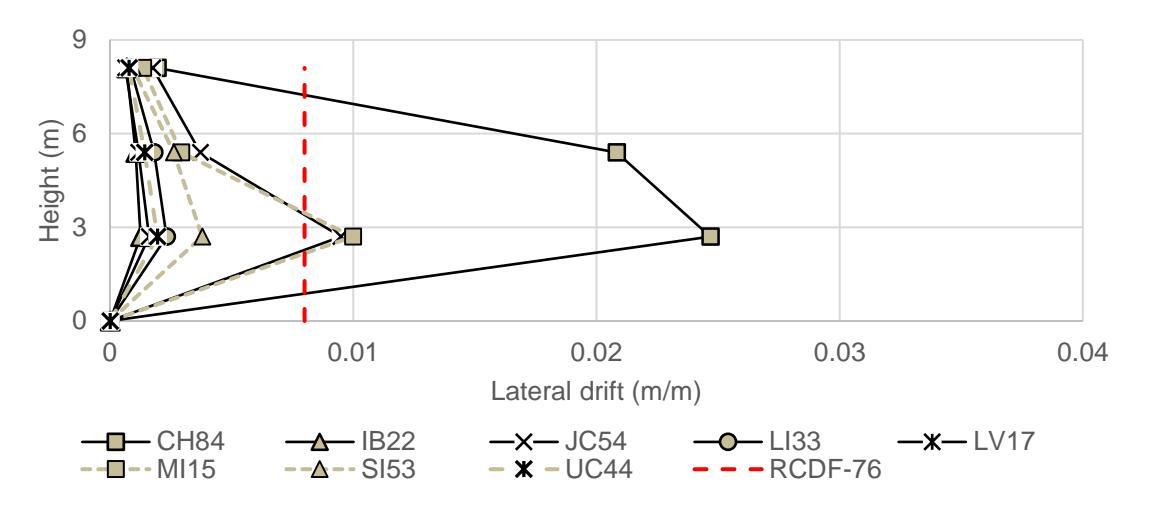
The demand parameter selected for assessing the seismic response of the buildings was the interstory drift ratio at the building's corners (Figure 10). Figures 11-14 present the interstory drifts at corners C1 and C3 for each floor of the three-story building in zone IIIa. The regular building RB (Figure 11 and 12) shows that drifts in both corners exhibit similar amplitude values, reaching a maximum value close to 0.031, and similar demand distribution with all seismic records as well. Conversely, Figure 13 and Figure 14 show that the C1 corner of the CB building exhibits a maximum drift of 0.025, given its contact with the two walls of the rear facades, which is a lower value than the drift at corner C3 of 0.037, indicating torsional effects in the building. The C1 corner of the CB building even presents lower interstory drifts than any other of the corners of the regular building (RB). The red dashed line in the figures displays the allowable interstory drift limit according to the RCDF (1976). As observed, all records exceeded this limit, except for the C1 corner of the CB building, effect that can be attributed to the stiffness provided by the infill walls, as mentioned earlier.

Figure 13. Interstory drift ratios in the three-story CB, corner C1-x direction, seismic records from zone IIIa

The drift limits proposed by Akbari (2012) to classified damage states were used to establish a relationship between seismic demands and potential structural damage in the buildings. The author proposes an interstory drift in the range of 0.025-0.05 for extensive damage. The buildings of this study presented seismic demands in this range, just below of the complete damage category (structural collapse). Furthermore, FEMA (2022) guidelines locate these drift values in the range of extensive-complete damage.

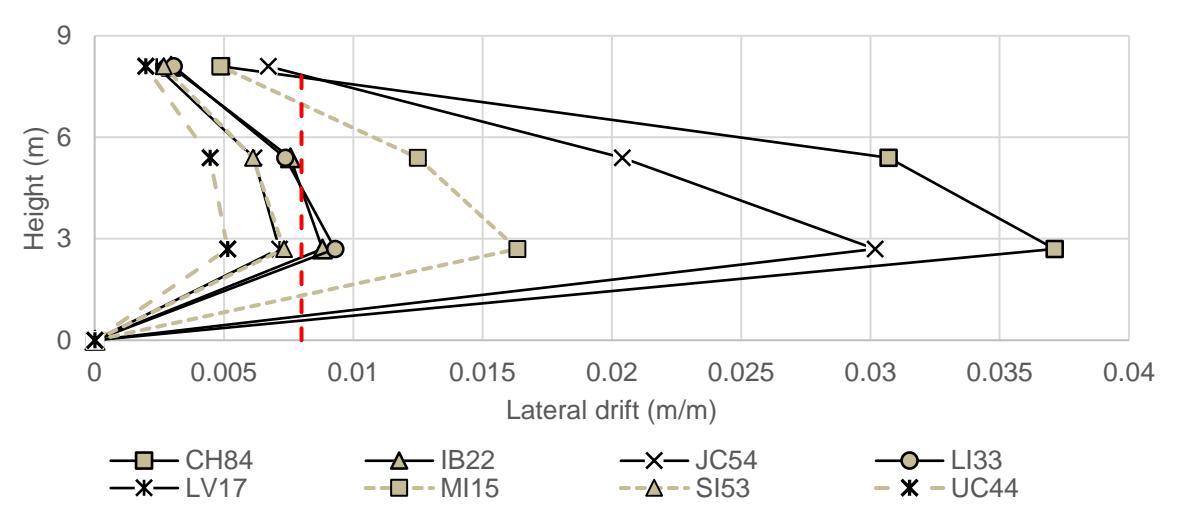
Figure 14. Interstory drift ratios in the three-story CB, corner C3-x direction, seismic records from zone IIIa

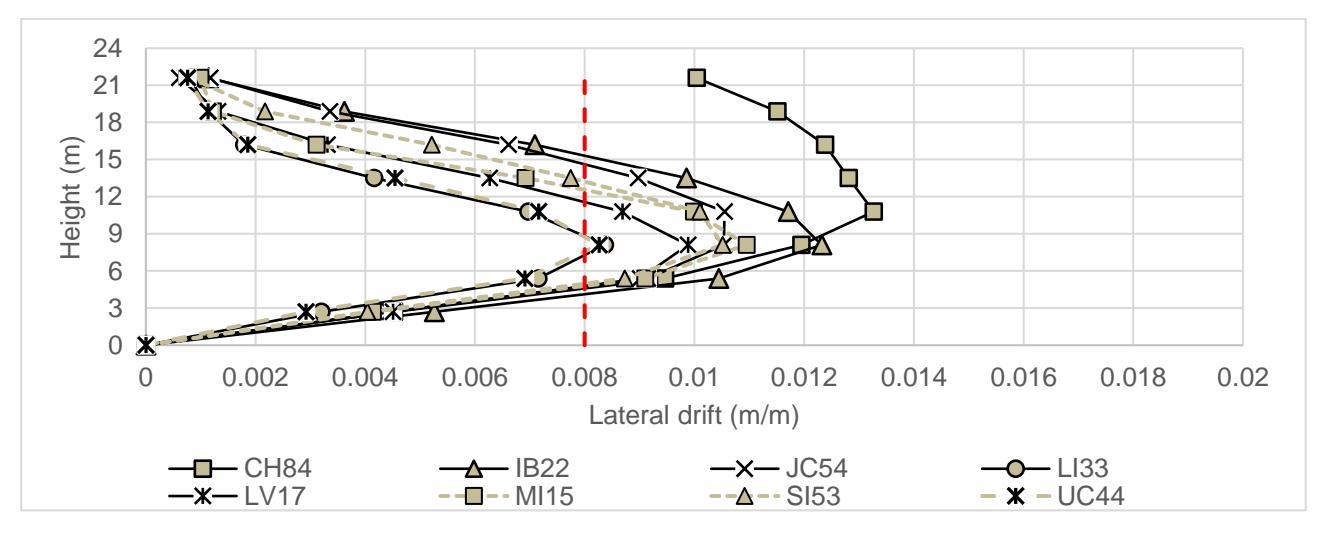
Figure 15-Figure 18 show that eight-story building presented a similar behavior to the three-story building regarding the interstory drifts at the corners of RB and CB buildings. C1 and C3 corners of the RB building had maximum drifts of 0.017 and 0.016, respectively, whereas these values of the CB building, changed to 0.013 and 0.018, respectively. These results suggest that the torsional effect was less pronounced in the eight-story building.

Figure 17. Interstory drift ratios in the eight-story CB, corner C1-x direction, seismic records from zone IIIa

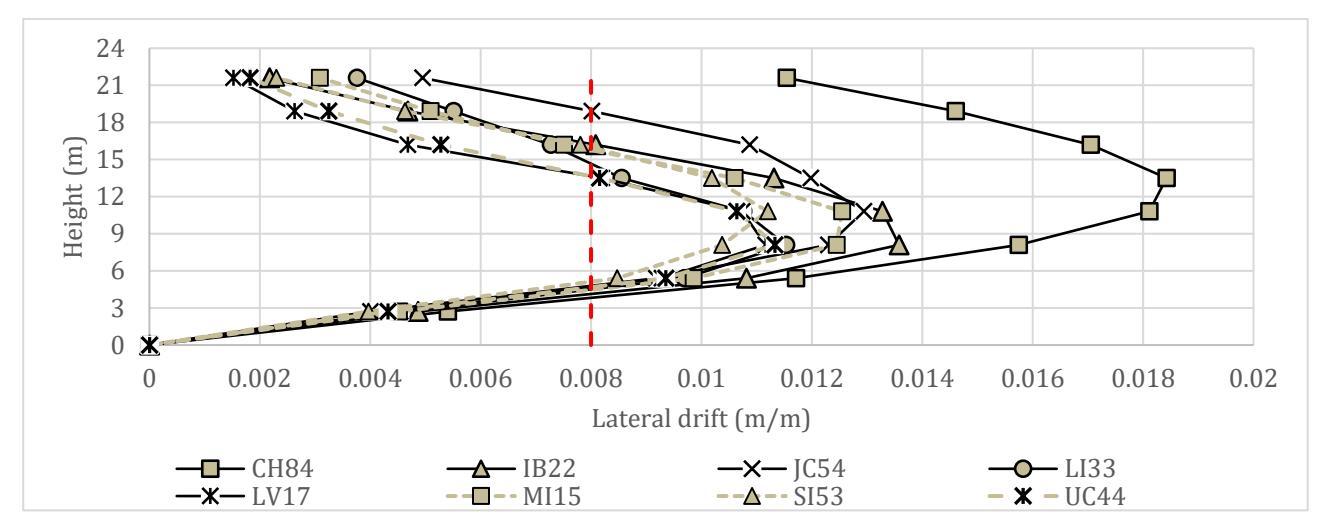
Figure 18. Interstory drift ratios in the eight-story CB, corner C3-x direction, seismic records from zone IIIa
