# Challenges in the preventive maintenance of early 20th-century reinforced concrete architectural sculptures

Esmeralda Paupério<sup>1</sup>, Xavier Romão<sup>2</sup>, Rui Silva<sup>1</sup>, Susana Moreira<sup>2</sup>

<sup>1</sup> Construct – LESE - Instituto da Construção da Faculdade de Engenharia da Universidade do Porto, Portugal

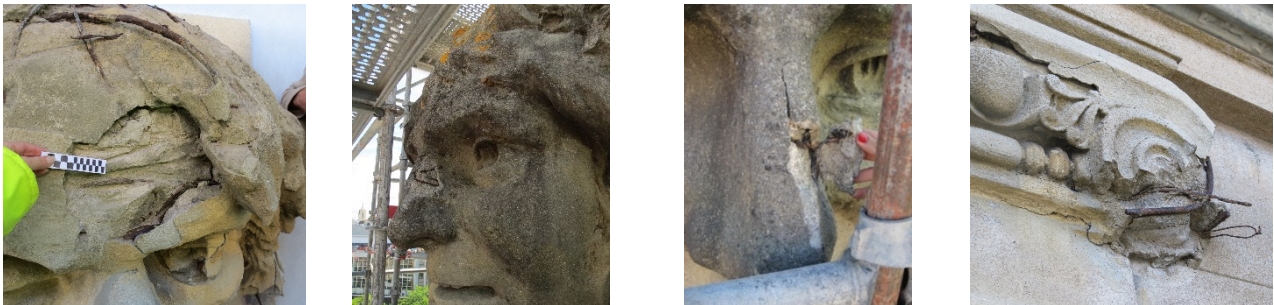
Fig. 1. Architectural sculptures in reinforced concrete with material degradation resulting from corrosion of the reinforcement.

Reinforced concrete, which is made of cement and steel, forms a material with a reduced lifespan when compared to natural and traditional construction materials such as stone or timber. Among other sources of decay, reinforced concrete deterioration is often caused by the corrosion of reinforcement steel [1]. Since the origin of this deterioration usually starts from within the concrete element, available repair approaches are seen as considerably intrusive. Therefore, this source of decay is especially difficult to address when dealing with the repair of reinforced concrete decorative elements or sculptures, where conservation operations could destroy their authenticity (Fig. 1).

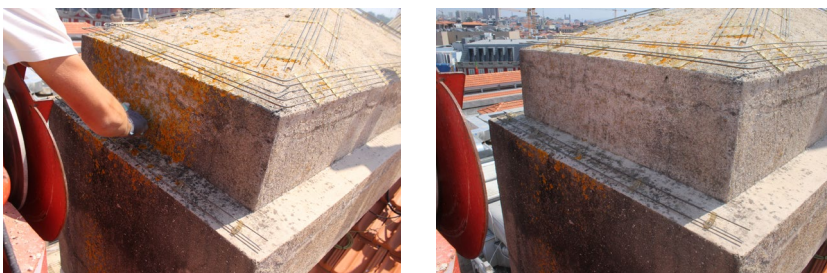
Fig. 2. Example of intervention type I1

The following three types of interventions were defined based on purpose and complexity (increased level of action from Type I1 to Type I3): Type I1 – preventive action, which encompasses the repair of fine cracks with mortar or replacement of the protective and/or water-repellent layer (Fig. 2); Type I2 – remedial action, which encompasses repair of cracks or fractures with stabilization of metallic components (e.g., steel reinforcements) and/or restoration of the previous form (Fig. 3); and finally, Type I3 – remedial action, which encompasses repair of fractures or missing parts, with the removal of the metallic component and grout injection, stitching or restoration of the previous form (Fig. 4). Therefore, each intervention that is planned should be classified with one of these levels of intensity, whenever they take place. Consequently, it will be possible to have a track record of the interventions being performed and assess their effectiveness over time.

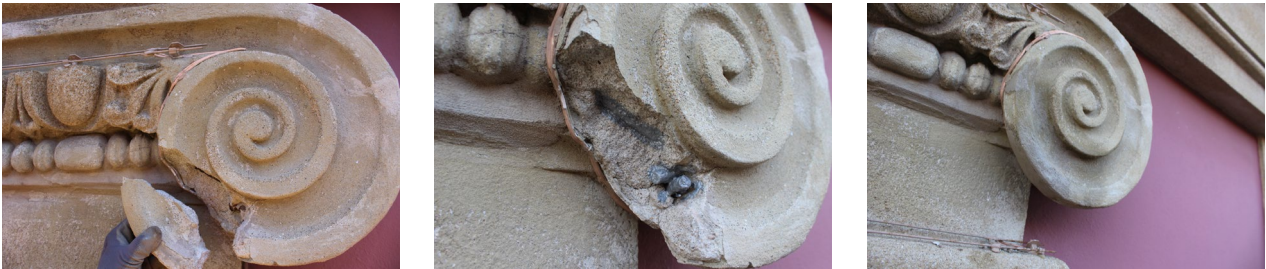
**Fig. 4.** Example of intervention type I3

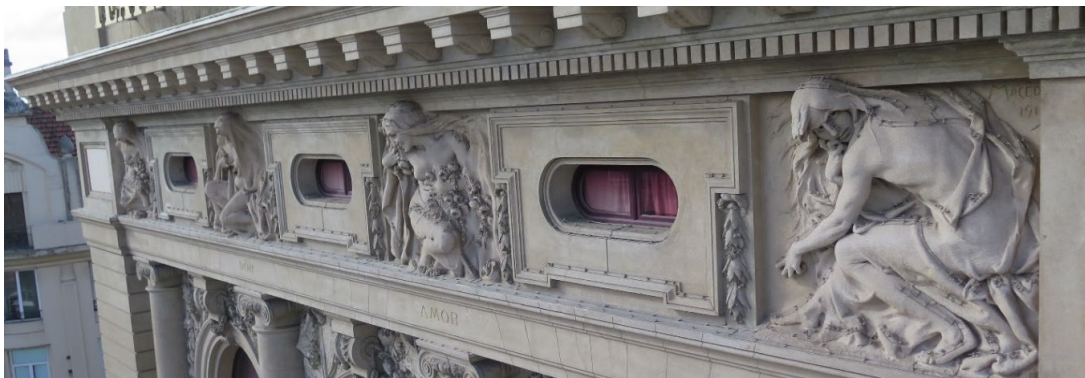
**Fig. 5.** Façade of the São João National Theatre

The Beaux-Arts architecture expresses a neoclassical architectural style that involved sculptural decoration along conservative modern lines and employed French and Italian Baroque and Rococo formulas combined with an impressionistic finish and realism. An abundance of balustrades, statues, columns, garlands, pilasters between doors and windows, and grand staircases is typical of this architectural style. In the case of the São João National Theatre, these decorative elements exist in all the façades (with a total area of approximately 4800m<sup>2</sup>) and are made of reinforced concrete (Fig. 5 e Fig. 6). Some of the decorative elements having vegetal and geometrical patterns are seen to be repeated throughout the façades.

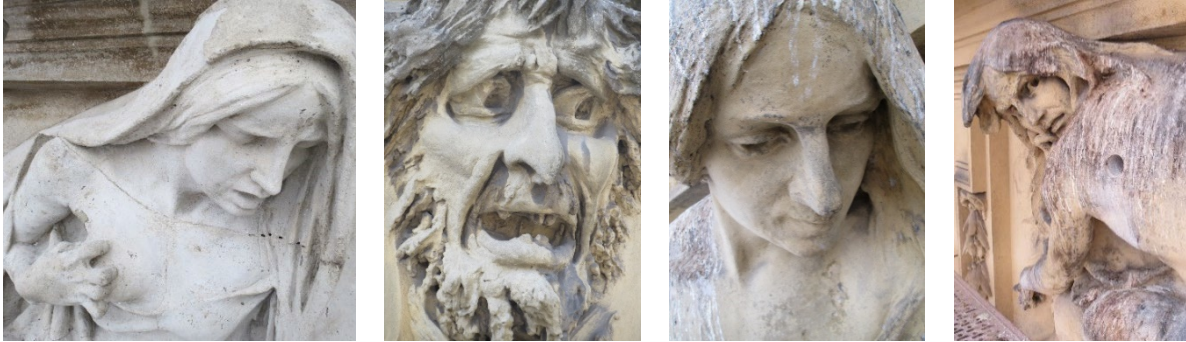
**Fig. 6.** Reinforced concrete architectural sculptures of the São João National Theatre

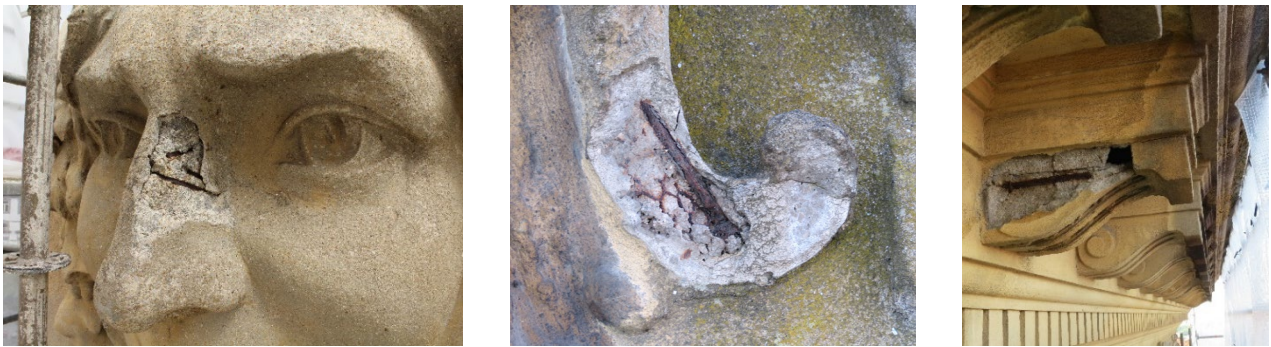
**Fig. 7.** Examples of damaged reinforced concrete decorative elements of the façades of the São João National Theatre.

Besides the severe cracking and spalling levels found in the concrete due to corrosion of the reinforcement, significant damages were also found to be related to bird-dropping deposits and the presence of black crusts. To illustrate the state of degradation of some of the reinforced concrete elements of the theatre façades, Fig. 7 presents some examples of damaged reinforced concrete decorative elements of the façades of the São João National Theatre.

To adequately plan and prepare these interventions that occurred in 2013/2014, a survey of the damages and degradation levels found on the façades and their decorative elements and sculptures was needed. A first assessment of their state of degradation was carried out before the cleaning operations of the façades took place, which resulted in an incomplete characterization of the elements' condition. A reliable assessment was only possible after the cleaning operations (Fig. 8). In addition to the damage survey, several concrete samples were taken from the façades for laboratory analysis and testing to determine the components and mix proportions of the original concrete, thus enabling the development of a repair mix with properties compatible with the original concrete.

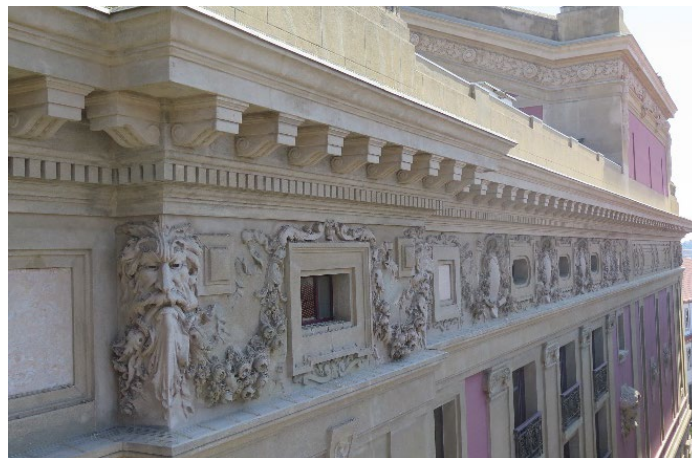
**Fig. 9.** Example of the considerable interconnection of architectural sculptures.

To apply the proposed methodology the identification of each element was not a simple operation due to the high level of interconnection between consecutive decorative forms (Fig. 9). In these cases, individual elements were selected based on symmetry and repetitiveness criteria.

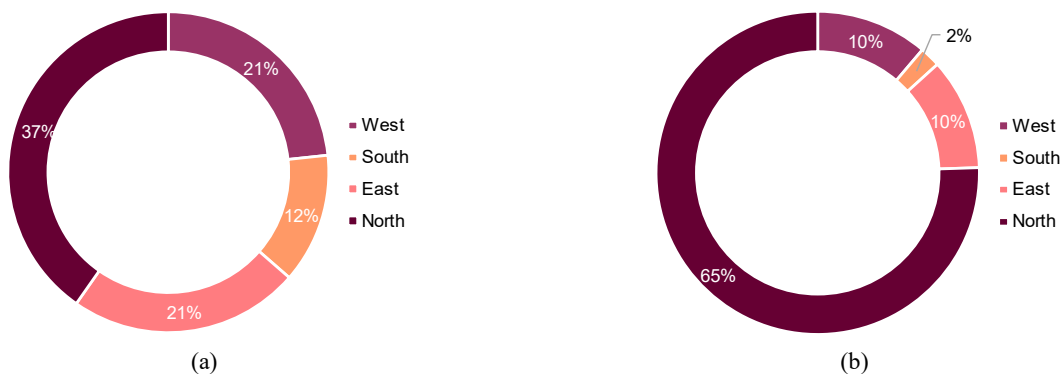
**Fig. 11.** Determination of elements’ density per façade: (a) Density of the total amount of decorative elements and sculptures per façade; (b) Density of unique decorative elements and sculptures per total of elements and façade.

According to what was established in section 2.2, one of the first steps is to determine the importance of each façade. This was accomplished by quantifying the total area of decorative elements and sculptures and the total area of unique decorative elements and sculptures on each façade. As shown in Fig. 11, the North façade, where the main entrance of the theatre is located, is the one with the highest density of decorative elements and sculptures, as well as unique elements, which leads to the classification of high importance. On the opposite side, the South façade clearly has less importance in terms of architectural sculptures, and the East and West facades have equal importance probably due to their symmetry (Fig. 11).
