# Geosynthetics tensile behaviour after exposure to non-conventional fill materials

C.S. Vieira and P.M. Pereira  
*University of Porto, Porto, Portugal*

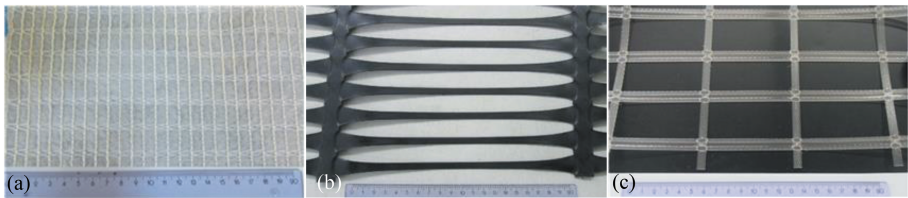
Figure 1. Appearance of the geosynthetics (ruler in centimetres): (a) high-strength composite geotextile (GTX); (b) uniaxial high-density polyethylene geogrid (GG1); (c) polyester geogrid (GG2).

The study involved three commercially available geosynthetics commonly used for reinforcement purposes (Figure 1): a high-strength composite geotextile, which combines a polypropylene (PP) continuous-filament needle-punched nonwoven with high-strength polyester (PET) yarns, designated as GTX (Figure 1a); a uniaxial geogrid made of high-density polyethylene (HDPE), named as GG1 (Figure 1b); and a uniaxial geogrid composed of extruded polyester (PET) bars with welded rigid junctions, referred to as GG2 (Figure 1c).

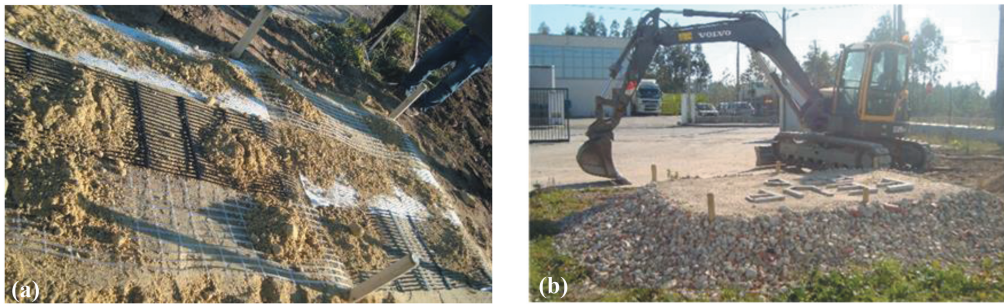
Figure 3. Trial embankment: (a) placement and arrangement of geosynthetics; (b) finished embankment with lateral protection with coarse aggregates.

The trial embankments were constructed with plan dimensions of 2 m × 3 m and a height of 0.45 m (Figure 3). Within each embankment, geosynthetic samples (approximately 0.45 m × 1.5 m) were placed at two vertical levels, spaced 0.20 m apart. More details can be found in Vieira & Pereira 2015, Vieira & Pereira 2021.
