RETROFITTING OF BRIDGE HOLLOW PIERS WITH CFRP

Pedro Delgado^{1*}, Patrício Rocha¹, João Pedrosa², António Arêde², Nelson Vila Pouca²,
Miguel Santos³, Anibal Costa⁴, Raimundo Delgado²

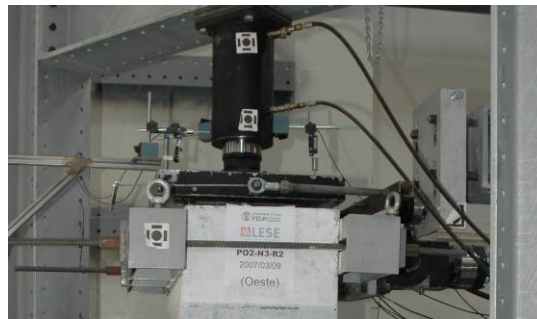
Figure 2: The sliding device used to apply the axial load.

The test setup, shown in Figure 1, makes use of a 500 kN actuator to apply lateral loads and a 700 kN actuator to apply axial loads. The specimen and reaction frame are bolted to the strong floor with high strength prestressed rods. A constant axial load was applied during the tests, herein described, while the lateral loads were cycled, under displacement controlled conditions. A special sliding device consisting of two steel plates, shown in Figure 2, was used to minimize the friction created by the axial loads. The lower plate is bonded to the specimen top, whereas the upper is hinged to the vertical actuator, allowing top-end displacements and rotations on the specimens to take place when lateral loading is imposed during the test. The upper plate is also connected to a load cell to measure the residual frictional force between the two plates. During the tests, the hydraulic system of the vertical actuator was designed to keep constant the oil pressure, in order to maintain constant the axial force. The

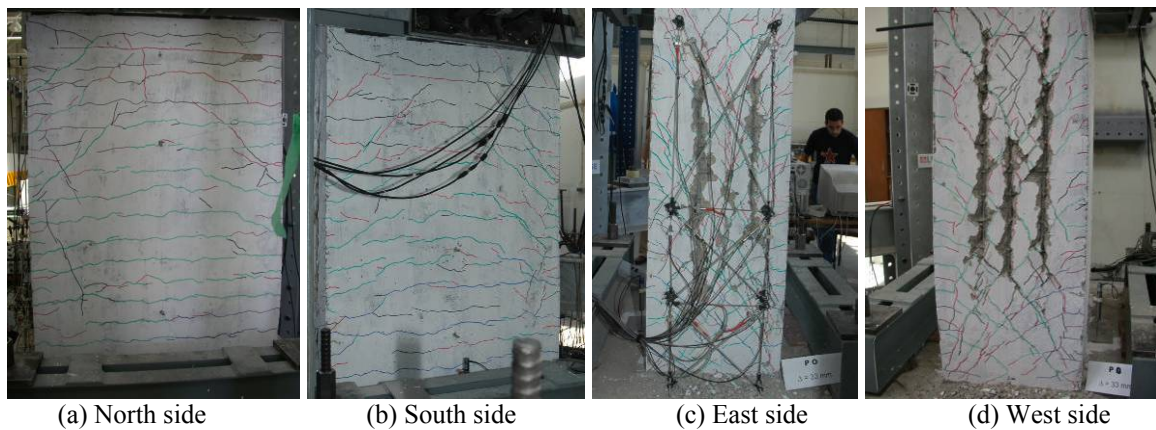
Concerning the test results of original specimens PO2-N2 and PO2-N3, the greatest amount of damage was mainly observed at the lateral sides, east and west, where the concrete cover crushed within the entire pier height (see Figures 4 and 5) and strong shear damage was achieved due to concrete degradation caused by lack of transverse reinforcement efficiency. Little damage was observed in the north and south sides, with well distributed cracks. However, the cracks observed in those sides are not only horizontal, as for the square piers tested before [4], but instead they show an angle that increases along the pier height, due the shear lag effect that occurs for this width/height ratio (2:1).

Figure 4: Pier PO2-N2 damage for 2.4% drift.

Figure 6a shows the experimental responses of both piers PO2-N2 and PO2-N3 in terms of top force-displacement diagrams; as expected, these diagrams show larger initial stiffness and maximum forces for the pier with higher axial load (PO2-N3). However, failure of both piers was reached by the first cycles of 25mm amplitude (1.8% drift), with visible shear failure mode and the shear lag effect evidenced in the damage pattern shown in Figures 4 and 5.

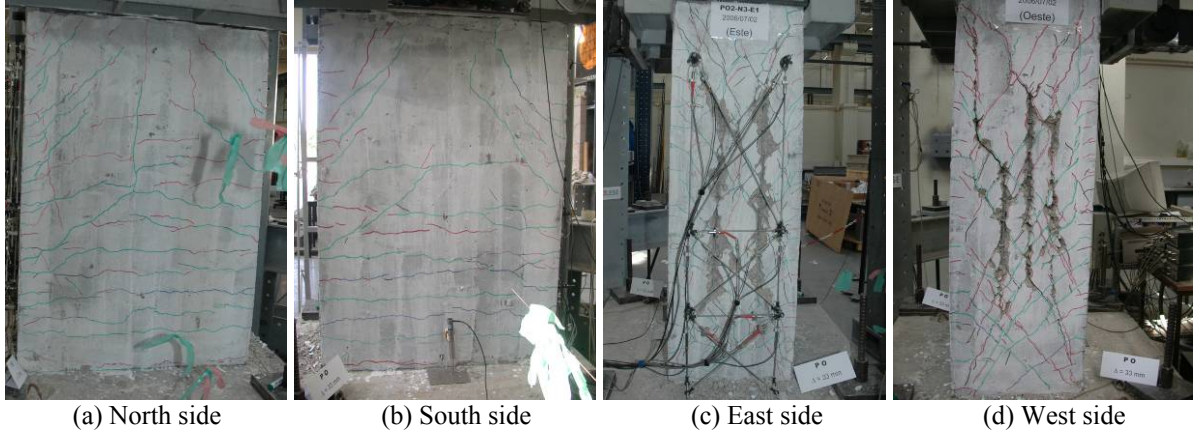
Figure 5: Pier PO2-N3 damage for 2.4% drift.

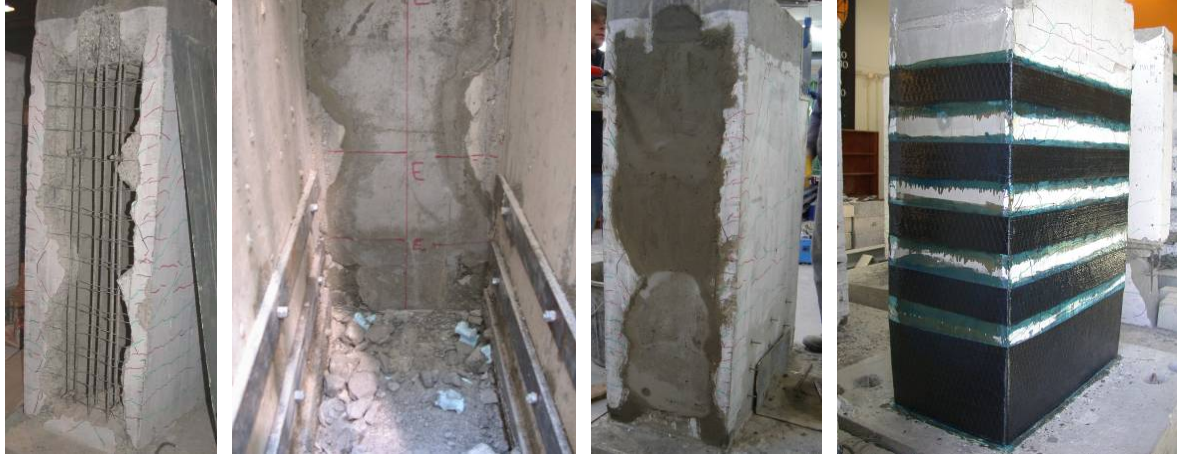
After the cyclic tests of the original specimens, they were repaired and retrofitted by an external contractor (S.T.A.P.) according to the following steps: 1) delimitation of the repair area; 2) removal and cleaning of the damaged concrete; 3) inside retrofit with transversal steel bars;

4) application of formwork and new concrete (Microbeton, a pre-mixed micro concrete, modified with special additives to reduce shrinkage in the plastic and hydraulic phase); 5) outside retrofit with the CFRP sheets. In order to provide a general idea of the pier damage and of the retrofit process, the following photographs show the piers during repair and after having been retrofitted with CFRP sheet jackets (Figure 8).

Figure 8: Hollow piers before and after the shear retrofitting with inside steel bars and outside CFRP sheet.

The inside transversal steel bars (only for pier PO2-N3-R2) were designed taking in account the feasibility for future real retrofits; such bars were concentrated at the bottom, in correspondence with the outer CFRP jackets, for improving the plastic hinge confinement. In order to design the outside shear retrofit with CFRP jackets, the authors adopted the Priestley approach [11] to evaluate the thickness of the rectangular hollow pier jacket for increasing the shear strength above the maximum flexural force while keeping the initial section conditions. According to Priestley methodology the shear strength can be conveyed by Eq. (1) [11]:

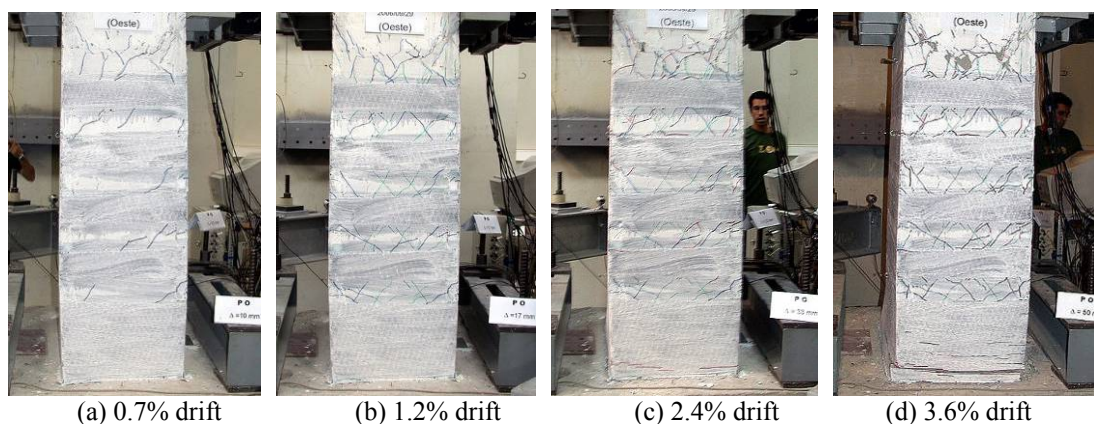
The damage evolution during the experimental test of the retrofitted specimen PO2-N2 is illustrated in Figure 9, for the pier west side. For small amplitude cycles, corresponding to drift below 0.7%, first cracks about 0.1mm wide occurred (Figure 9a). In the subsequent cycles the crack widths increased and new cracks were also developed along the pier height. For 17mm top displacement (1.2% drift), the damage pattern shown in Figure 9b was mainly characterized by diagonal cracks in the interval zones between the CFRP strips. Shear damage continued to increase in the next cycles and, for 2.4% drift (Figure 9c), cracking was concentrated at the pier base without visible damage on the CFRP sheets. Failure of some of the fibers at the base was audible from this stage on. During the last cycles for 33mm top displacement (2.4% drift) the cracks on the concrete and CFRP developed a little. Figure 10 shows the damage evolution on the pier internal faces also visualized during the test, in correspondence with the exterior damage, presented in Figure 9. When the CFRP strips collapsed at the pier base, for 2.4% drift, the interior cracks increased considerably, as shown in Figure 10d. In the last cycles, generalized damage became visible, with interior collapse of the walls and buckling of the longitudinal reinforcement (Figure 10d), that caused a fast reduction of the pier capacity as evidenced in the response diagrams included in Figure 12. The final damage stage is also shown in Fig. 11. As can be seen in Figures 9 - 12, the retrofitted specimen showed good behavior in comparison with the original one, exhibiting well distributed cracking along the CFRP spacing. The shear retrofit design, as used for this pier, showed excellent performance since the shear failure mechanism was prevented and the collapse was achieved after the CFRP failed at the pier base under a flexure mechanism that occurred further after the original specimen response. Figure 12 shows the comparison between the original and retrofitted pier, where about 40% increase of the top force is reached and about 100% more of the maximum displacement is obtained, without significant reduction of the resistant force.

Figure 9: Retrofitted pier PO2-N2. Damage from west side view during the test.

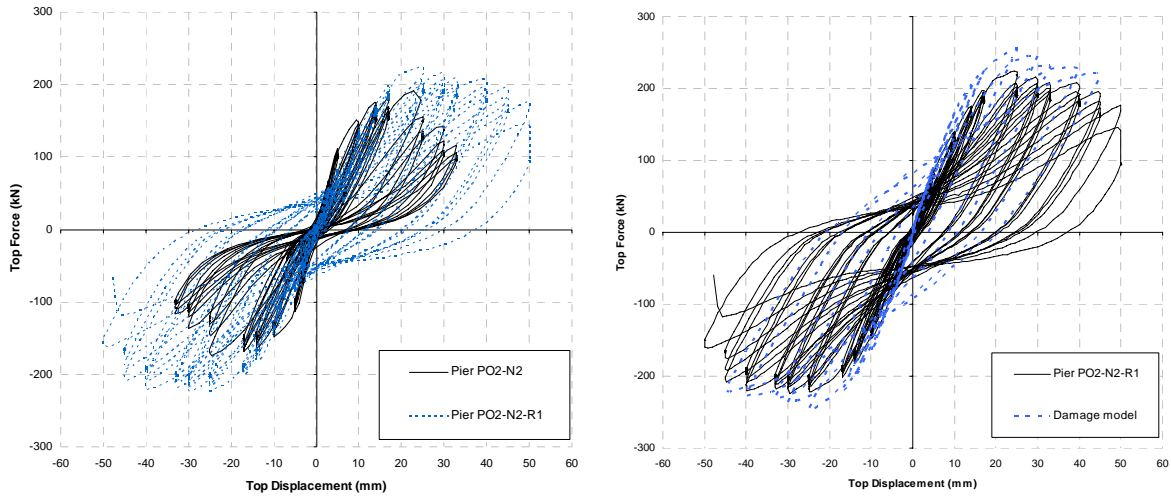
(a) PO2-N2 experimental curves before and after retrofit. (b) Numerical analysis for pier PO2-N2-R1

Figure 12: Experimental and numerical results comparison.

Figure 12b includes the comparison of numerical and experimental results for the test of PO2-N2-R1, in terms of top force-displacement response, showing that the numerical simulation model slightly overestimated the stiffness and peak strength of the specimen. Numerical simulations show also that compressive damage for 1.8% drift (Figures 13a and b) is greater than for the original pier because shear capacity increased by CFRP sheets and a flexure type deformation mode was activated. From the results illustrated in Figure 13e, it can be seen that a plastic hinge was formed, since red colors of the longitudinal bars are concentrated at the pier base; this fact agrees with the deformed mesh shown in Figure 13c. Although transverse steel has reached the yielding phase (Figure 13d), the CFRP sheets, simulated as high strength steel bars and shown in Figure 13f, are resisting well bellow the ultimate strength (about

3800MPa), avoiding the pier to exhibit a shear failure mode and, therefore, reducing shear deformation. In fact, this is the reason for the maximum flexural forces increase on the retrofit pier (see Figure 12), due to the greater number of longitudinal rebars having reached yielding.

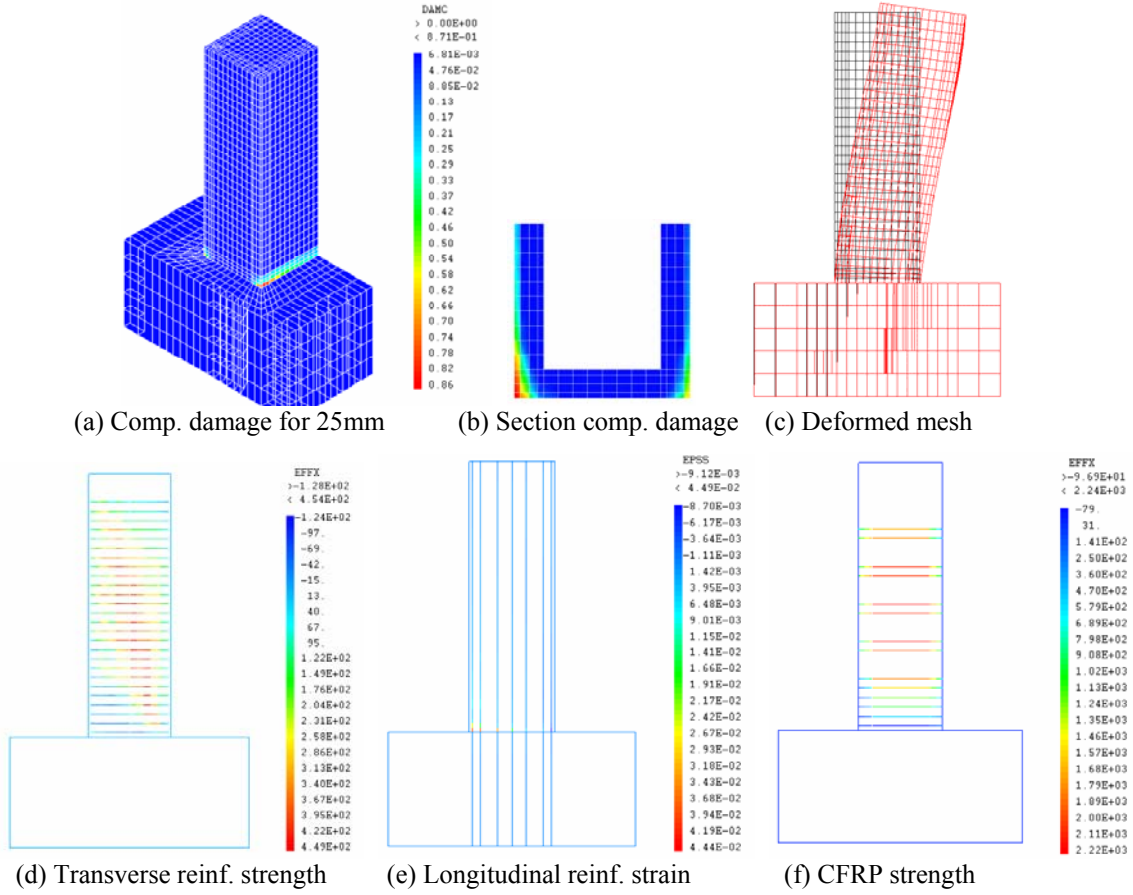
Figure 13: Numerical results of PO2-N2-R1 for 1.8% drift.

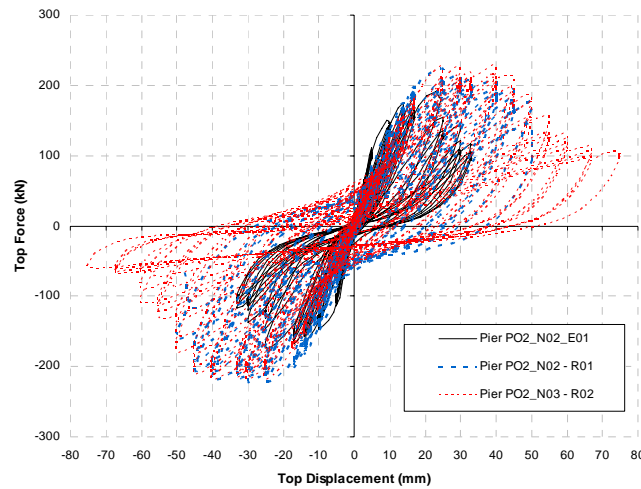
As can be seen in Figures 14 and 15, this retrofitted specimen showed good behavior and relevant improvement in comparison with the other retrofitted one (PO2-N2-R1), mainly in terms of maximum displacement. Again the shear retrofit design provided excellent performance since the shear failure mechanism was prevented and the collapse was reached after longitudinal rebar failure and crushing of concrete (Figure 15b) for a very high level of top displacement under flexure mechanism. Figure 16 shows the comparison between the original and the two different retrofitted piers.

Figure 16: Experimental results comparisons of PO2 piers before and after retrofit with different confinement.
