## TOPIC 3 – Procedures

### Structural Analysis of a Masonry Chimney – In-Situ Assessment Tools

**Keywords:** Masonry; Chimney; Damage; Modal Identification

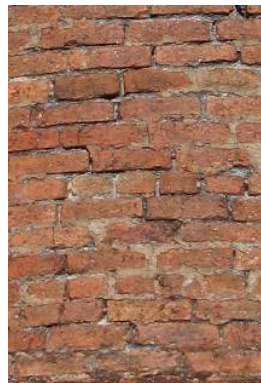
**Figure 8: Masonry  
type 1**

Two types of brick masonry were identified, indicating two different construction time periods. This information, missing on the municipal archives, was confirmed by local people. The line dividing the two periods is 26m above the ground floor (Figure 7); the bottom zone (Masonry type 1 – Figure 8) appears to be in worse conservation state than the top one (Masonry type 2 – Figure 9).

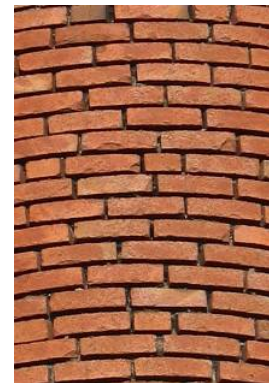
**Figure 9: Masonry  
type 2**

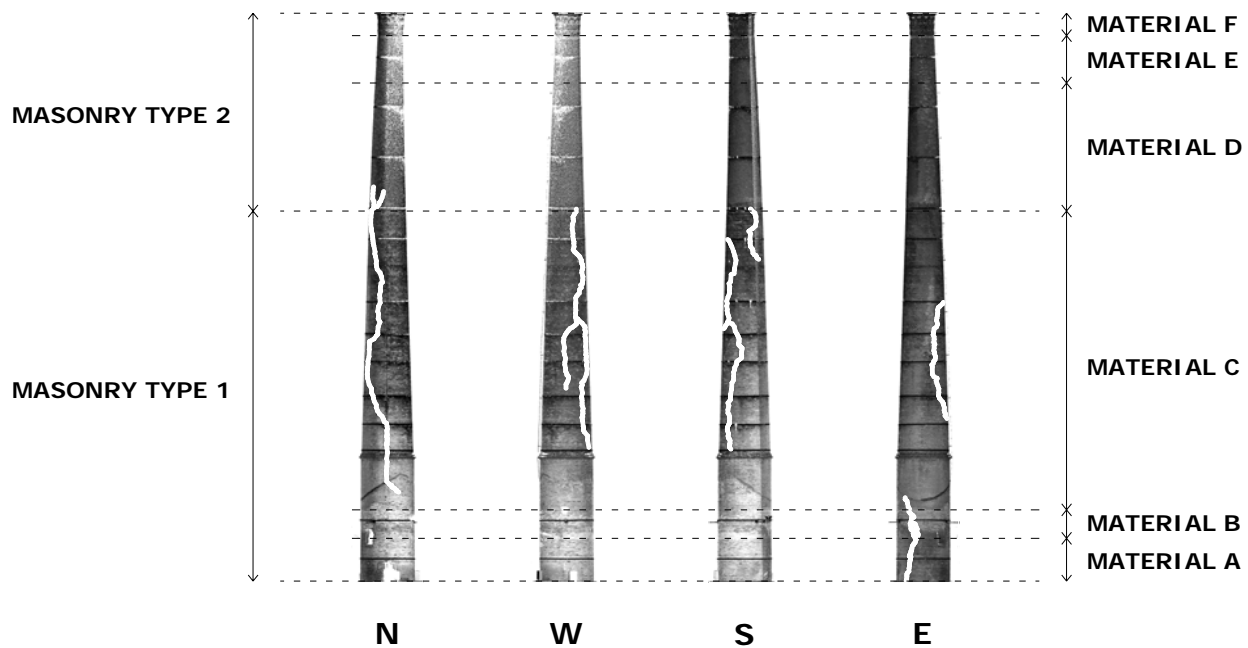
**Figure 10: Material and damage identification – North, West, South and East view**

According to the visual inspection, different zones were also identified inside each category M1 and M2 based on the brick and/or mortar degradation state, allowing the identification of a total of 6 material types (Figure 10). Major cracks were identified and represented in white in Figure 10. Figure 11 shows the photographic record of each of these zones. As for the steel rings, they presented important levels of corrosion (Figure 12). Moreover, some of these rings were not working and there were opened cracks crossing them (Figure 13). Therefore, they were not considered in the numerical model.

The Young modulus obtained for Model 1 was 1,425GPa, while figure 16 shows the Young modulus obtained for each of the 6 materials considered (see Figure 10). In both models, the Poisson ratio was 0,20 and the density 1650kg/m3 [2].

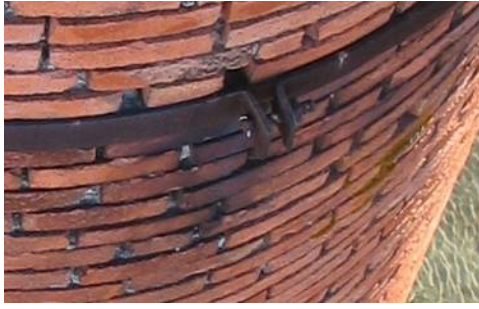
**Figure 12: Corroded ring connection**

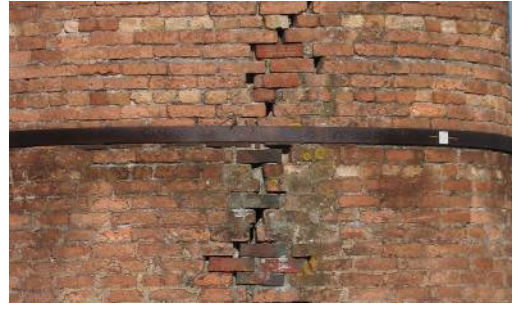
**Figure 13: Crack crossing a corroded ring**

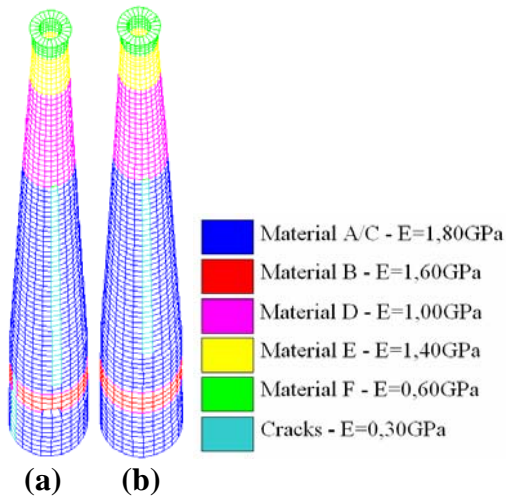
**Figure 16: The Young modulus in Model 2: (a) +X view; (b) -X view**
