## **IN-PLANE BEHAVIOR OF A STONE MASONRY PIER: EXPERIMENTAL TEST, NUMERICAL SIMULATION AND RETROFITTING EFFICIENCY EVALUATION**

### **SUMMARY**

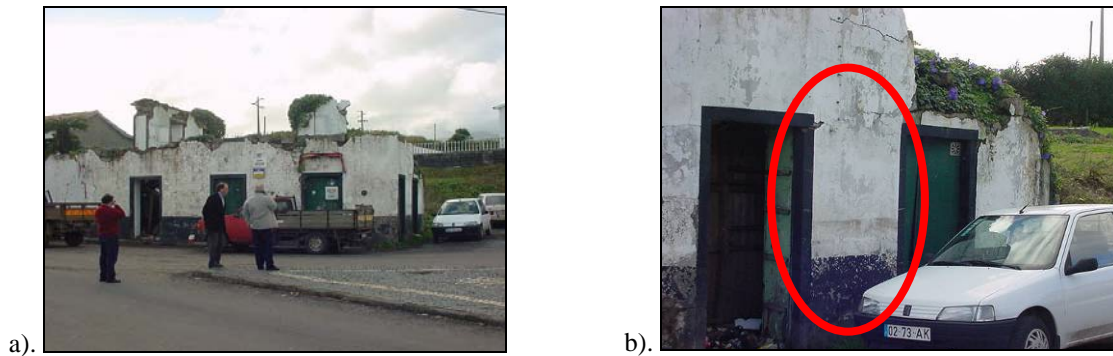
The tested pier was extracted from a two storey house (Figure 1-a) located at Pedro Miguel parish, Horta council, Faial Island of the Azores Archipelago. The wall was located at the ground floor between two main doors of the house façade, as it is possible to observe in Figure 1-b.

Figure 1: Original location of the wall: a). General view; b). detailed view

The specimen consists of a traditional double leaf stone masonry wall with poor cohesionless infill material and covered with cement mortar, as commonly found in most of the old constructions in the Archipelago,.

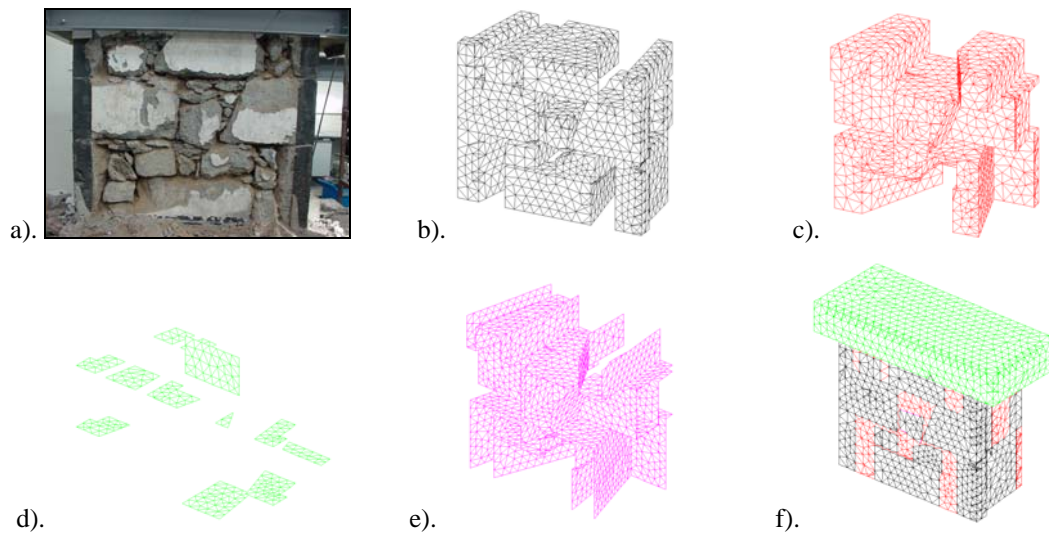
Figure 6 shows the complete geometry discretization of the tested wall, divided according to each type of elements, as well as the final full FEM mesh.

Figure 6: Geometry of the wall: a) real full geometry; b) blocks (FEM); c) infill (FEM); d) joints block-block (FEM); e) joints block-infill; f) final full FEM

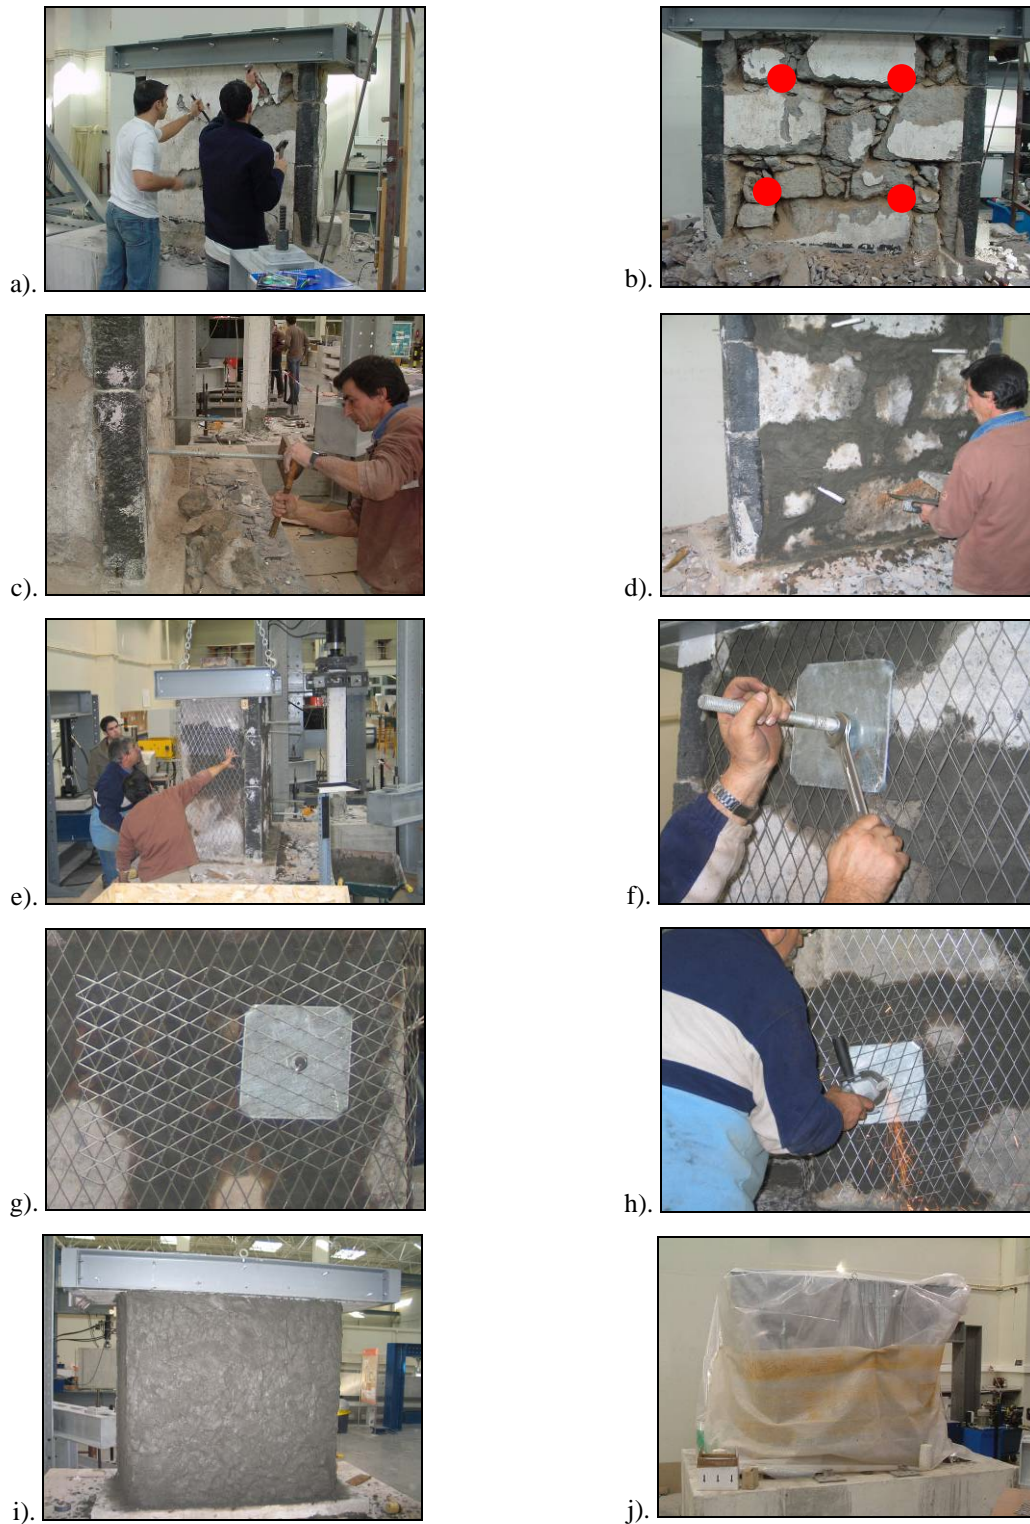
In this section the technique used to retrofit the wall is briefly presented, always accompanied with explicit figures clarifying each step followed. Hence, Table 3 presents each operation necessary to complete the wall retrofit as well as the time required to perform it; Figure 11 complements the referred table.

Figure 11: Retrofitting technique: a) cover removal; b) position of the steel rods; c) placement of the rods; d) mortar (1<sup>st</sup> phase); e) installation of the steel mesh; f) placement of the steel plates and tightening; g) installation of the steel mesh above the plates; h) cutting the excess of steel rods; i) mortar cover (2<sup>nd</sup> phase); j) mortar cure simulating Azores' humidity

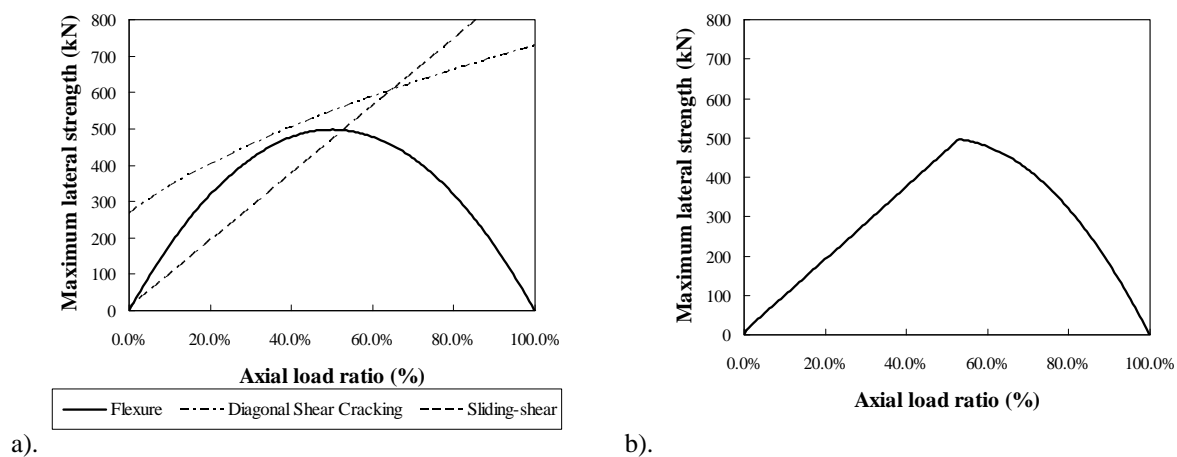
Figure 15: Influence of axial load on maximum strength and failure mode for a hypothetical specimen: a) interaction diagram for each failure mode; b) envelope of the interaction diagram
