## Experimental study of the out-of-plane behaviour of masonry infill walls with and without previous in-plane damage

A. Furtado, A. Arêde & H. Varum

**ABSTRACT:** Recent earthquakes demonstrated a significant contribution of the masonry infill walls in the structural response of the existent reinforced concrete buildings. When subjected to seismic actions, they tend to interact with the surrounding RC frames, which can result in different failure modes depending on the combination of the in-plane and the out-of-plane behaviour. From the surveys on damaged and collapsed RC buildings in the L'Aquila (Italy) and Lorca (Spain) earthquakes a large number of buildings that suffered severe damage or collapse had their poor performance associated with the influence of the infill panels. The masonry infill walls are considered non-structural elements but, their contribution should be considered in the structural response analysis of existing buildings, for which the understanding out-of-plane non-linear behaviour of infill walls is of full importance in order to develop efficient strengthening solutions to prevent and improve their performance in future earthquakes, and consequently redu

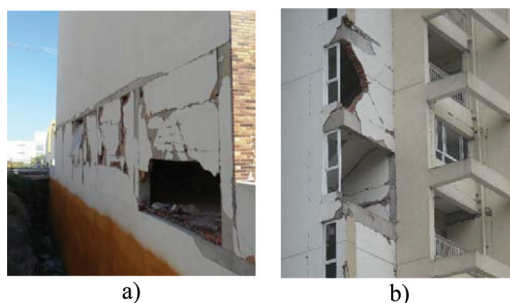
Figure 1. Out-of-plane collapse of IM walls after: a) Lorca (Spain) earthquake in 2011; and b) Ghorka (Nepal) earthquake in 2015.

One of the most critical failures is the out-of-plane infill (Figure 1), and the major factors that causes the out-of-plane instability and poor performance is the deficient/insufficient support-width of the RC beams and/or slabs, normally adopted to minimize the thermal-bridge effect, with no connection between the interior and the exterior panels and, finally, no connection to the

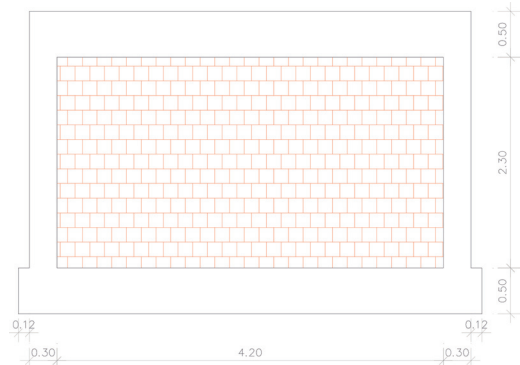
Figure 2. Infilled RC frame specimen general dimensions (in meters).

Figure 2 shows the RC infilled frame geometry. All infill panels have equal geometry with in-elevation dimensions of  $2.30 \times 4.20$  m made of horizontal hollow clay bricks, as usually found in the most common masonry in Portugal. No reinforcement was used to connect the infill panel and the surrounding RC frame. Three infill panels were built (denoted as Inf\_01, Inf\_02 and Inf\_03), all having an external leaf (150 mm thick) aligned with the external side of the RC beam. For the panel Inf\_03, an internal leaf, 110 mm thick, was added aligned with internal side of the beam, leaving a hollow thickness of 40 mm. This double-leaf panel was first tested for in-plane cyclic displacements, after which the internal leaf was removed, leaving the external leaf to be tested under the same out-of-plane loading conditions as for panel Inf\_02.

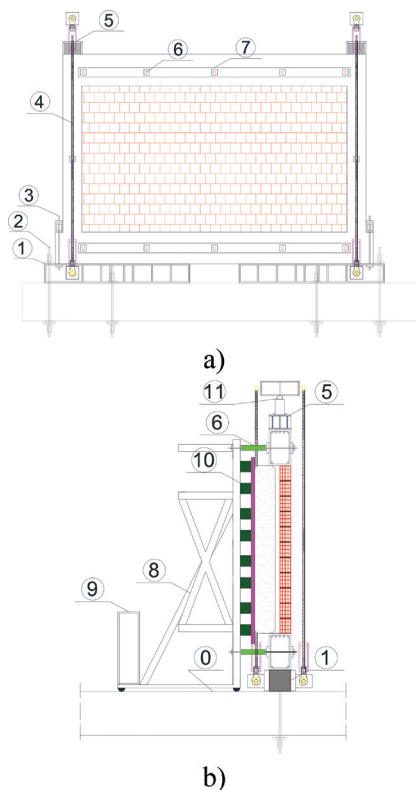
Figure 3. Layout of the out-of-plane test setup: a) Front view; and b) Lateral view. 0 – strong floor, 1 – foundation steel shape, 2 – high-strength rods ( $\phi 30$  mm) fixing the foundation steel shape to the reaction slab, 3 – steel rod ( $\phi 20$  mm) connecting the RC frame to the foundation steel shape, 4 – vertical high-strength rods ( $\phi 30$  mm) to apply axial load, 5 – steel cap, 6 – steel rods ( $\phi 20$  mm) connecting the RC frame and the reaction structure, 7 – distributing load plate, 8 – self-equilibrated reaction steel structure, 9 – counterweight, 10 – wood bars, 11 – hydraulic jack (for axial load application), 12 – vertical wooden platform, 13 – airbags, 14 – infill panel, 15 – RC column, 16 – steel plate for rod force distribution.

The out-of-plane test consisted of the application of a uniformly distributed surface load through a system composed of seven nylon airbags, reacting against a self-equilibrated steel structure, as shown in Figure 3. The application of a uniform out-of-plane loading pretends (as was observed) to globally mobilize the out-of-plane response of the IM wall. In the literature similar out-of-plane load distribution adopted by other authors can be found (Griffith et al., 2007, Ferreira et al., 2015).

This reaction structure is composed by five vertical and four horizontal alignments of rigidly connected steel bars, in front of which a vertical wooden platform is placed to resist the airbag pressure and transfer it to the steel reacting grid elements. Thus, 12 steel threaded rods, crossing the RC elements in previously drilled holes, were used to equilibrate the reaction force resulting from the pressure applied by the airbags in the infill panel. The steel rods were strategically placed to evaluate the load distribution throughout the entire infilled RC frame resorting to load cells attached to each rod, which allowed continuous measurement of the forces transmitted to the reaction structure to which the rods were directly screwed. On the other extremity of each tensioned rod, appropriate nuts and steel plates were used to anchor the rod and apply its reaction force to the concrete surface by uniformly distributed normal stresses, thus avoiding load concentration on the RC elements crossed by the rods.

In each column, the axial load was applied by means of a hydraulic jack inserted between a steel cap placed on the top of the column and an upper HEB steel shape, which, in turn, was connected to the foundation steel shape resorting to a pair of high-strength rods per column. Hinged connections were adopted between these rods and the top and foundation steel shapes; the axial load actually applied to the columns was continuously measured by load cells inserted between the jacks and the top of each column, which was paramount in performing the in-plane tests.

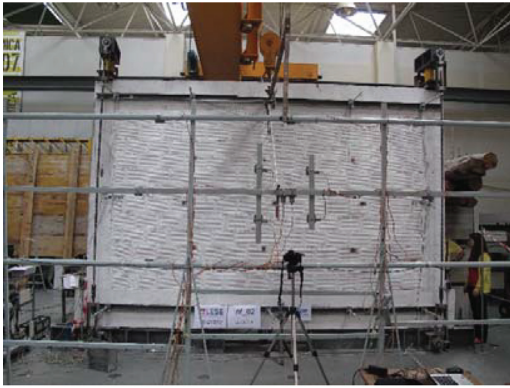
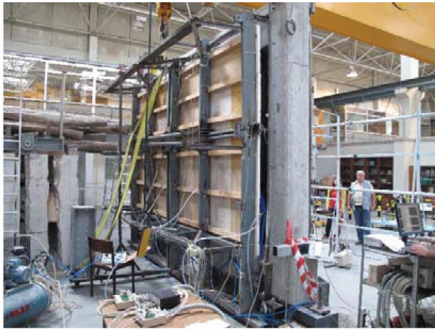
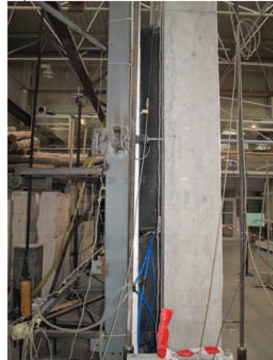
Figure 4. General view of the out-of-plane test setup: a) Front view; b) back view; c) Lateral view; and d) detail of the out-of-plane loading application.

The pressure level inside the airbags was set by two pressure valves which were controlled according to the target and measured out-of-plane displacement of the central point of the infill panel (the control node and variable) continuously acquired during the tests using a data acquisition and control system developed in the National Instruments LabVIEW software platform (NI, 2012). Prior to the experiments, calibration of the whole system was undertaken; this consisted of comparing the sum of the load cell forces with the airbag pressure resultant force (the pressure multiplied by the theoretical loaded panel area), in order to obtain the variation of load distribution, i.e. indirectly the actually loaded area, with the increase in distance between the steel reaction structure and the surface loaded panel. This calibration was achieved by inserting a vertical wooden panel supported in wood beams reacting against the RC top and bottom beams, thus without involving the brick masonry panel. In Figure 4 it is presented the general view of the out-of-plane test setup.

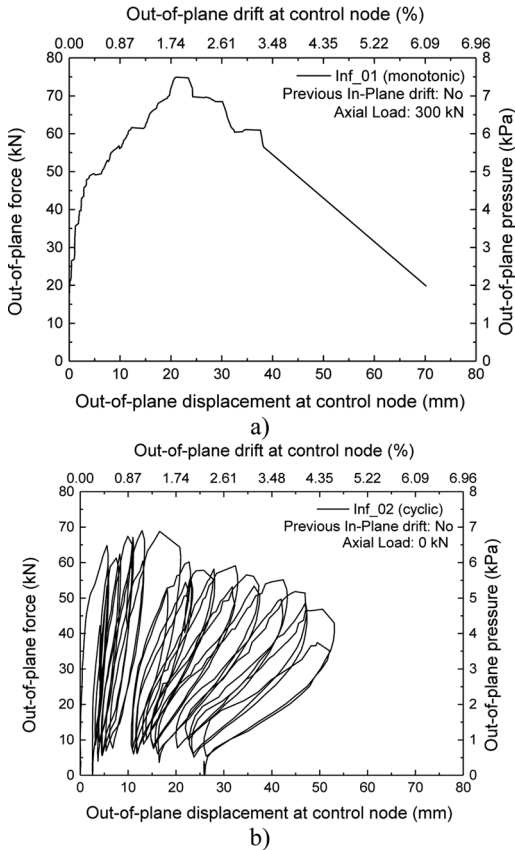
Figure 5. Original and non-damaged IM wall force-drift results: a) monotonic test Inf\_01 and b) cyclic test Inf\_02.

The maximum strength was almost four times higher for the tests without previous in-plane damage (In\_01 and Inf\_02) and for higher out-of-plane drift values. For the Inf\_01 and Inf\_02 tests the maximum strength occurs for out-of-plane drift values of 1.5–2% as illustrated in Figure 5.

The strength degradation is particularly pronounced in both tests. This fact can be explained by the failure mode observed in this test (described below). In the monotonic test between the displacement of 40 mm and 70 mm it is observed a linear range which is explained by the brittle collapse observed at the 40 mm approximately. By comparing Inf\_01 and Inf\_02, it was also verified that the initial stiffness of the IM walls was slightly affected by the axial loading in the RC columns. Namely, it was verified that the test with axial load (Inf\_01) had about 5% more initial stiffness when compared with Inf\_02. It was also verified that the initial cracking for the lower out-of-plane drift values for the Inf\_02 was about 10%. The cracking force in both experimental tests was about 50 kN.

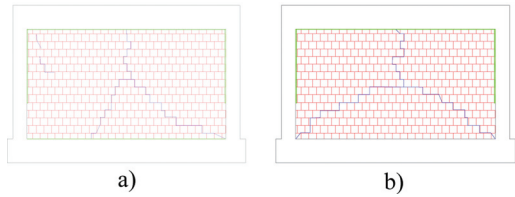
Figure 6. Original and non-damaged IM wall cracking pattern: a) monotonic test Inf\_01 and b) cyclic test Inf\_02.

of Inf\_01 was vertical, with detachment between the infill panel and the surrounding RC frame in the top and bottom joints, as shown in Figure 6a. However, the Inf\_02 test exhibited a trilinear cracking pattern with deformation concentrated in the mid-point of the wall, with slight cracking in the top joint (Figure 6b). This difference could be justified by the axial load applied in the columns during the monotonic test that changed the border restrains of the original panel or due to testing procedure (monotonic and cyclic load). Further tests will be performed in the future to understand the relationship between the cracking pattern and the load condition.

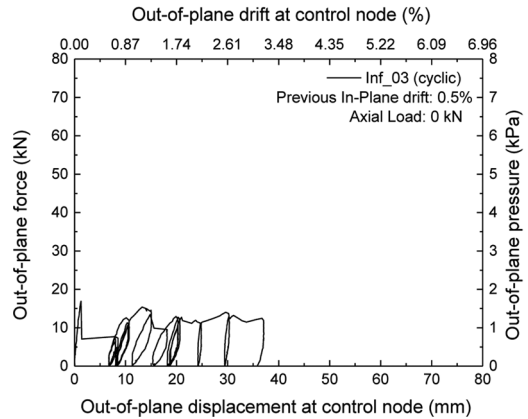
Figure 7. IM wall with previous in-plane damaged (Inf\_03) force-drift results.

Concerning the tests without previous in-plane damage, initial cracking was found for the lower out-of-plane drift values (about 0.1% drift) for the Inf\_02 test. The cracking force in both experimental tests was about 50 kN. In the test with previous in-plane damage (Inf\_03), initial cracking occurred at 0.1% drift and at a maximum strength of 18 kN, as shown in Figure 7.

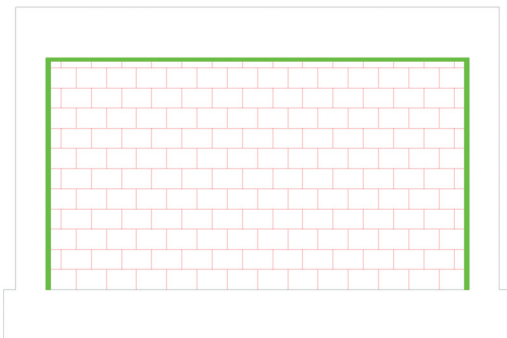
Figure 8. IM wall with previous in-plane damaged (Inf\_03) cracking pattern.

Finally, no cracking pattern occurred in the middle of the IM wall Inf\_03, which is related to the observed detachment between the infill panel and the surrounding top beam and columns, evidencing typical rigid body behaviour, as illustrated in Figure 8.

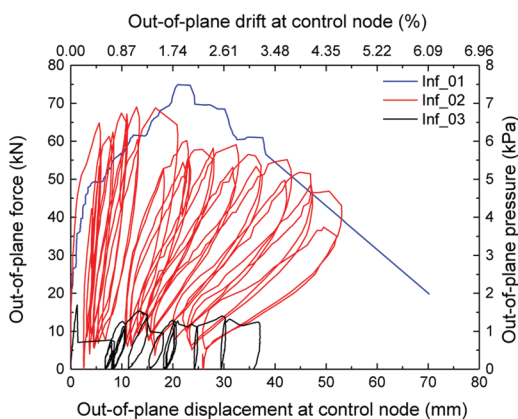
Figure 9. Global results: force-drift.

maximum strength was almost four times higher for the tests without previous in-plane damage and for higher out-of-plane drift values; b) the initial stiffness was significantly affected by the introduction of the in-plane damage, that of the test with previous in-plane damage (Inf\_03) being almost 30% lower than the original IM walls; c) a significant maximum strength reduction was found in the tests without the previous in-plane damage, which was not verified in Inf\_03 (Figure 9).

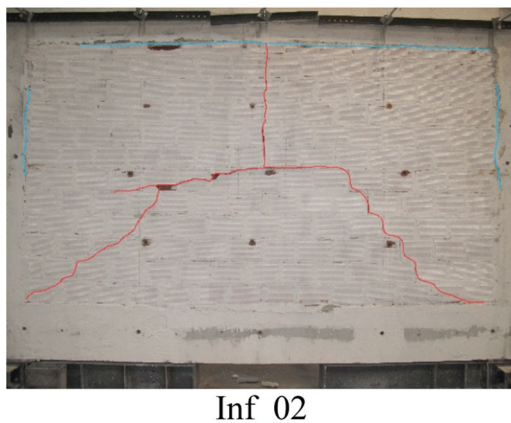
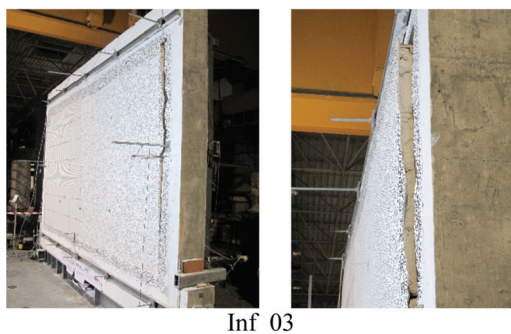
Figure 11. Global results: final damaged a) Inf\_02 and Inf\_03.

In the Inf\_02 wall, trilinear cracking was observed with concentrated deformation in the middle point of the wall, with slight cracking in the top joint. For the test with previous in-plane damage, only detachment was observed between the

infill panel and the surrounding top beam and columns, and typical rigid body behaviour was found (Figure 11a and Figure 11b respectively)
