# Seismic Resistance of Portuguese Vernacular Architecture: A critical review

Nuno Pereira and Xavier Romão

A report developed at the request of the European Centre for Urban Risk (CERU), Portugal, within the context of the research project LAReHBA - Local Appropriate Retrofitting of Historical Built-up Areas - and of the EUR-OPA framework sponsored by the European Commission.

Porto, December 2016

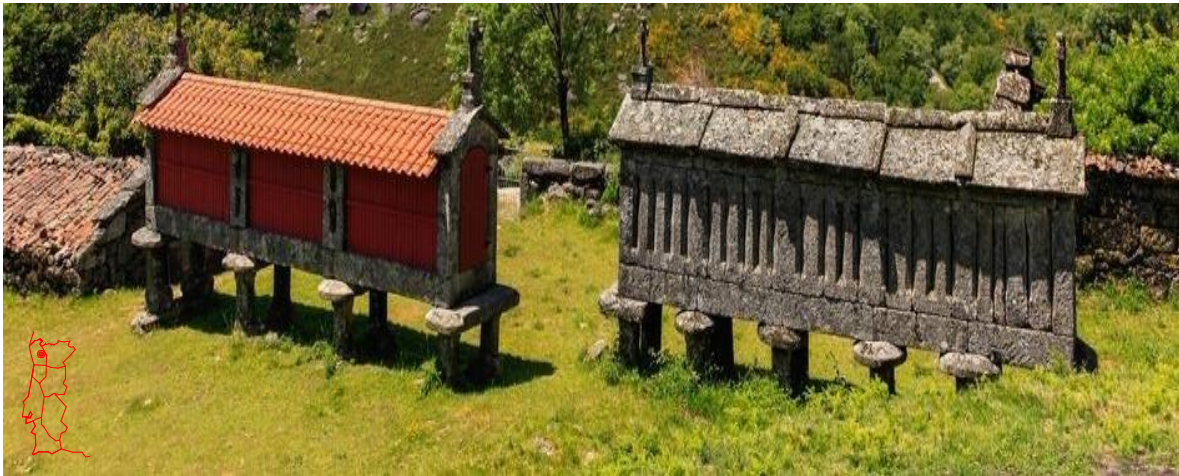
Figure 6 shows an example of two storage structures located near each other: the left-hand side structure has a partial timber structure with ceramic tiles and the right-hand side structure is fully made with granite stone elements.

Figure 6. Example of storage structures constructed. Credits: <http://www.aldeiasportugal.pt>.

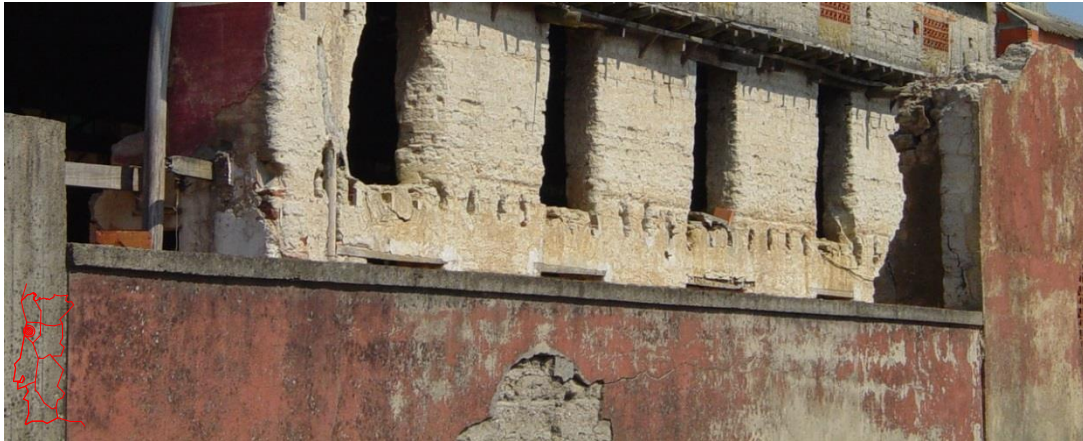
Figure 7. Adobe building in Aveiro. Credits: Aníbal Costa.

(see Silveira *et al.*, (2014) for a comprehensive material analysis). These adobe blocks are used in recent constructions, while older constructions are made of moulded sun dried clay adobe bricks connected with lime and sand mortar. The Murtosa and the Gandaresa houses are two cases of single storey buildings that are typical (Fernandes, 2013) of the southern part of region R1. Nonetheless, other structures can be found in the area comprising building with different configurations, such as the one shown in Fig. 7.

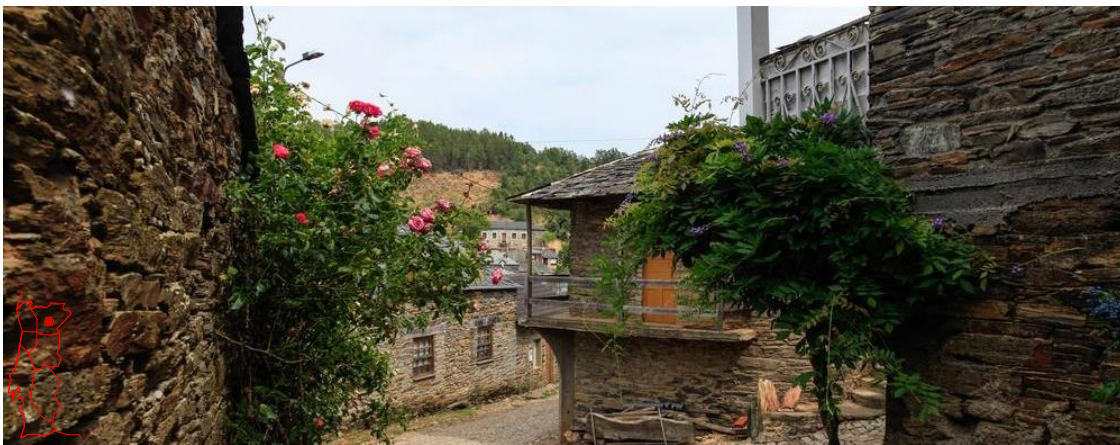
Figure 9. Schist masonry building with timber balcony and roof made of schist slabs. Credits: <http://www.aldeiasportugal.pt>.

The existence of balconies and porches are the most distinctive feature in buildings that are otherwise similar in configuration to those that exist in R1. The balconies are usually constructed in timber (see Fig. 9), covered by part of the roof which is connected to the balconies by timber columns. The support of the balcony is also made of timber diagonal elements which are connected to the walls.

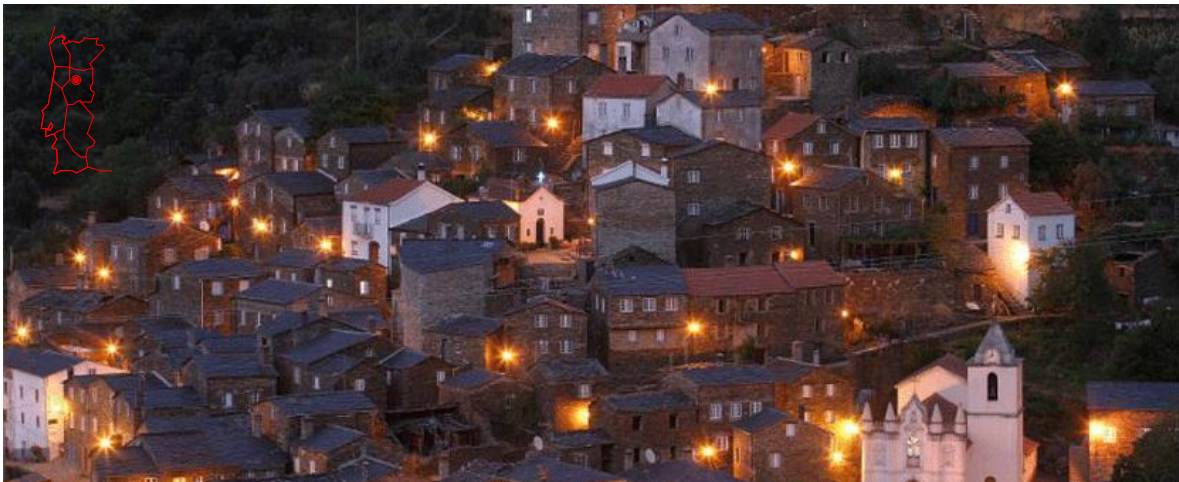
Figure 12. A general view of the village of Piodão. Credits: <http://www.visitcentrodeportugal.com.pt/pt/piodao/>

Region R3 includes the Central-Northern area of mainland Portugal where the local geology exhibits schists and granite. In the survey used in the present study, R3 was subdivided into seven sub-regions where different construction typologies have been identified, as shown in Fig. 11. This division aimed at separating the different types of stone masonry and building configurations found in the region. In sub-region A, two-storey buildings of granite or schist masonry were observed with porched balconies closed with glass windows and an approximately rectangular plan shape. The schist buildings have granite stones in the corners when this material is available. The roofs are also made of schist slabs and the chimney is small when compared with the building size. This type of buildings can be found in the village of Piodão (Fig. 12) which is known for its agglomerate of dwellings made of schist stone masonry.

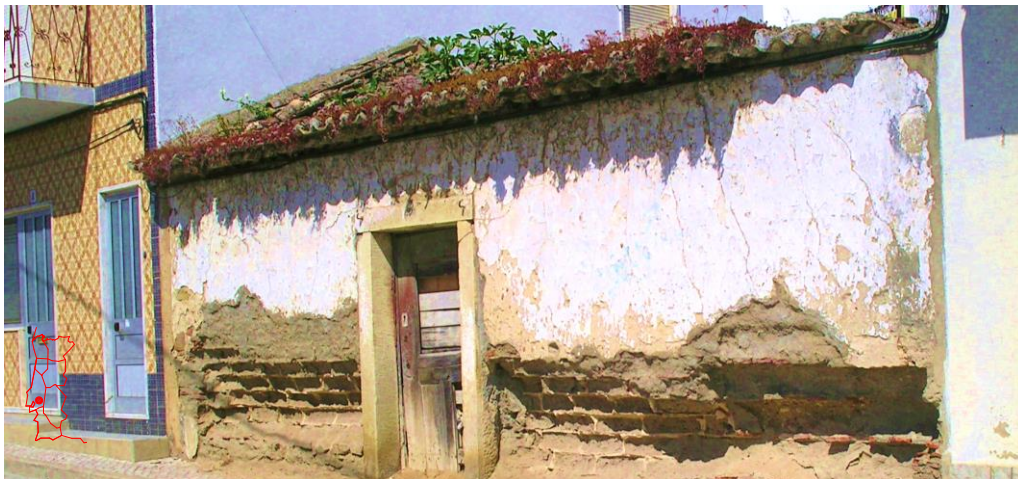
Figure 16. Adobe houses in Benavente. Credits: Aníbal Costa

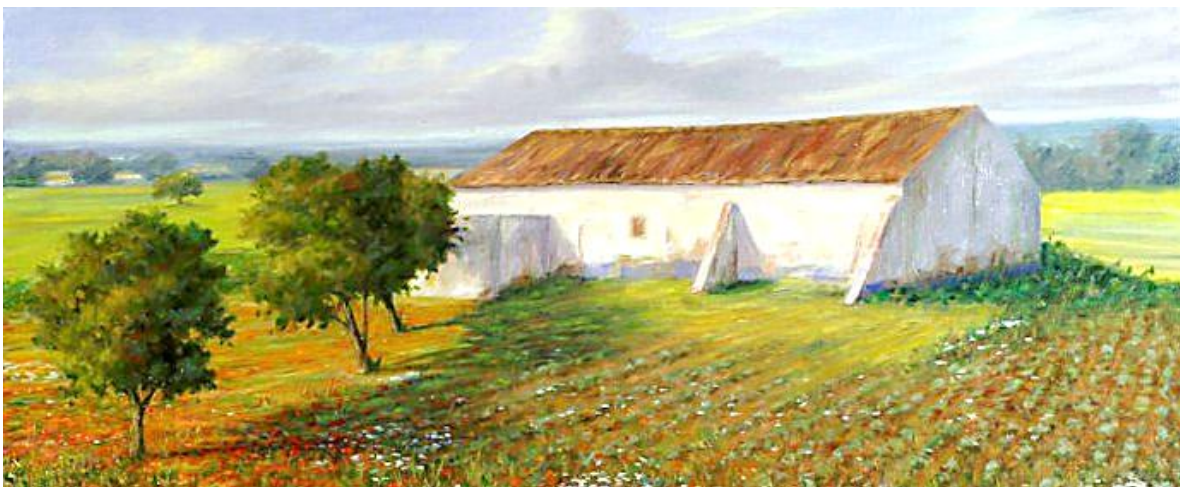
Figure 19. Typical Alentejo construction ("Monte Alentejano", painting by Salvação Barreto).

Two typologies that represent the general layout of the vernacular Alentejo buildings were defined. Both are based on a structure with rammed earth elements, timber roofs or vaults and often found in isolated areas (called *montes*). According to the survey results, these vaulted roofs have a very small height and cover spans in the range of 5-7m. Typically they can be found in houses located at the Évora plateau, Borba mountain range, Guadiana region, Serpa and Moura.

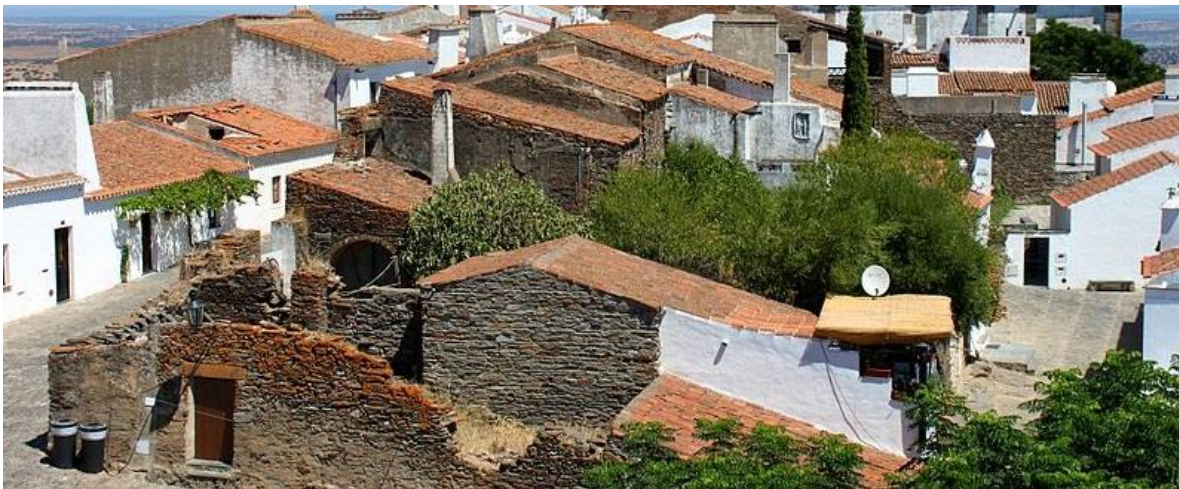
Figure 20. Schist masonry buildings in the fortified village of Reguengos de Monsaraz (Credits: @ creative commons)

In the Borba mountain range, which includes the area between the villages of Borba, Vila Viçosa and a part of Alandroal, there is a generalized use of schist masonry with or without lime cover. Buttresses are used to sustain the buildings through the irregular terrain levels. Figure 20 shows an example of schist masonry used in the village of Reguengos de Monsaraz, whose buildings were constructed from 1830 based on the remainings of military structures left in the village, often using the materials from the defence walls of the village.

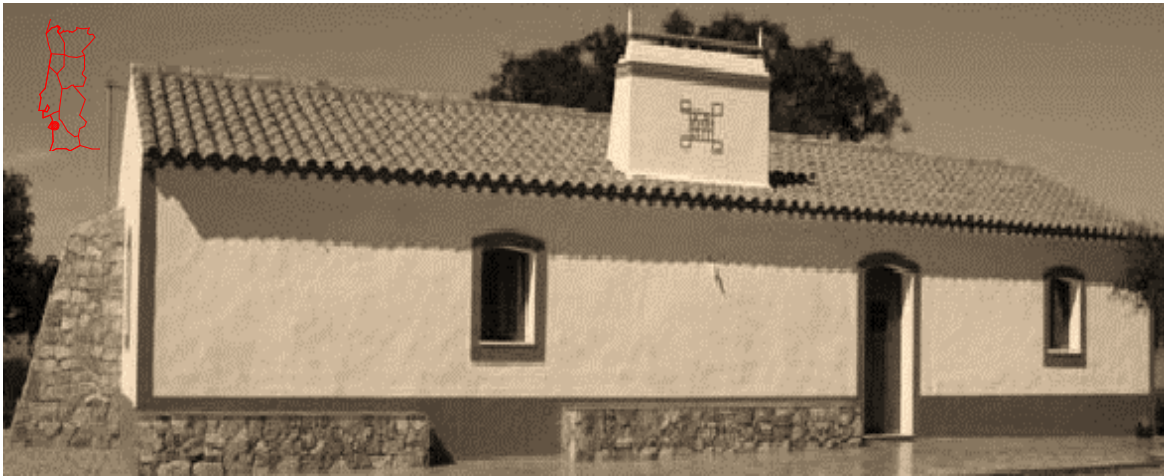
Figure 22. Typical dwelling found in Melides.

As can be seen in Fig. 21, rammed earth is the dominant construction technique used in the area. The Alentejo Atlantic coastline presents building typologies that are similar to those observed in the interior Alentejo dwellings, with the use of rammed earth and buttresses. In the outfall of the Sado river, groups of six houses in a row were observed spread over the elevation of the terrain. The rammed earth buildings have lime covering with buttresses that consolidate the walls (Fig. 22). The row buildings are common in this area, forming large one storey blocks. On the southeast side, schist masonry is more typical. It corresponds to the Guadiana river region. In this area, the buildings are masonry structures made of local schists which have also a considerable amount of clay and

have shed roofs inclined towards the dominant wind direction to protect the buildings from rain infiltrations. Currently, fragile roofs have been replaced by ceramic tiles over timber structures.

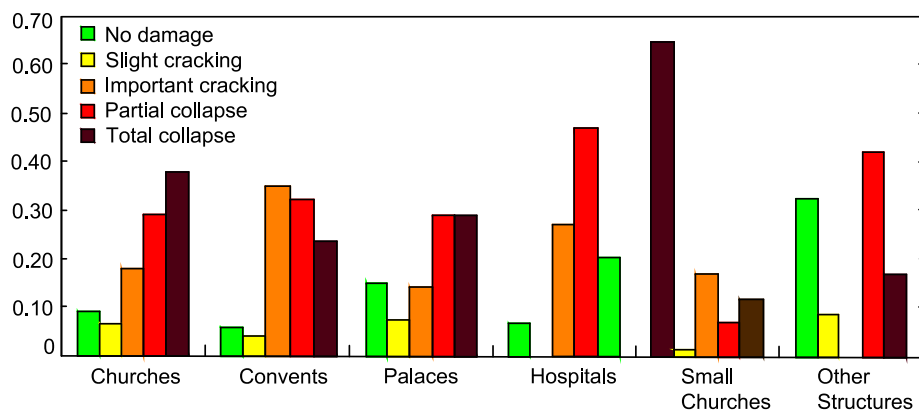
Figure 37. Damage statistics for the city of Lisbon (Data from Oliveira, 2008).

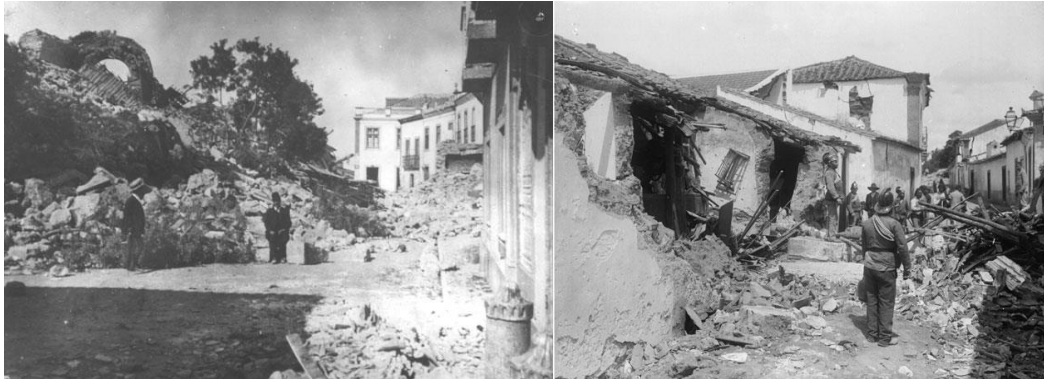
Figure 39. Collapses observed after the 1909 earthquake in Benavente (source: <http://www.cm-benavente.pt/conhecer-benavente/historia/terramoto-de-1909>).
