# A proactive approach to the conservation of historic and cultural Heritage: the HeritageCare methodology

Conference Paper · March 2019

### 3. Case study of Ducal Palace

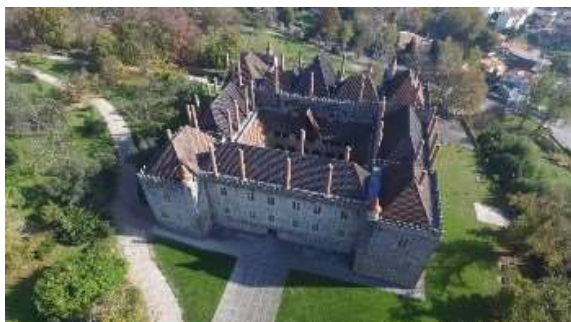
The case study here presented is the Ducal Palace in Guimarães, Portugal (see Figure 1), a three-story masonry building dated from the 15<sup>th</sup> century and classified as National Monument. Nowadays with an important restoration in the XX century, this building is hosting a museum, serves as presidential residence and receives several cultural initiatives.

Figure 1. Ducal Palace in Guimarães (Portugal).
