## THE EFFECT OF SLAB AND TRANSVERSE BEAMS ON THE BEHAVIOUR OF FULL-SCALE PRE-1970'S RC BEAM-COLUMN JOINTS

### **Abstract**

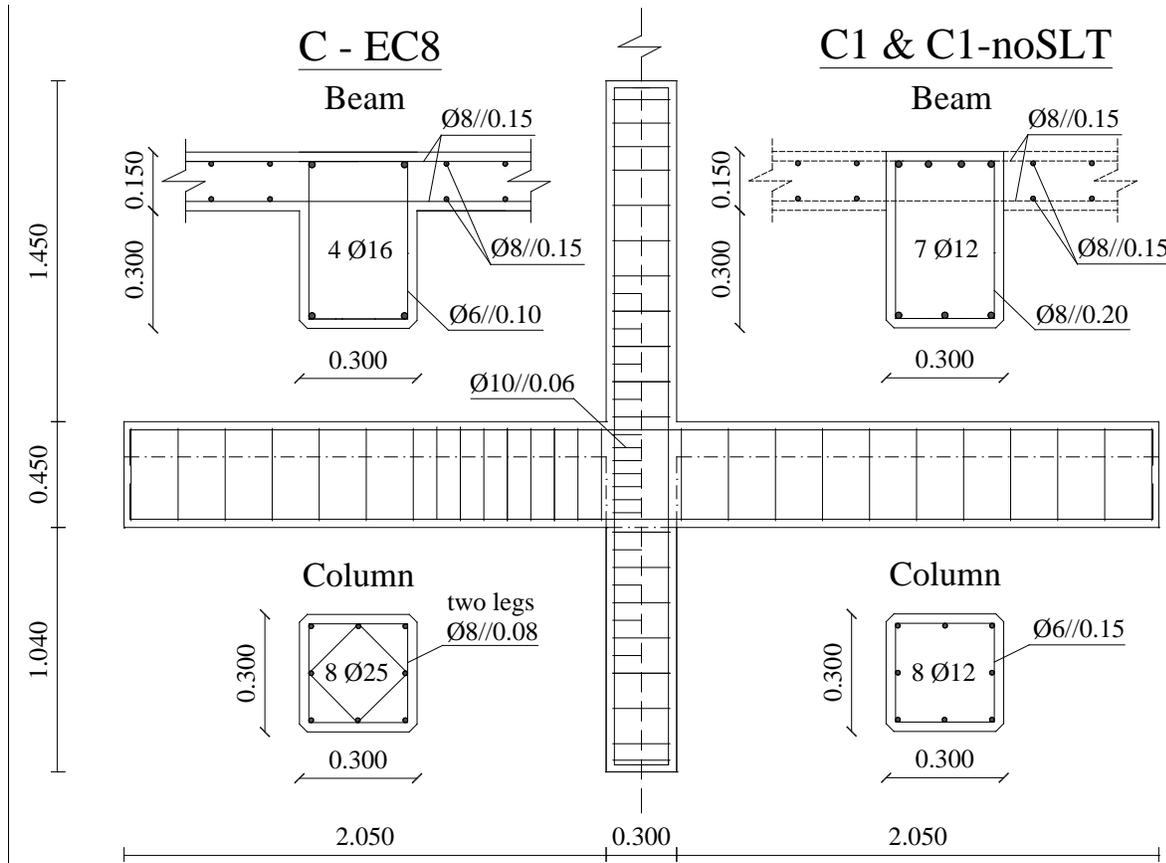
Fig. 1. Schematic of the geometry and detailing of the full-scale RC joint sub-assemblages tested. Note: the left side of the figure shows reinforcement details for specimen C EC8; the right side of the figure shows the reinforcement details for specimens C1 and C-noSLT (dashed line indicates slab for C1).

A schematic of the specimen geometry and reinforcement is presented in Fig. 1. The reinforcement detailing for one of the specimens, C EC8, is carried out according to Eurocode 8 provisions (Fig. 1 left). The steel reinforcement detailing of specimen C1 is instead designed according to the REBA (1967) code for reinforced concrete buildings in Portugal, chosen as representative of the codes of practice in place in southern Europe in the 1970's. This code shows several seismic detailing deficiencies common at the time, such as no transverse reinforcement in the joint, a lower flexural strength in columns as compared to beams, inadequate spacing of transverse reinforcement in columns for the provision of confinement (see Fig. 1 right). The third specimen, C-noSLT has identical detailing to C1 but does not comprise a slab or transverse beam (as denoted by the dashed lines in the beam section drawing), i.e. is of the cross shape commonly used in other studies. The average results of material tests on the three specimens are presented in Table 1.

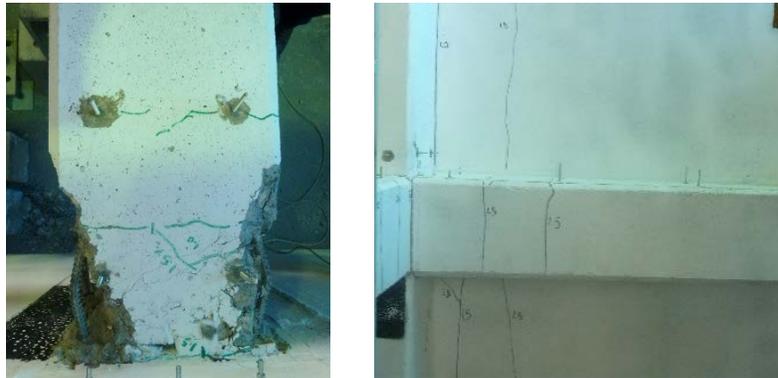
Fig. 2. Final damage state in C1; left: superior column, right: beam underside

For the specimen designed to pre-1970's guidelines, C1, numerical modelling predicts a brittle failure dominated by large rotation in the superior column, leading to a localised plastic hinge formation followed by concrete crushing and buckling of the superior column bars just above the column-slab interface [10]. The experimental observations shown in Fig. 2, confirm this. The type of mechanism observed can be described as a single-storey column failure, as no damage is observed in the rest of the specimen. As shown in Table 2, a relatively low lateral capacity of 63.1kN, combined with a low displacement ductility (3.6) are observed for the non-seismically designed specimen. The inadequate seismic performance of the specimen is also characterised by a very low energy dissipation (32.1 kN.m) and significant a post-peak softening slope.

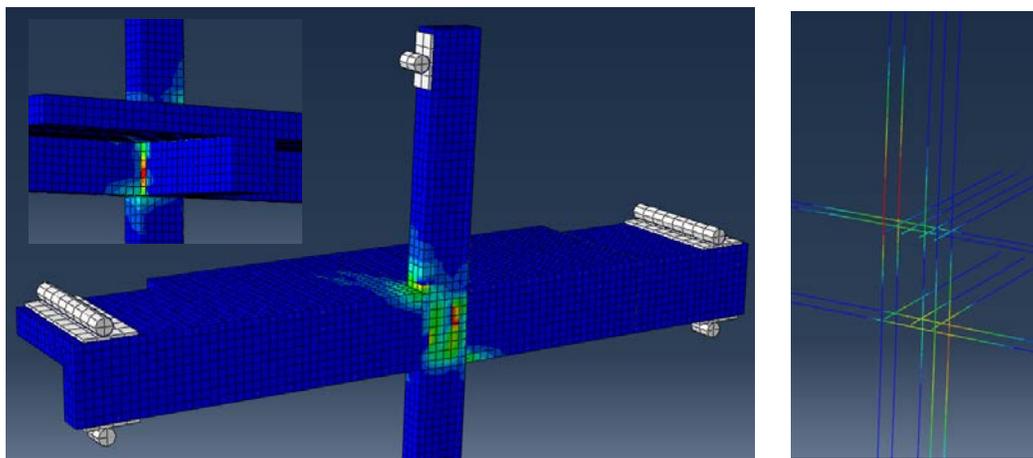
Fig. 3. Left - Damage location in control model with slab (Inset: view from the back); Right - yield of column bars – note: the displayed view is a cross-section through the centre-line of the interior joint specimen.

Analysis of the numerical model offers more in-depth understanding of the effect of the slab and transverse beam contribution. In Fig. 3, locations plastic strain in concrete, corresponding to cracking in the model, are shown. Damage is concentrated in the top column, at the joint interface, but high stains in the concrete are also observed at the interface between transverse beam and joint (inset), and interface of the slab and column, as the transverse beam cross-section is resisting joint deformation. Moreover, limited rotation of the primary beams is observed and their longitudinal reinforcement does not reach yield strain in the model and experiment alike. Yielding of reinforcing bars is limited to the columns (red colour in Fig. 3, right), and is observed at a drift of 0.65% in the experiment.

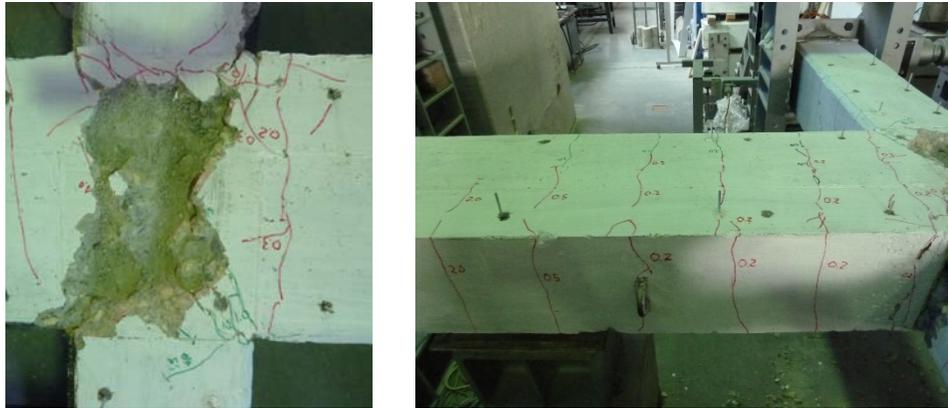
Fig. 4. Final damage state in C-noSLT; left: joint, right: beam

For the control specimen without slab and transverse beam, C-noSLT, a very different failure mechanism and damage pattern are observed. As shown in Fig. 4, and as predicted by numerical modelling, large damage occurs in the joint region, with cracks noticeable along the beam and at the beam-joint interface. Limited cracking in the columns and no yield of the column bars are observed, as the rotation of the column and hence the demand are reduced. This is in stark contrast to the column failure observed for C1.

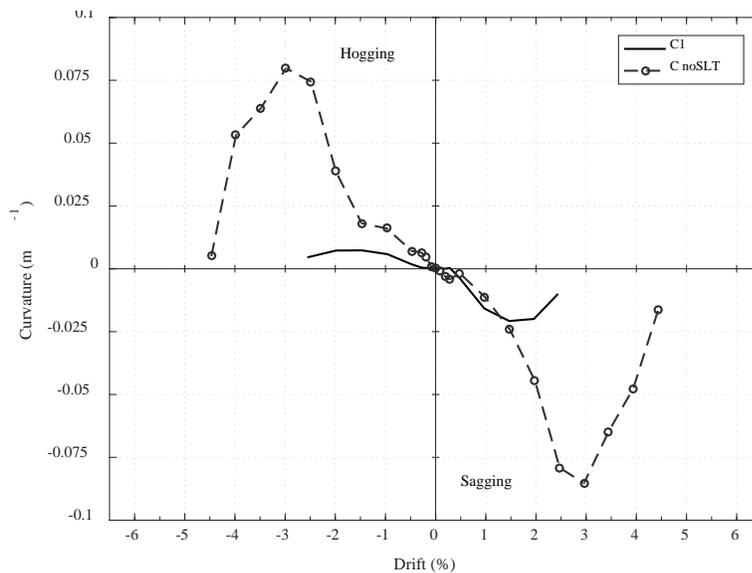
Fig. 5. Comparison of the experimental beam curvatures close to the joint interface for C1 and C-noSLT versus level of drift (%).

The effect of the slab is clearly highlighted by the evolutions of curvatures at the beam to joint interface shown in Fig. 5. In the case of C-noSLT the beam rotation is not limited by the slab and a symmetric curvature evolution is observed between positive and negative cycles (imposing sagging and hogging, respectively). Without the slab, the hogging moment capacity of the beam is similar to their sagging moment capacity and the beams and joint rotate. For C1, in turn, overall a much lower maximum curvature in the beams are recorded (-67%), with the curvatures at the bottom of the beams three times larger than at the top.

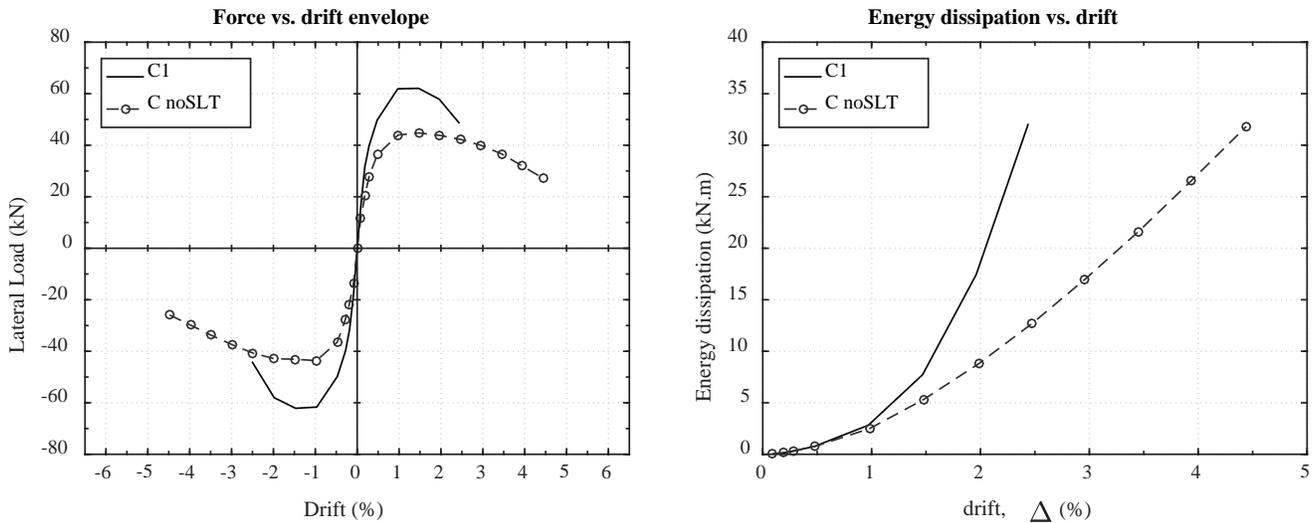
Fig. 6. Force-drift envelope and energy dissipation against drift for C1 and C-noSLT

In terms of global force-drift envelope and energy dissipation (Fig. 6), specimen C-noSLT displays a much more ductile response, but with a much lower peak force (-28.4%) and a decreased energy dissipation (-0.8%). The increase in ductility is a direct consequence of the reduced yield drift and reduced initial stiffness. Due to the removal of the slab contribution, yielding is observed in the beams, and this leads to a lower yield drift of 0.59% (-9.2% compared to C1). As shown in Table 2, the initial stiffness of the specimen without slab is also much lower (-27%).

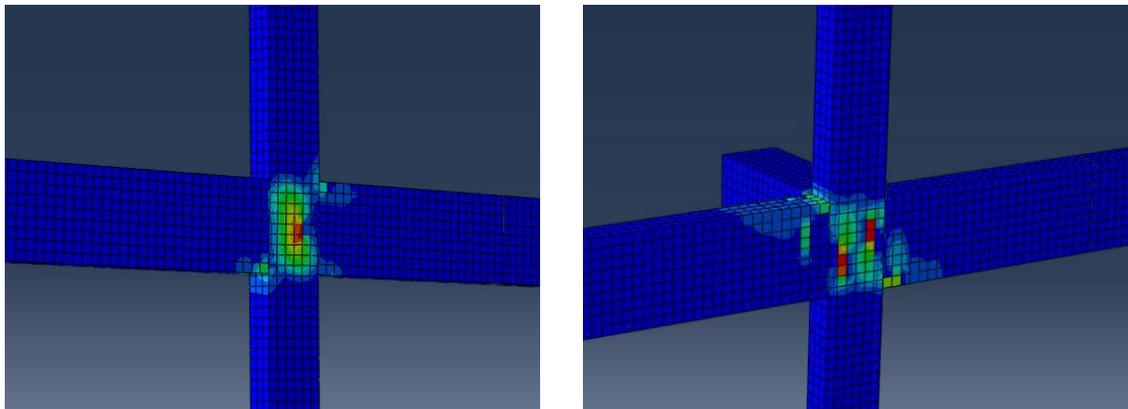
Fig. 7. Damage location in the specimen without transverse beam and slab (left) and the specimen without slab (right) [10]

While not tested in the laboratory, the isolated effect of the transverse beam is assessed by numerical modelling, as shown in Fig. 7. A specimen without slab but with transverse beams is modelled (Fig.7 right) and shows reduced damage as compared to the specimen without transverse beam (Fig.7 left). Furthermore, the transverse beam is seen to confine the joint and to also hinder the rotation of the joint, leading to larger damage in the adjacent beams. Finally, comparison of the behaviour of the numerical model of the specimen with transverse beams but no slab and C1 clearly shows the former having larger rotation and damage in the beams as opposed to the case with the slab present.

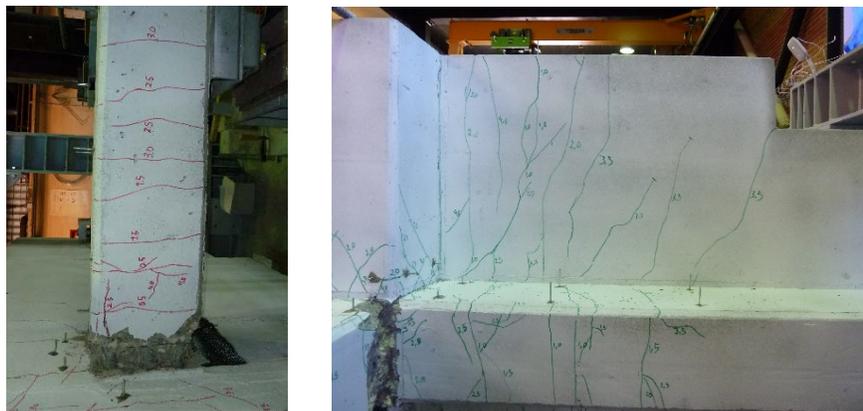
Fig. 8. Final damage state in C-EC8; left: superior column, right: beam underside

However, the importance of considering the slab in the experiment is highlighted by the final damage state, shown in Fig. 8. Despite implementation of capacity design, concrete crushing in the columns is observed for C-EC8. This ultimately causes failure of the specimen. A higher over-strength of the beam bars may be one of the reasons for this failure of compliance with the anticipated hierarchy of strengths. However, the reason for this could also be attributed to a stronger slab contribution than anticipated by the Eurocode 8 design equations. Indeed the experimentally observed strength of the beams is 33% larger than anticipated by Eurocode 8 equations. It is worth noting that for the specimen without slab the prediction from EC8 is nearly perfect (-1%). In the numerical model, high strains in the slab longitudinal bars along the entire width of the slab are observed. A longer effective width of the slab, i.e. the t-section of the beam, (830 mm, i.e. 5.5 times the thickness of the slab) hence contributes to the moment capacity of the beam than what is anticipated in section 5.4.3.1.1 of Eurocode 8 (i.e. 4 times the thickness of the slab). This observation confirms results in [5] for which a capacity 39% higher than that calculated using seismic guidelines was also observed.
