The Viana footbridge: construction and dynamic monitoring

A new moveable footbridge was recently built at the entrance of Marina Atlântico in the city of Viana do Castelo, Portugal. This paper presents a brief description of the global solution, with a special focus on the characterisation of the construction methods adopted. Particular consideration is given to the construction of the pivot pylon and the steel structure, showing how all the bridge components work together to ensure a safe working relationship with the marina, the river and users of the continuous bicycling and pedestrian pathway running across the closed bridge. The mechanical, hydraulic, electrical and navigational light systems play fundamental roles, especially during bridge opening and closing operations. Moreover, as this light footbridge is susceptible to vibrations due to human traffic, the paper also describes the dynamic tests performed during and after construction, including two ambient vibration tests, the measurement of cable-stay forces, and tests with groups of pedestrians used to evaluate induced vibration levels along with the monitoring of bridge accelerations over 4 months of use.

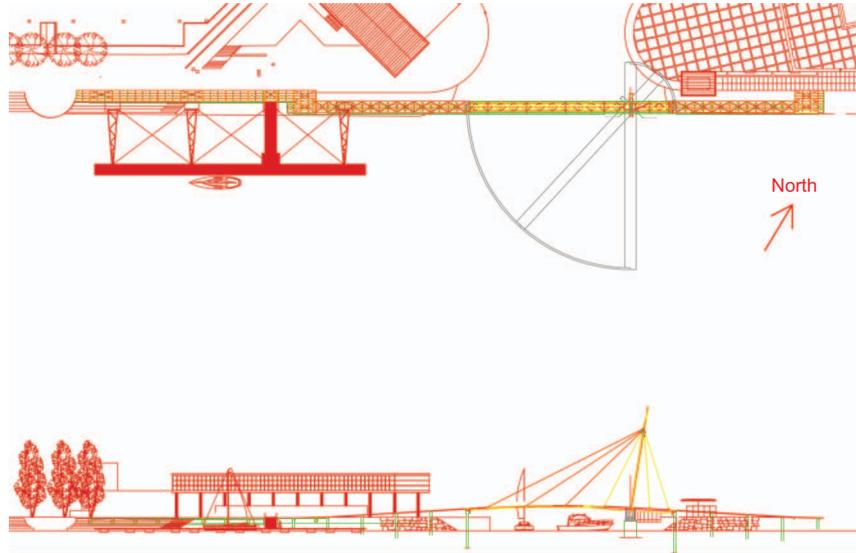
Figure 1. Overview of the general solution (source: unpublished 2005 document, Structural Project of Viana do Castelo Moveable Footbridge, by Lopes *et al.*)

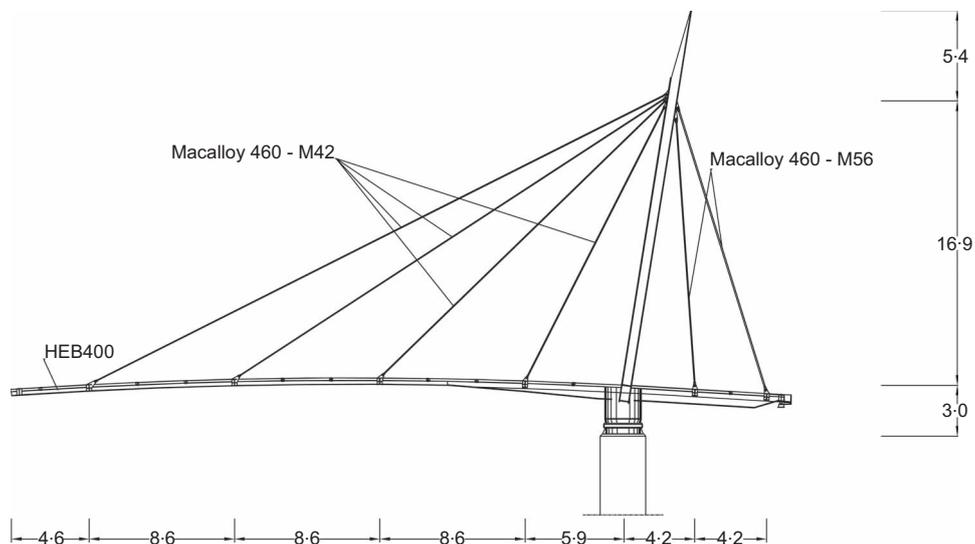
Figure 2. Elevation (dimensions in m)

The bridge structure (Figures 2 and 3) is composed of a ladder deck, approximately 36 m long and 2.5 m wide, which is suspended by four pairs of cables from a mast. This mast is back-anchored by two pairs of cables in a shorter span (9 m), from which 11 high-density blocks, with a total mass of 80 t, are hung to balance the weight of the longer span. The mast base is welded to a cylinder that accommodates two planetary gear units, each motorised by an hydraulic axial piston motor, and a 3-m diameter wheel gear bearing that allows for rotational

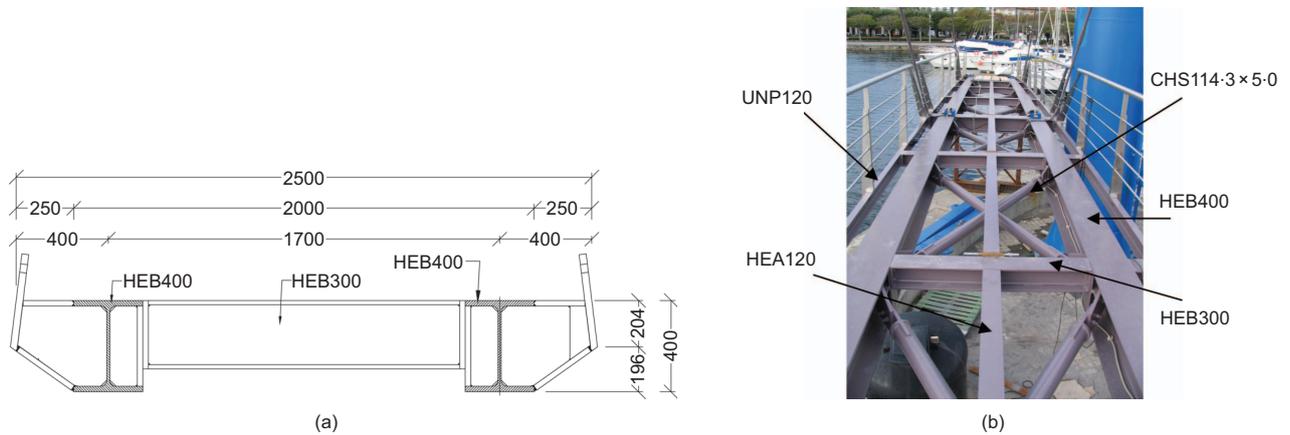
Figure 3. (a) Typical cross-section (dimensions in mm); (b) detailed view of the deck

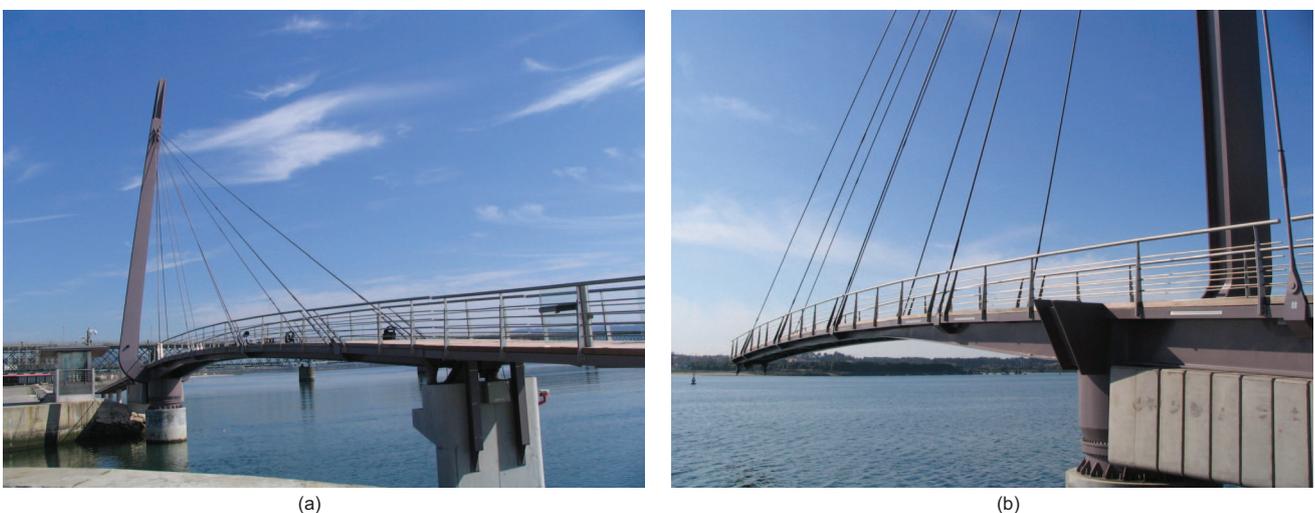
Figure 4. Images of the footbridge in the two operating positions: (a) closed, for use by pedestrians; and (b) open, to allow the entrance of sailing boats into the marina

Figure 4 presents photographs of the bridge, showing the two alternative configurations. When the bridge is in use (left image), the vertical and lateral displacements of the two ends of the deck are constrained by their connections to the abutments. When the bridge is opened to allow the entrance of sailing boats into the marina, the main span behaves as a cantilever supported by the pylon and balanced by the concrete counterweight. Further details of the bridge characteristics can be found in Delgado *et al.* (2008). The authors were involved in the construction, commissioning, testing and temporary monitoring of the Viana footbridge, and the subsequent sections describe some of the most relevant experience gained during that work.

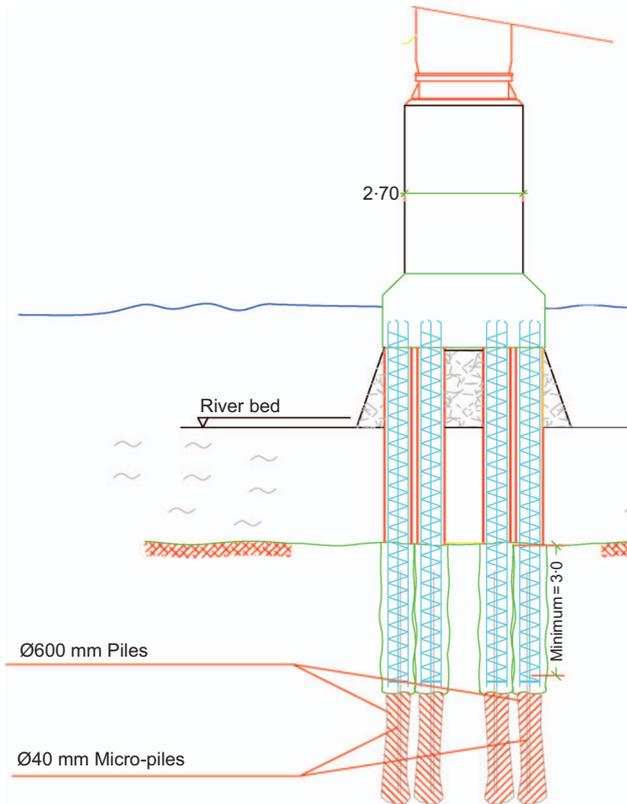
Figure 5. Initial solution (Delgado *et al.*, 2008) (dimensions in m)

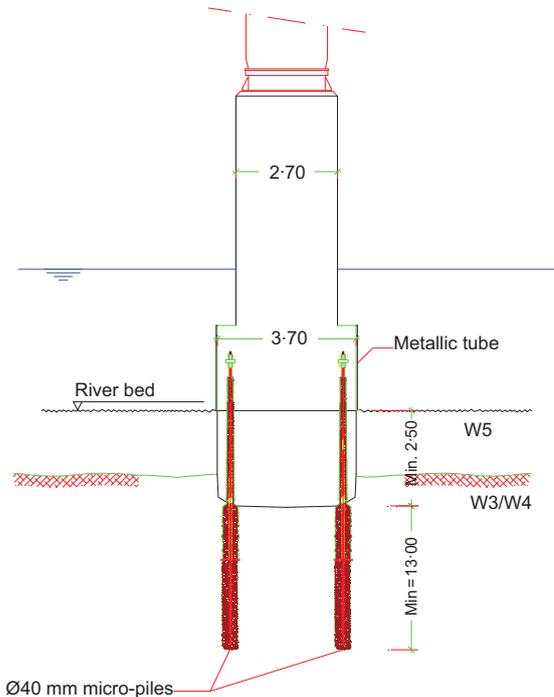
Figure 6. Contractor's solution (dimensions in m)

The design team decided that the widest part of the steel tube, shown in Figure 6, with a height of 2.5 m, should be placed on the riverbed, and a cavity 3.70 m in diameter by 2.5 m long

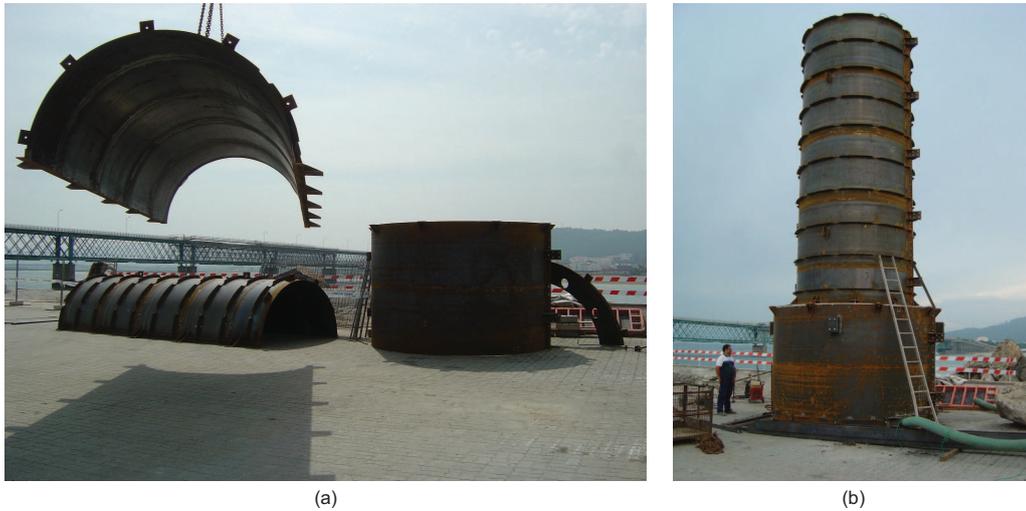
Figure 7. Formwork components and erected formwork

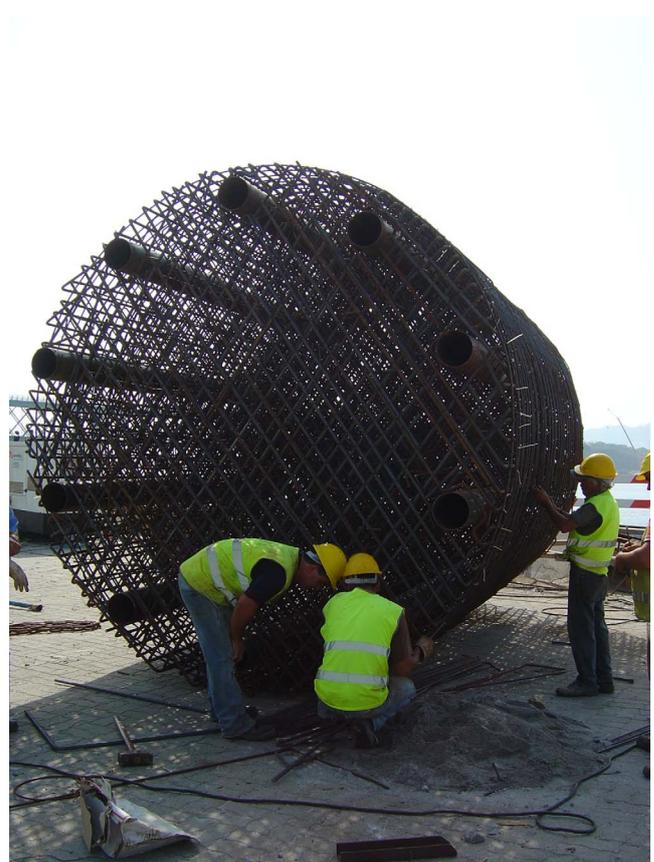
Figure 8. Lower reinforcement

should be opened in its interior. The micropiles were then extended 13 m below this level. The contractor designed a steel formwork composed of three pieces: a sacrificial tube 3.70 m in diameter by 2.5 m long and two linkable parts for the tidal part of the pillar, each 2.70 m in diameter and 7 m long. The formwork was transported in pieces and assembled at the construction site (Figure 7). Simultaneously, the lower reinforcement including a set of tubes was prepared, as shown in Figure 8.

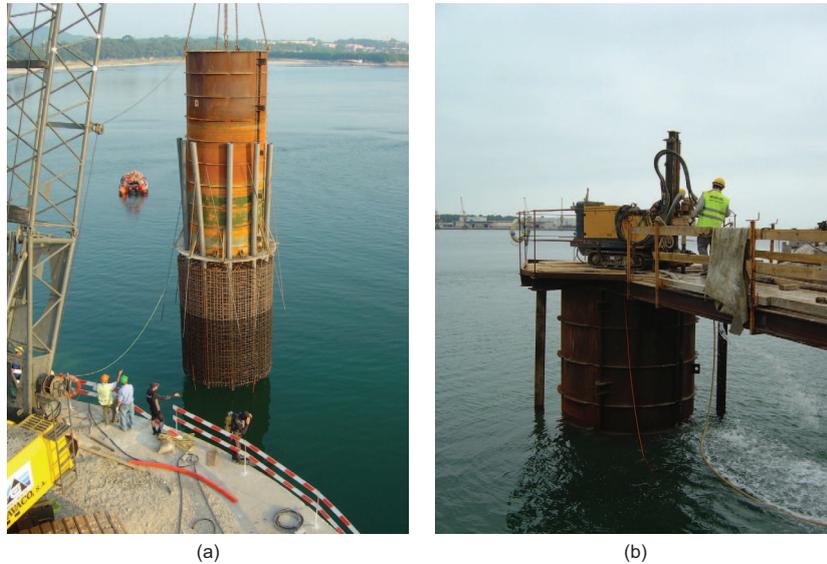
Figure 9. Placing of the lower reinforcing steel and installation of the micropiles

In the first stage, concrete was filled into the first 4 m; the micropiles were installed (Figure 9), and then the upper part of the formwork was dismantled into two separate pieces. The upper reinforcement steel, containing an inner steel tube to enable the future passage of the electrical cables and oil-hydraulics pipes, was installed inside the upper formwork (Figure 10). In a subsequent phase, the whole formwork was filled with concrete, and threaded rods were placed at the top and welded to the reinforcement structure for the subsequent support of the mast.

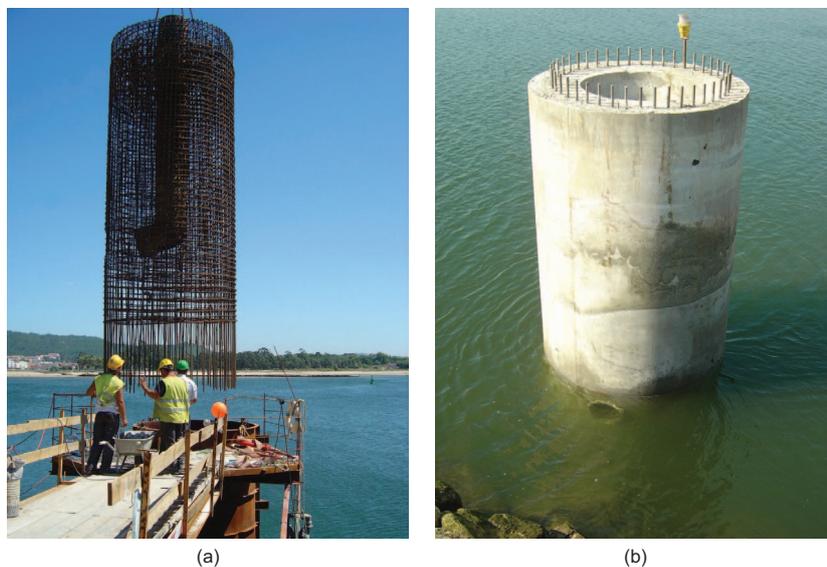
Figure 10. Placing of the upper reinforcing steel and view of the constructed pylon

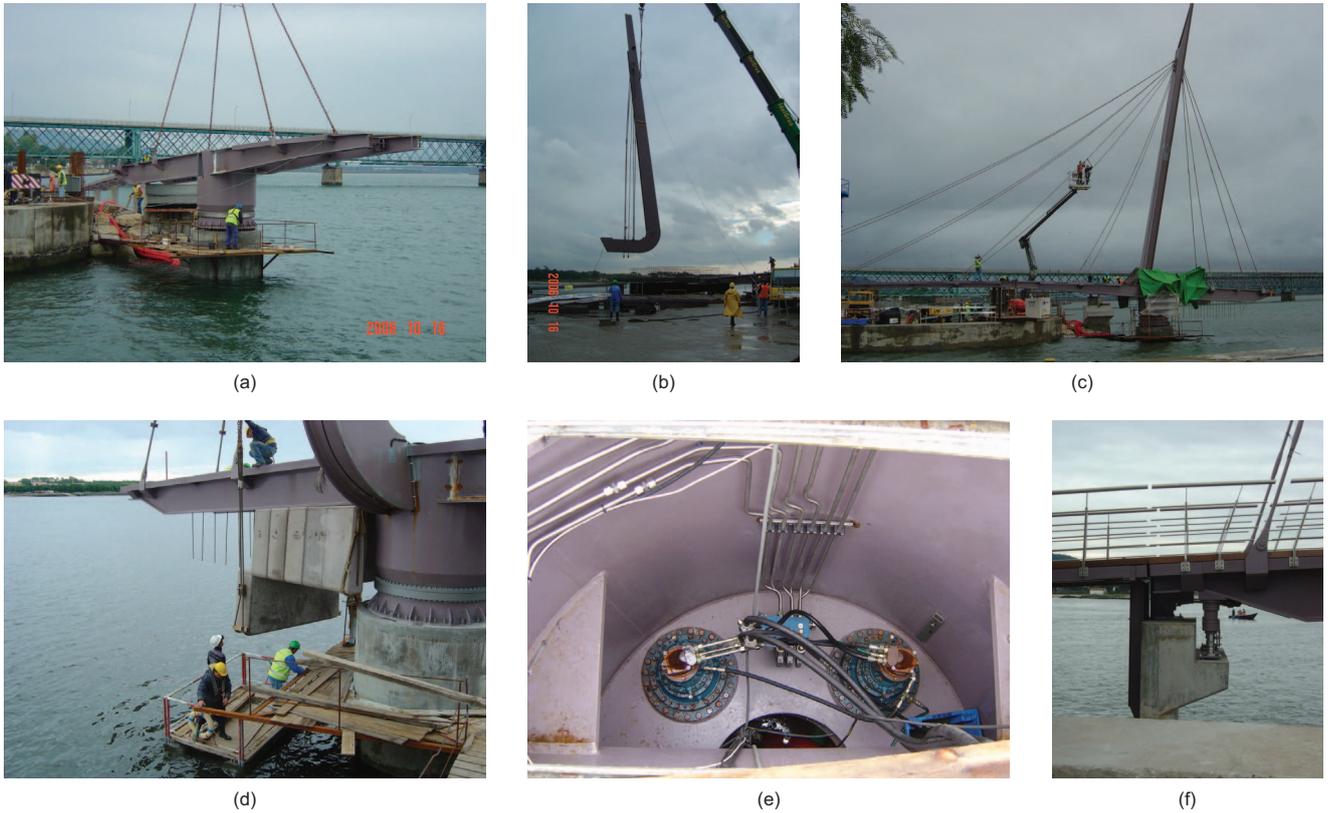
Figure 11. Phases of bridge construction: (a) installation of the first piece; (b) mast lifting and placement in the steel cylinder; (c) installation of cable stays; (d) counterweight: modular insertion; (e) planetary gear units; (f) locking devices

Once the pivot pylon was ready and the ramp piers were near completion, the bridge structural steel components were delivered to the construction site over the quay. The bridge parts were placed in the following phases (Figure 11).

- The first part was the steel cylinder; at the construction site, it was welded to the back span deck and parts of the main span segments. This piece was lifted, placed over the pivot pillar and bolted to the adjusting screws.

- The mast had to be transported in two separate pieces that were also welded at the quay. It was then lifted and placed in the existing openings in the cylinder. Four stays were previously tied at the mast top and later to the decks.

- At this point, the structure was manually rotated towards the quay, and the other part of the main span deck was welded. The main span deck was supported on a steel structure, with vertical adjustment positioned at the quay, and the remaining stays were placed using a crane.

- According to the stressing plan, the first six modules of the counterweight were inserted. Topographic readings revealed that the back span deck worked as a rigid group with the mast, and the main span deck displayed acceptable variations in position at its end.

- Once the counterweight was positioned, the supporting steel structure at the quay was removed, and the stays were tensioned to achieve the specified design stresses. Any

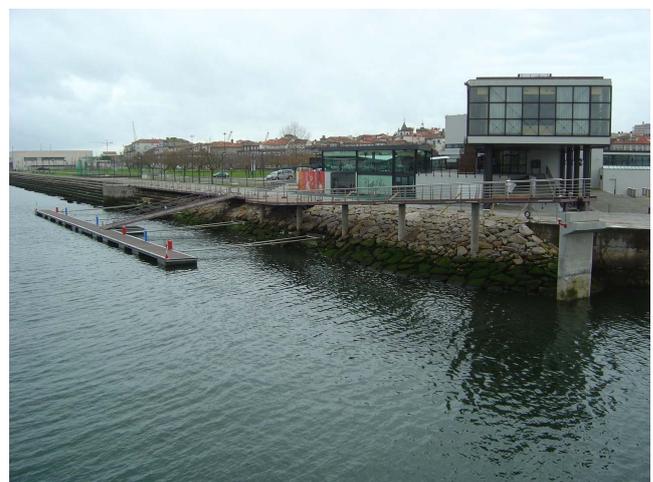
Figure 12. Waiting pontoon and west access platform

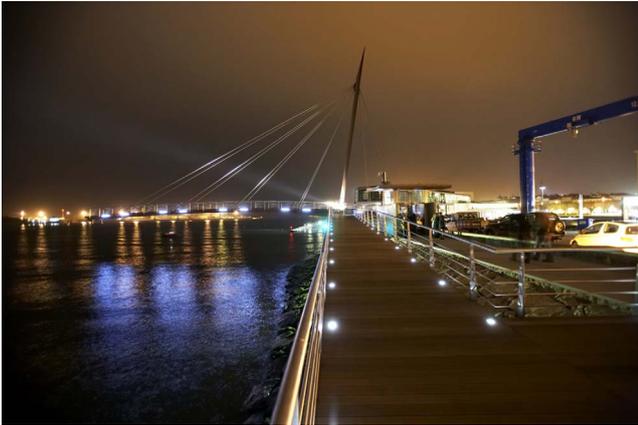
Figure 13. Night-time photograph: illumination and navigational lights

automatic gates. When the bridge is closing the reverse process is executed. Navigation lights were also installed at the closing piers and over the posterior deck (Figure 13). Communication between the switchboard in the control building and the switchboard from the west side is by radio.

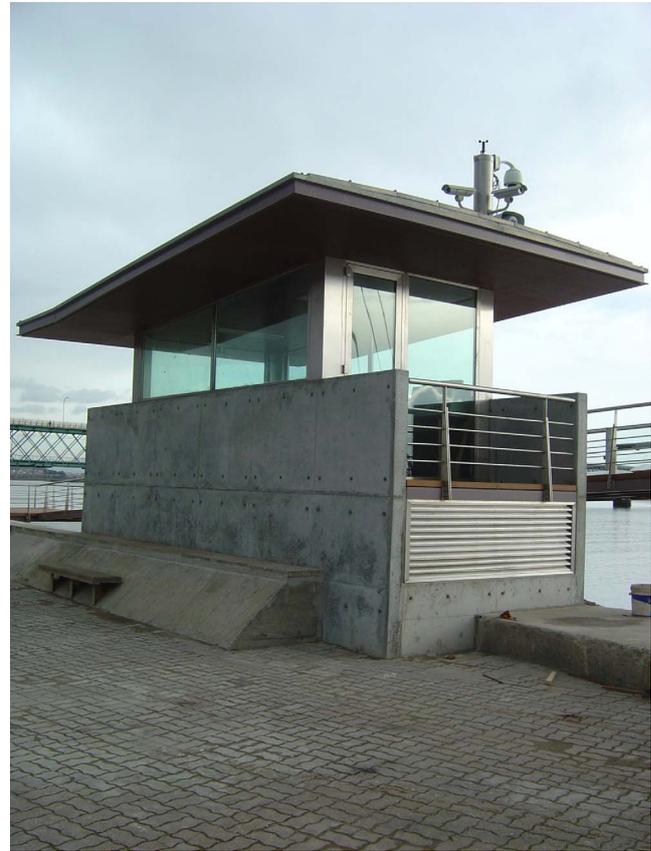
Figure 14. Control building

The system command is performed totally at the control building (Figure 14), where the hydraulic power pack (Figure 15), the switchboards and the surveillance equipment are located. The power pack includes a main variable displacement axial piston pump with electronic proportional control for the main movement, an emergency variable displacement axial piston pump with electronic proportional control and an auxiliary gear pump for all remaining actuators and control and safety valves. All system commands and equipments status, including peripheral devices, are housed in an electronic cabinet that includes a 17-in (43-cm) touch-screen control panel (Figure 15). This control panel has a graphical summary representation of the bridge, and the operator must confirm, step by step, a pre-programmed sequence that provides total safety for the people and equipment during opening and closing manoeuvres.

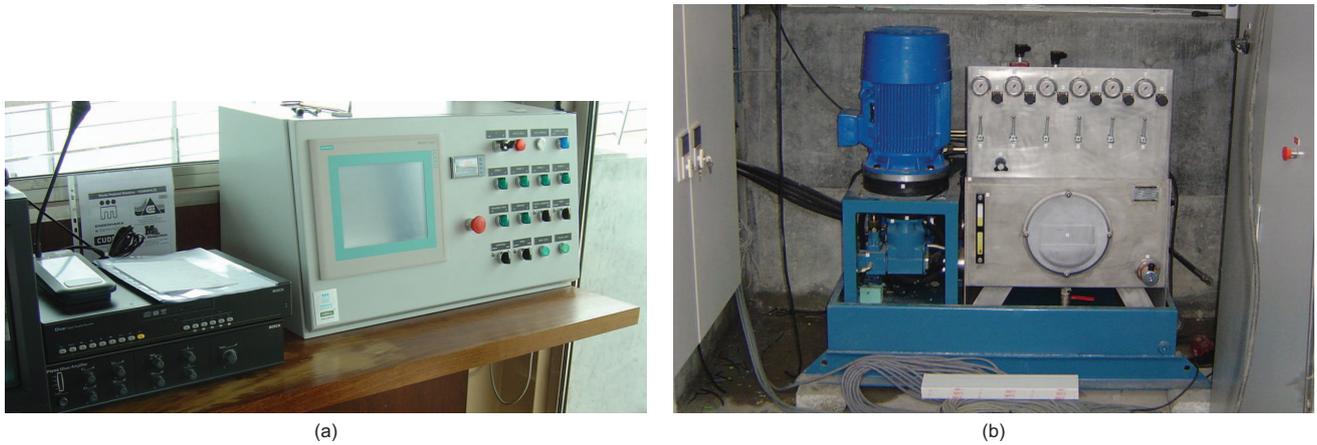
Figure 15. Touch-screen control panel (a) and hydraulic power pack (b)

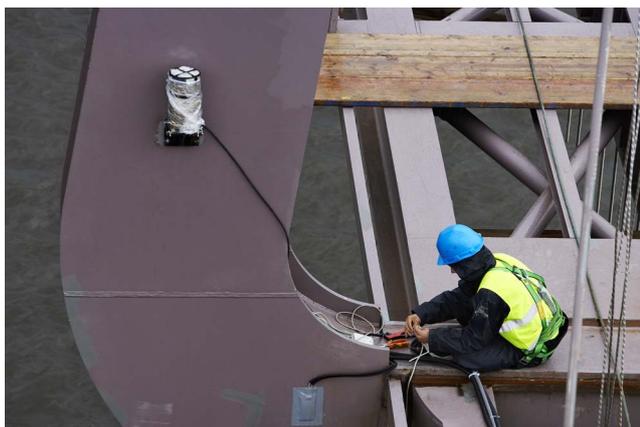
Figure 16. Installation of monitoring equipment

The installation of monitoring systems (Figure 16) began at an early stage, when the structure was dismantled over the quay, continued during the assembling of the bridge and ended 4 months after opening to the public.

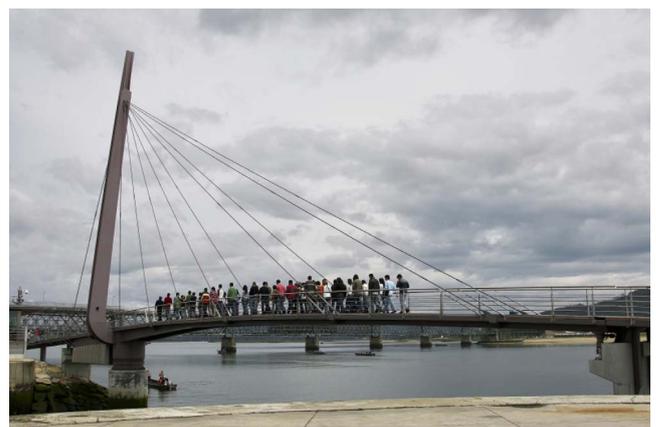
Figure 17. Dynamic test

The following sections describe the performed tests (Figure 17), the procedures used for the identification of the bridge modal properties and for the estimation of stay cable forces, the

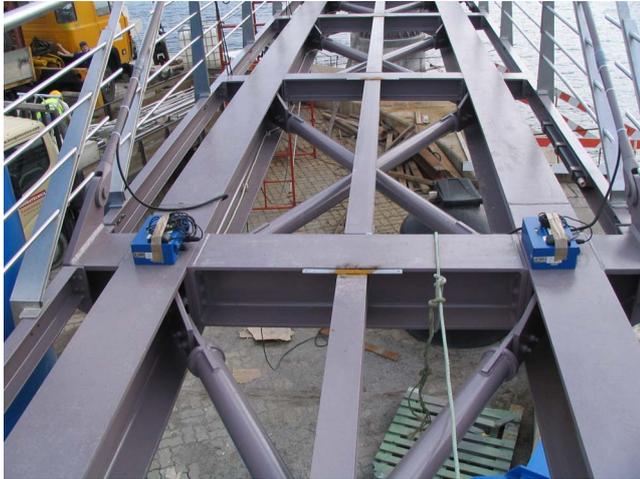
Figure 18. Bridge deck during the first ambient vibration test and two measuring units

The first ambient vibration test was performed with the bridge in the cantilever position during construction, before installation of the timber surfacing. Figure 18 shows a detail of the placement of the measuring equipment at that stage.

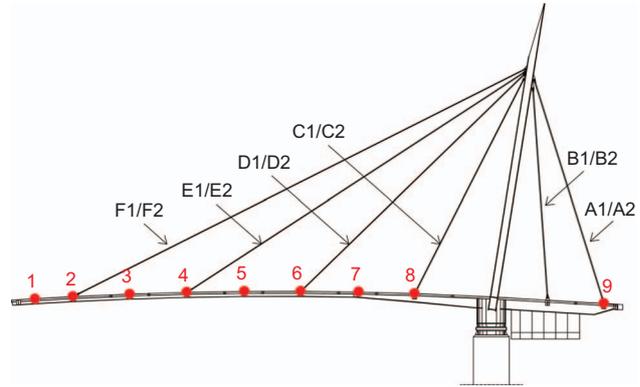
Figure 19. Instrumented sections

The bridge response to the ambient excitation was measured using four seismographs with tri-axial force-balance accelerometers and analogue to digital converters of 18 bits (Figure 18 shows two units). The sections instrumented in both tests are marked in Figure 19. The nine selected sections were covered in eight setups, using a reference section to link the results of each setup. In each section, measurements were performed in both sides of the deck (over the two main longitudinal beams) in order to provide data for the identification of torsion modes.

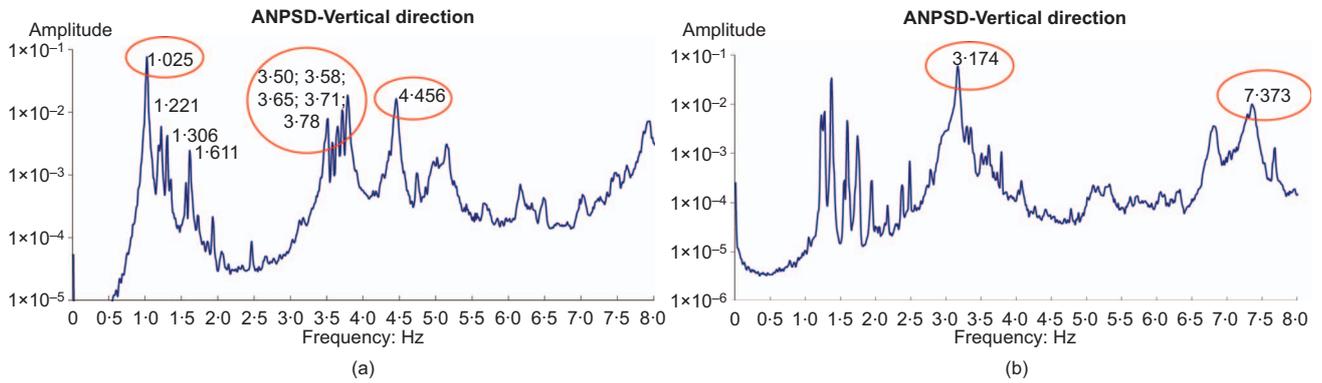
Figure 20. Average normalised power spectrum density functions of the vertical acceleration for the two bridge positions: (a) bridge open; (b) bridge closed

The average normalised power spectrum density functions of the vertical accelerations collected in both ambient vibration tests are represented in Figure 20. It can be observed that these graphics exhibit not only the peaks that are associated with the global modes of the deck but also peaks that represent local modes of the stay cables or combined modes of the deck and stay cables (Caetano *et al.*, 2000a, 2000b). This fact originates an increased difficulty in the identification of global modes whenever the corresponding natural frequency is close to a cable harmonic. Such is the case of the second vertical mode associated with the open position, for which it was not possible to define an exact value for the natural frequency, as several peaks around 3.6 Hz with the same mode shape were identified. The most relevant mode shapes are plotted in Figures 21 and 22.

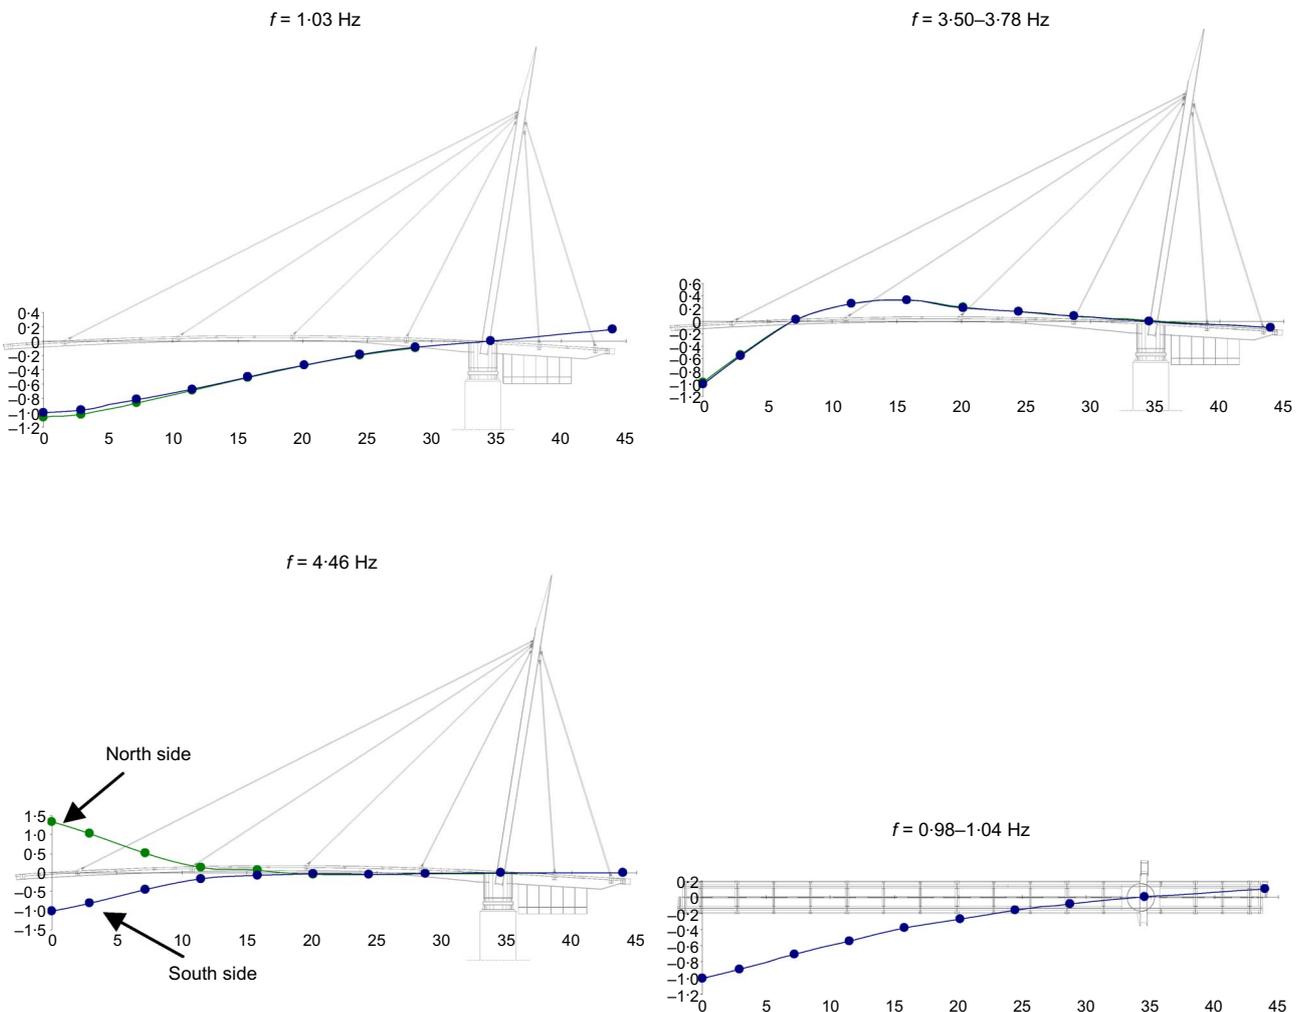
Figure 21. Bridge in open position: first two vertical mode shapes (1.03, 3.50–3.78 Hz), first torsion mode shape (4.46 Hz) and first lateral mode shape (0.98–1.04 Hz)

During the night period, the dominant frequency is approximately 1 Hz, corresponding to the first vertical bending mode of the bridge in the open position (Figure 21). The frequency observed in the finished bridge is slightly lower than that identified during the ambient vibration test, because the mass of the timber surfacing was added. In some periods the mode is more excited (red colour/dark), meaning that the wind is stronger during those setups.

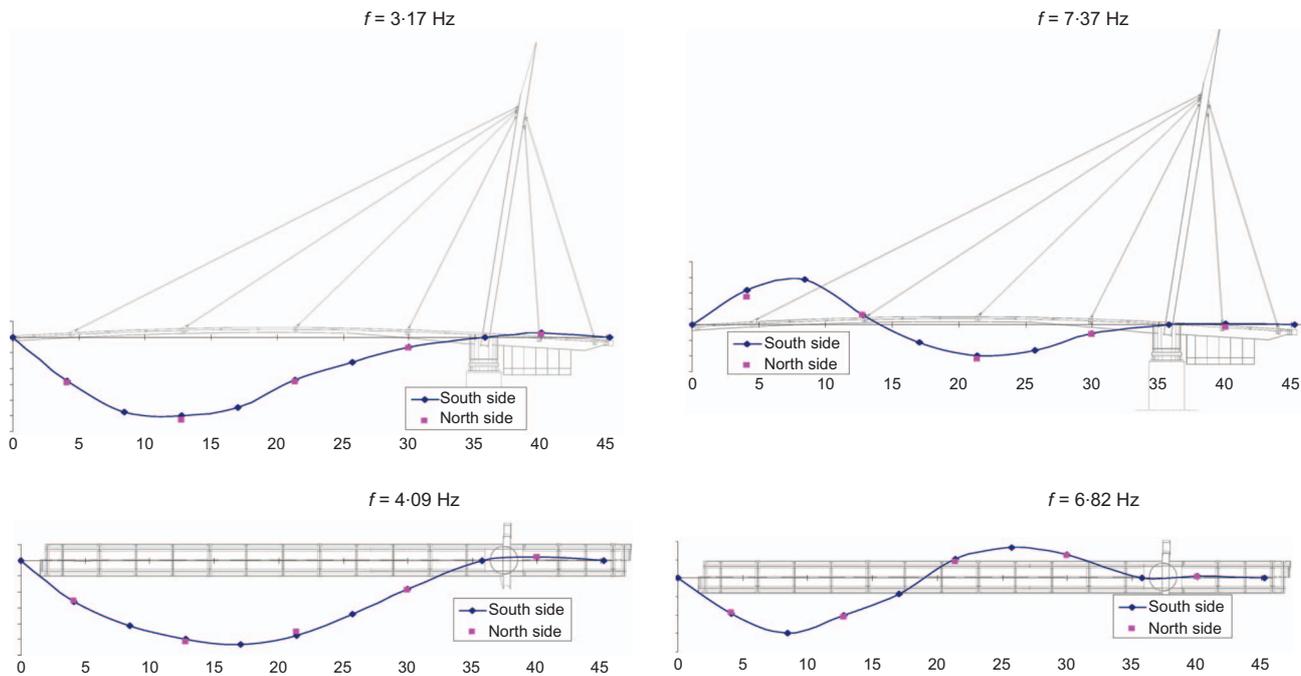
Figure 22. Bridge in closed position: first two vertical (3.147, 7.37 Hz) and lateral mode shapes (4.09, 6.82 Hz)

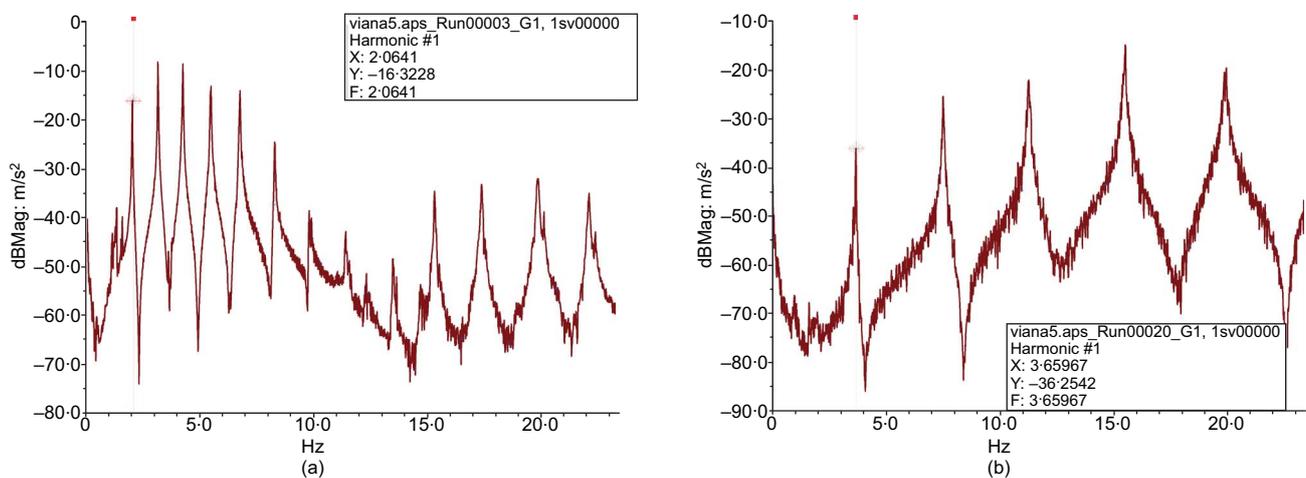
Figure 23. Auto-spectra density functions measured in two stay cables: (a) stay cable in central span; (b) backstay cable

The measurements were performed under ambient excitation, using a piezoelectric accelerometer conveniently fixed to the stay cables. Acceleration time records were collected and processed by means of a portable Fourier analyser installed in a laptop. Examples of the resulting average auto-spectra density functions are shown in Figure 23.

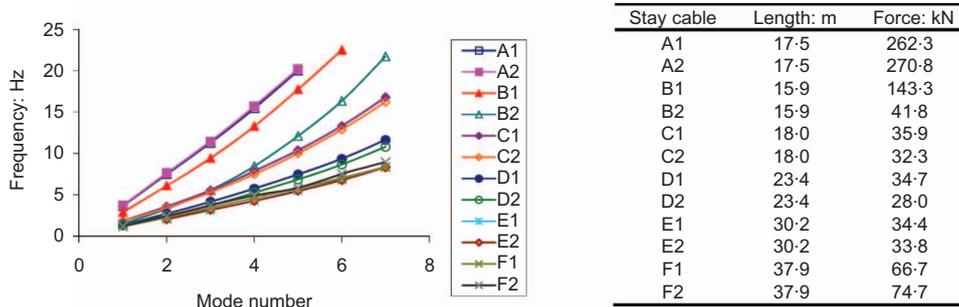
Figure 24. Measured stay cable frequencies and identified forces in the open position, before installation of timber surfacing

The plot of the successive stay cable frequencies compared with the corresponding mode number represented in Figure 24 shows that for all stay cables except the two longest backstays A1 and A2 (see Figure 19) significant deviations from the straight line expected for a tensioned cable occur. This fact results from the low tension installed in those cables (with stresses varying from 20 to 130 MPa), and invalidates the application of the vibrating chord theory relating the installed tension to the measured natural frequency of the cable. For that reason, the estimation of stay cable forces was based on a combination of the results from a numerical modelling of the cables with the recorded frequencies.

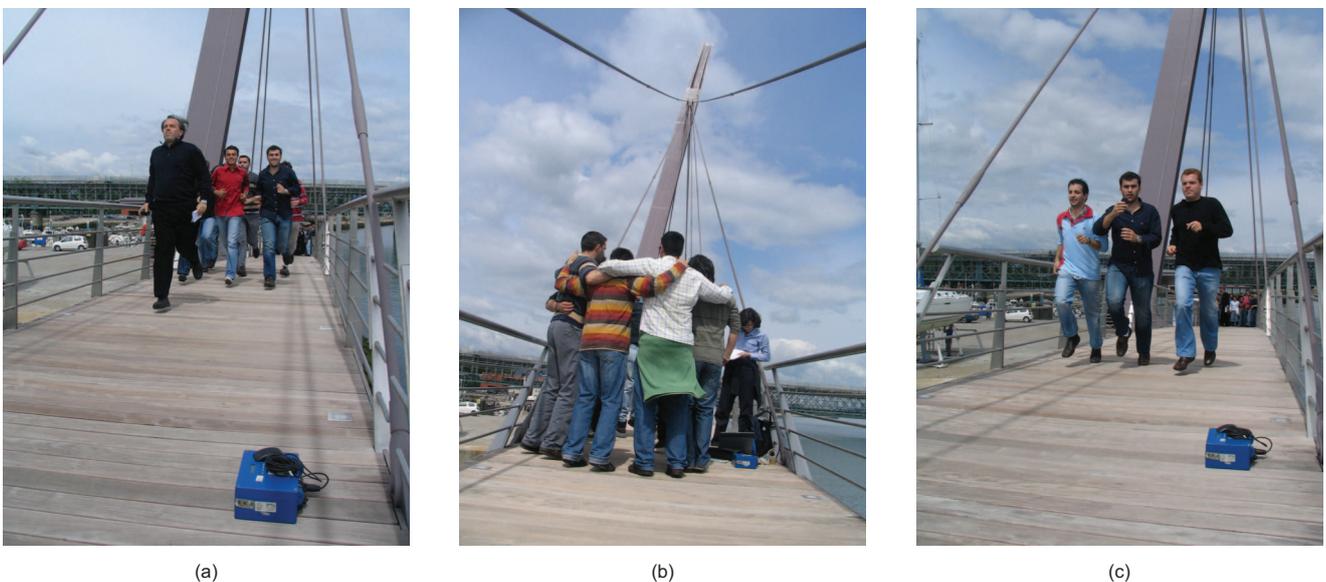
Figure 25. Images collected during dynamic tests for some of the considered load scenarios. Group of ten pedestrians running, group of six pedestrians jumping, group of three pedestrians running

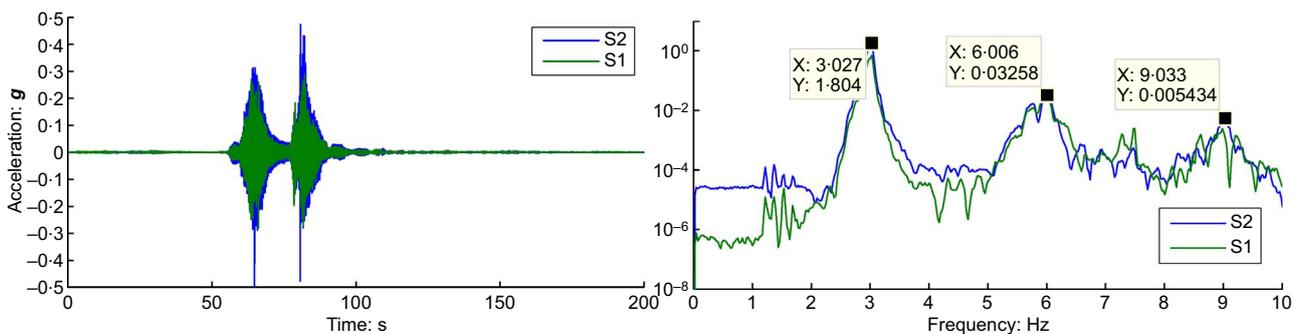
Figure 26. Time series and auto-spectra of the accelerations measured at sections 2 (S1) and 4 (S2) (Figure 3) during the crossing of the footbridge by 10 pedestrians running synchronously with a step frequency of 3.10 Hz (go and return)

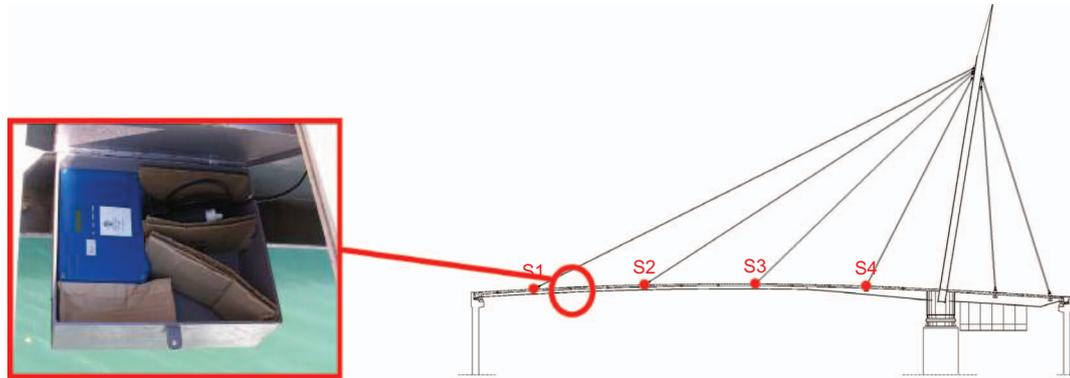
Figure 27. Installation of one seismograph under the bridge pavement

normal service. For that purpose, a seismograph was placed inside a steel box under the timber surfacing, fixed to one of the main longitudinal beams (Figure 27). The instrumented section was chosen between the two pairs of longest stay cables, taking into account that it was important to monitor not only the vibration motivated by the pedestrians, but also the deck vibrations during the rotation operations or the vibration produced by the wind in the open position.

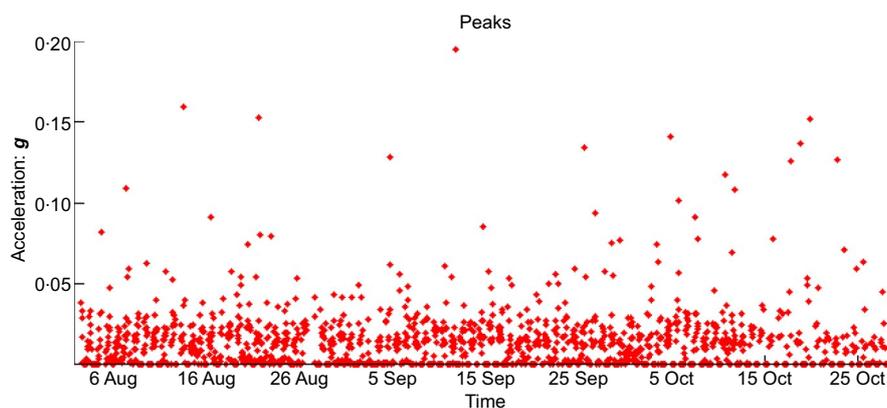
Figure 28. Maxima of the vertical acceleration time series collected between 02/08/2007 and 29/10/2007

The graphic presented in Figure 28 shows the maxima observed in all the vertical acceleration time series collected from August to October. It can be observed that values above 1 m/s^2 (0.1 g) are rare and that accelerations higher than 2 m/s^2 (0.2 g) were never recorded. These results prove the good dynamic behaviour of the bridge under normal use.

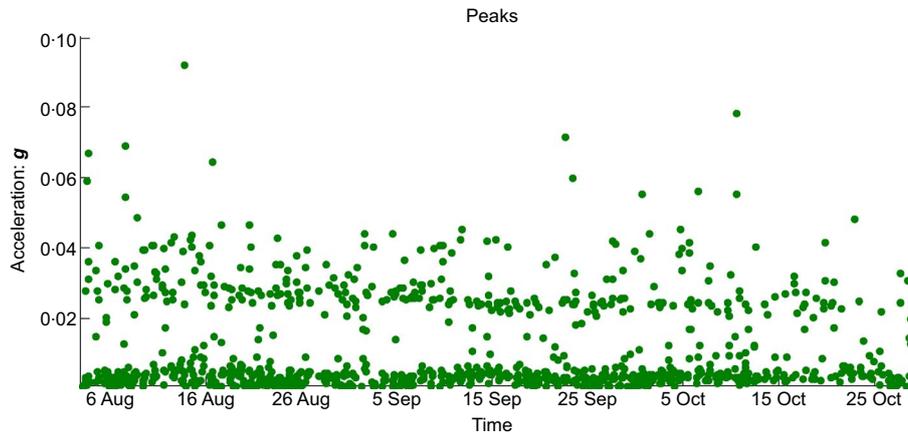
Figure 29. Maxima of the lateral acceleration time series collected between 02/08/2007 and 29/10/2007

The graphic presented in Figure 29 shows the maxima detected in all the lateral acceleration time series collected from August to October. Two bands of maxima are clearly observed. The higher band, corresponding to acceleration amplitudes close to 0.3 m/s^2 , is associated with the rotation operations. The lower band refers to the extreme values motivated by the pedestrian excitation (during the day) and by the wind (mainly during the night). Figure 30 presents one example of the time series of accelerations measured during a typical rotation operation (maximum lateral acceleration 0.3 m/s^2). The records are associated with the bridge opening to allow the entrance of a sailing boat into the marina. This operation takes approximately 1.5 min.

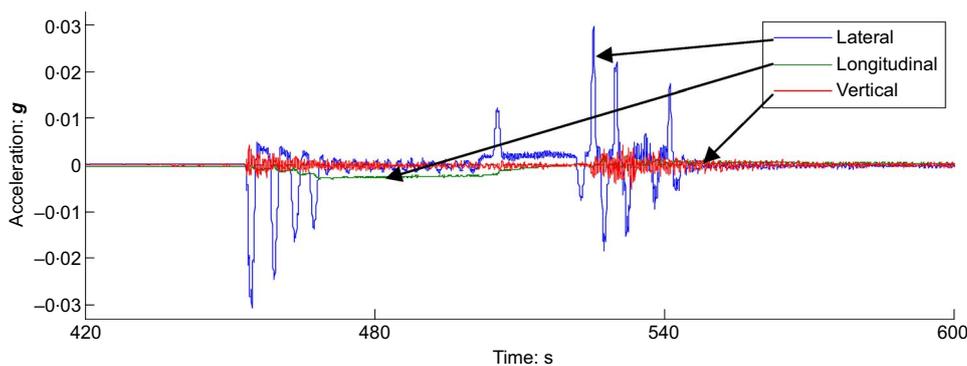
Figure 30. Time series collected during a rotation operation (from closed to open position)

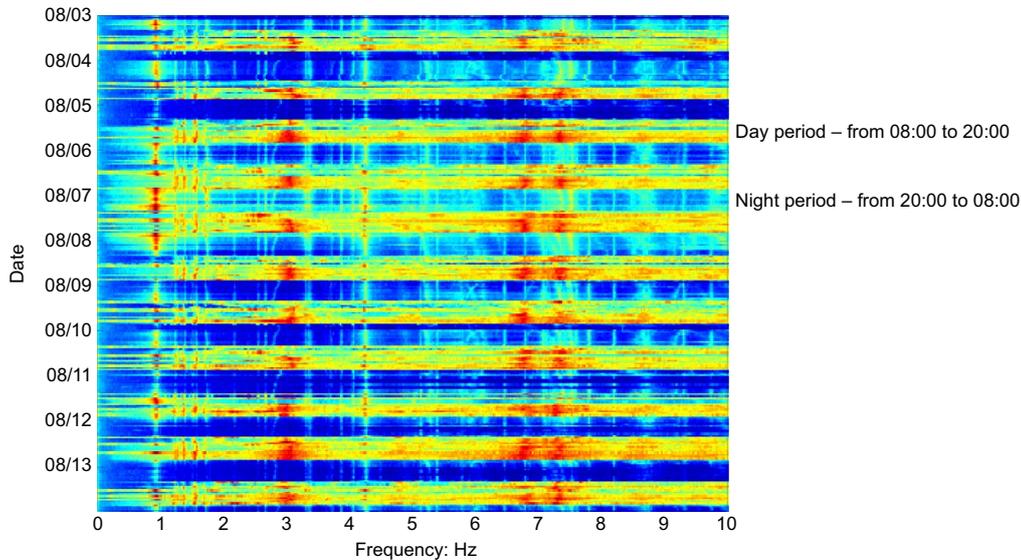
Figure 31. Colour map representing the frequency content of the time series collected from 03/08/2007 to 13/08/2007

As expected, the observed dominant frequencies during the night, in the open position, are completely different from those recorded during the day when the footbridge is normally closed and in use by pedestrians. During the night, the structure is only excited by the wind; while during the day (from 08:00 to

During the day period, three natural frequencies stand out: 3 Hz, 6.8 Hz and 7.3 Hz. These are associated with the same mode shapes that were identified in the second ambient

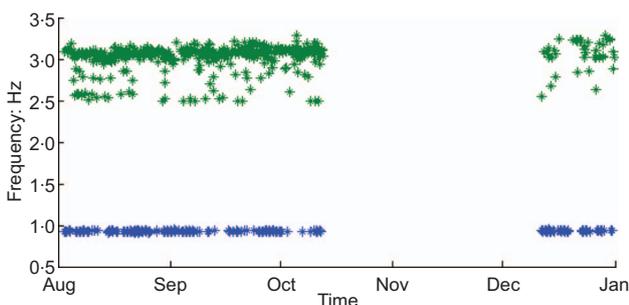
Figure 32. Evolution of the bridge first natural frequencies from 02/10/2007 to 31/12/2007: lower plot points (blue online) cantilever scenario; upper plot points (green online) bridge supported at the abutments

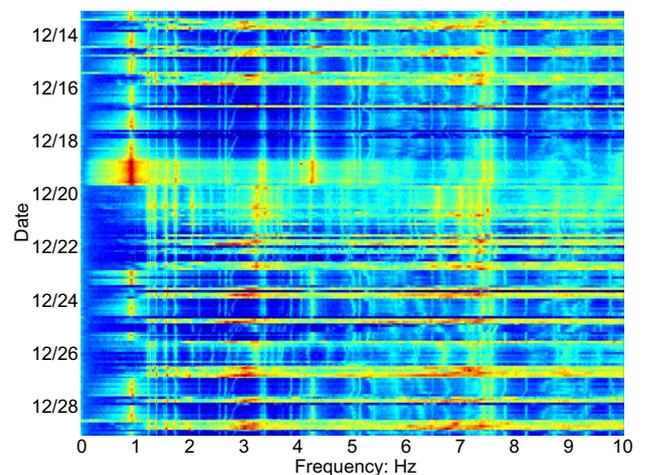
Figure 33. Colour map representing the frequency content of the time series collected from 13/12/2007 to 28/12/2007

The colour map of Figure 33 resumes the frequency content of the time series collected during the second half of December. The higher amount of energy observed on 19 December for the bridge first mode denotes the occurrence of strong winds. During the subsequent 2 days, wind velocities higher than 70 km/h were observed and the bridge was closed as a precautionary measure during the night (in the colour map the first frequency in the open position is not observed on 20 and 21 December). In this last colour map, the energy content
