Documentation, Restoration and Reuse of Heritage

BOOK OF PROCEEDINGS

Implementation of a wireless structural monitoring system and reverse engineering for numerical analysis purposes of a 16th century church

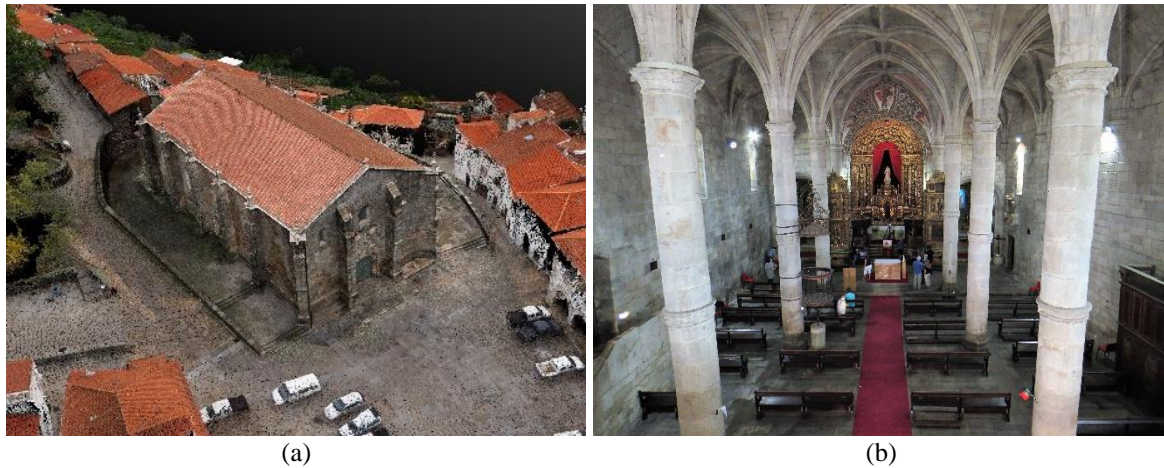
Figure 2. Church of Freixo de Espada à Cinta: (a) Aerial view; (b) interior view facing the altar [source: authors].

The Church of Freixo de Espada à Cinta is located in the urban center of the town of Freixo de Espada à Cinta, in the northeast of Portugal but isolated from other buildings (see Figure 2a). It was ordered built by King Manuel in the 16th century. It is a hall church, with 2 aisles almost the same height to the nave, covered with ribbed vaults (Figure 2b), an apse, two apse chapels and a sacristy. The hall rectangular plan is marked by a set of exterior buttresses, and the volumes of the sacristy and the apses [2]. The choir loft is supported by granite regular masonry arches and the ceiling is composed by a set of eight-part ribbed vaults, in granite regular masonry. External walls and interior columns are assumed to be built with the same material and arrangement, although no material characterization was carried out. The roof structural system is formed by timber trusses that are supported by the external walls and interior wooden columns located in top of the vault structure.

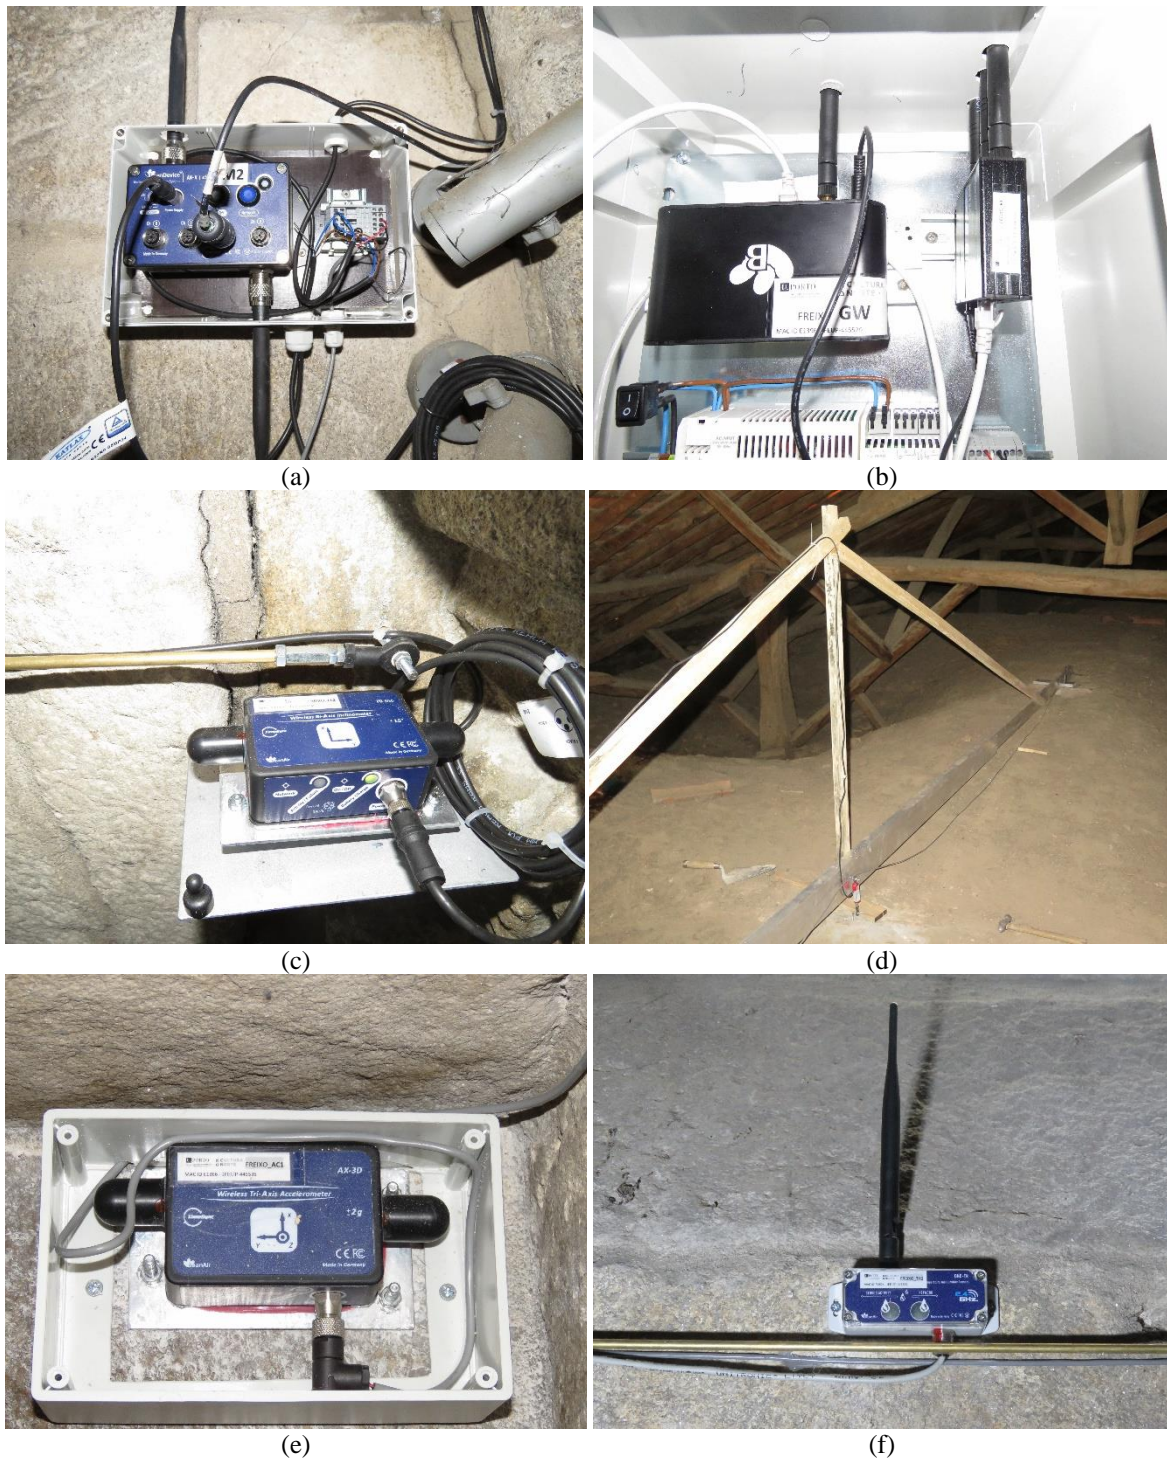
Figure 5. Monitoring system installed: (a) acquisition module M2; (b) gateway; (c) tiltmeter (CL2) and extremity of crackmeter FS3; (d) crackmeter FS7 installed on the extrados of the vault; (e) accelerometer (AC1); (f) temperature sensor TH1 and the extension rod of the crackmeter FS2 [source: authors].

The crackmeters installed are linear potentiometers with ball joints on the extremities, with a measurement range of 25 mm. To measure large distances, they are equipped with extension rods (see Figure 5c,d). Crackmeters FS1 to FS3, and FS8 and FS9 measure the in-plane deformation of walls, while crackmeters FS4 to FS6 measure the out-of-plane deformation, since they have one end positioned on the rib vault and the other end fixed to the façade. Additionally, crackmeter FS7 is measuring the out-of-plane deformation of the rib vault close to the façade (see Figure 5d). Their key performance indicator (KPI), meaning their control variable used for structural interpretation, is displacement (in mm), more precisely crack opening in respect to existing or new cracks.

For tiltmeters, were chosen wireless biaxial inclinometers, with a measurement range of $\pm 15^\circ$. The tiltmeters acquire measurements in two directions, described in the sensor as X and Y (see Figure 5c), corresponding respectively to the in-plane rotation and out-of-plane rotation of the wall. The KPI for tiltmeters is angle of rotation, measured in degrees ($^\circ$) or mm/m. The accelerometers installed are triaxial wireless vibration sensors, suited for acceleration but also velocity monitoring, with built-in data loggers (see Figure 5e). Their

measurement range is $\pm 2g$. The KPI for the accelerometers are the resultant Peak Particle Velocity (PPV) and peak acceleration.

The temperature and humidity sensors are also wireless, with built-in data loggers, with a temperature range between -40°C and $+85^{\circ}\text{C}$, and a relative humidity range of 0 to 100% (see Figure 5f). There are no KPIs associated with temperature and humidity measurements since they are being controlled to assess their influence on data from other sensors.

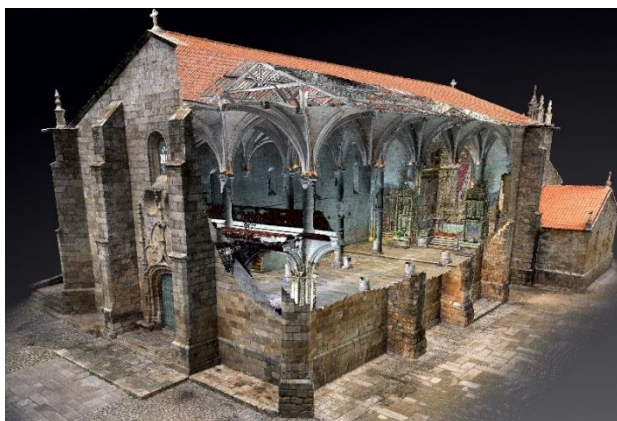
Figure 8. Models being developed: (a) realistic model [source: HPires]; (b) CAD model, geometry only [source: authors].

- Realistic model: very rigorous (the survey was done with 0.5 mm of precision) but computationally heavy. A model with all the information that will allow comparison with future acquisitions, enabling the detection of alterations or slight movements of the structures, for instance, deformations of the vaults (see Figure 8a).
- Simplified BIM model, which will be used for more functional applications, requiring less detail and therefore lighter memory use. It is a model compatible with various platforms, which can be accessed on any computer or mobile device. In Figure 8b. is presented the CAD (computer-aided design) model prepared for structural purposes.
