## The energy efficiency evaluation on rehabilitated social housing buildings:

Machado Vaz Neighbourhood, Porto - Portugal.

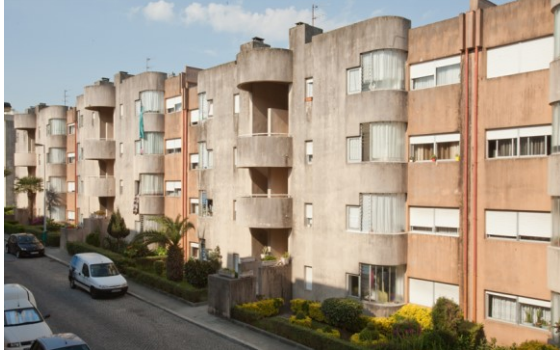
**Figure 1:**

*Santa Luzia Neighbourhood, Porto (640 dwellings). Before rehabilitation.*

At the present time, the analysis of Santa Luzia Neighbourhood, Porto (Fig. 1, 2 and 3), and its redevelopment project, allowed to study the factors that compromise the urban integration and how the requalification met such conditions.

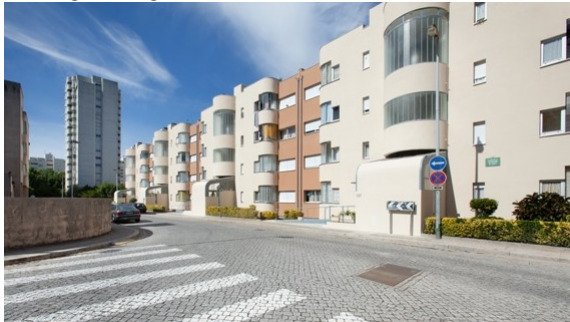
**Figure 2:**

*Santa Luzia Neighbourhood, Porto. After the architectural and engineering rehabilitation.*

In both examples we can see a big improvement of the architectural design with new energy solutions (Fig. 2, 3 and 5).

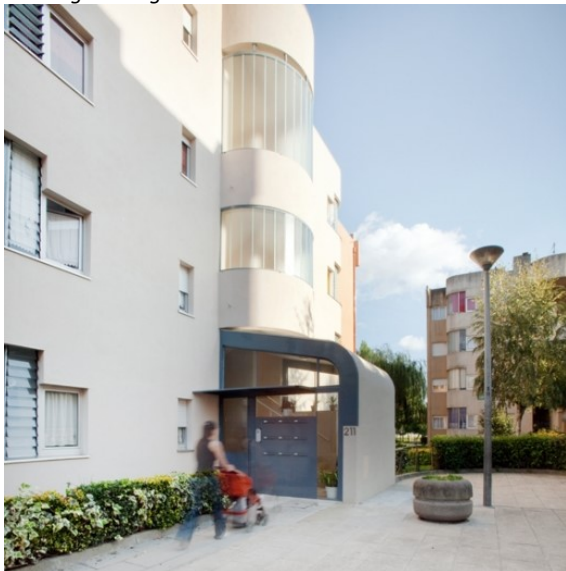
**Figure 3:**

*Santa Luzia Neighbourhood, Porto. After the architectural and engineering rehabilitation.*

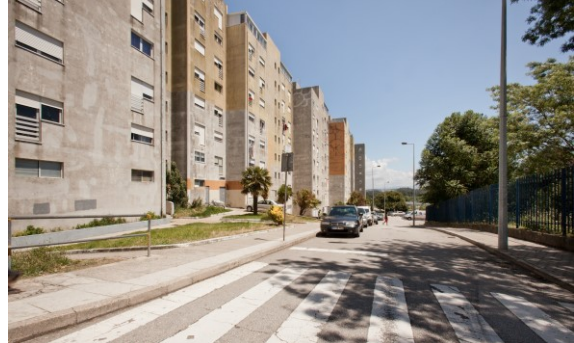
**Figure 4:**

*Vila d'Este Neighbourhood, Vila Nova de Gaia (2085 dwellings). Before rehabilitation.*

Regarding a second example - the Vila d'Este Neighbourhood, the analysis of the morphological characteristics of this Neighbourhood in two stages (before and after the physical rehabilitation), allowed us to study the factors that compromised

the urban integration, the architectural quality and the residents' satisfaction (Fig. 4, 5).

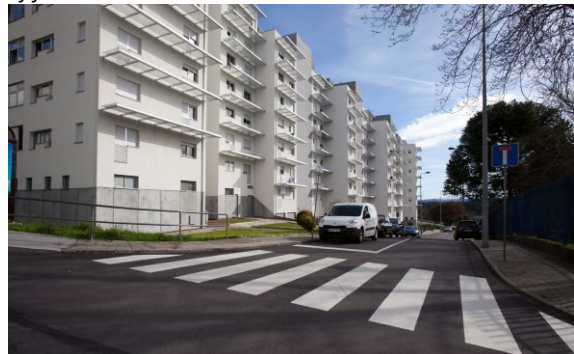
**Figure 5:**

*The rehabilitation of Vila d'Este Neighbourhood - Some energy solutions have been integrated in the new design of facades.*

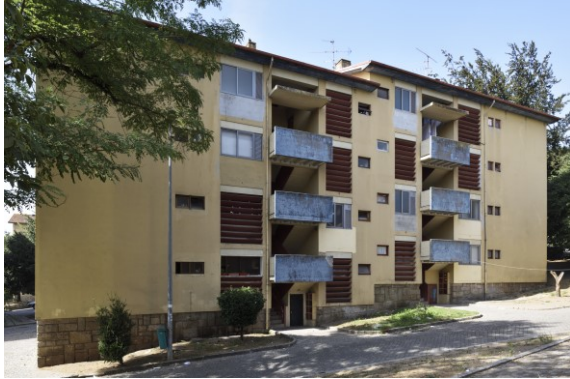
**Figure 6:**

*The Machado Vaz Neighbourhood, Porto. Before the architectural and engineering rehabilitation.*

The present study case concerns one of the urbanizations of "low cost" social residence in the city of Porto, with great visibility and localization next to the North-South highway – the Machado Vaz Neighbourhood (Fig. 6 and 7). Built in 1966, the neighbourhood is a large estate with thirteen blocks comprising two hundred and seventy-two units.

The roof is in tile. and the walls façade are a unique wall of stone. The windows have window frames in wood and single glass.

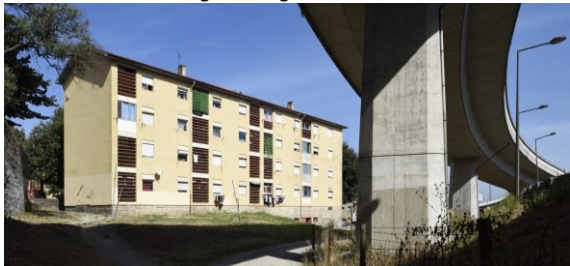
**Figure 7:**

*The Machado Vaz Neighbourhood, Porto. Before the architectural and engineering rehabilitation.*

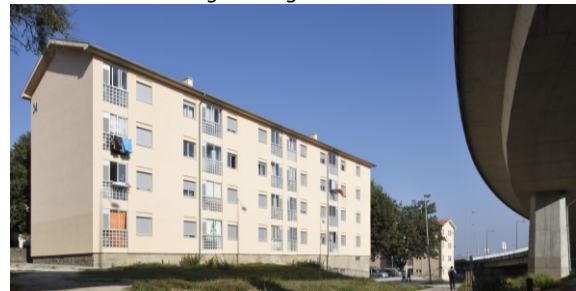
**Figure 8:**

*The Machado Vaz Neighbourhood, Porto. After the architectural and engineering rehabilitation.*

Portuguese social residences are subject to the controlled-costs construction regime for social housing. In what concerns to the present study case, the rehabilitation process was promoted by DomusSocial Municipal Company, in 2017. Next, the main rehabilitation procedures are presented (Fig. 8, 9, 10 and 11):

1. Requalification of the façades with the application of Thin Synthetic Reinforced Coating;
2. Replacing the structure and ceramic cladding of the roofs;
3. Replacing the exterior frames (Fig. 10 and 11);
4. Enclosing the stairwells (Fig. 10 and 11);
5. Treating and requalifying entrance/ staircase surfaces, namely walls and floors;
6. Increasing the unit's ventilation systems;
7. Reformulating the structure of the communal areas to comply with current demands: water, supply, rainwater drainage, electricity, telecoms and cable tv;
8. Installing gas supply infrastructure;
9. Installing solar panels (the first housing estate in Portugal equipped with this technology) (Fig. 9).

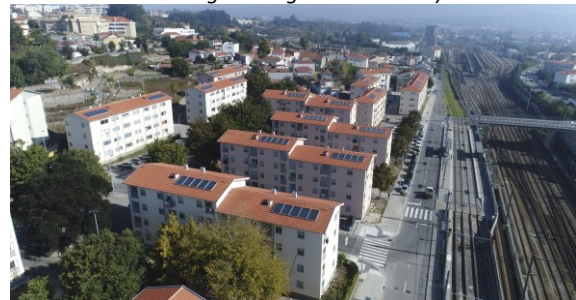
**Figure 9:**

*Solar panels at Machado Vaz Neighbourhood (after the architectural and engineering rehabilitation).*

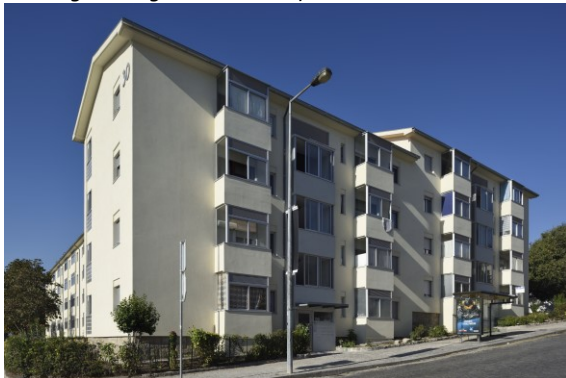
**Figure 10:**

As regards the buildings's architectural requalification I would highlight the proposal to close the communal stairwell area with an iron structure at ground level, including a stainless-steel door, laminated safety glass and letter boxes.

On the upper storeys the wells were closed on the front part with windows and on the sides with iron grids (Fig. 10).

*The Machado Vaz Neighbourhood (after the architectural and engineering rehabilitation).*

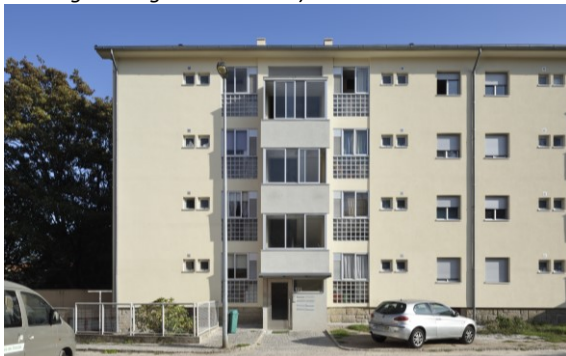
**Figure 11:**

The clothes drying areas were enclosed with glass brick walls serving as the base for a ventilation frame and grid with a diffuser for future connection to gas and water heaters (Fig. 11).

*The Machado Vaz Neighbourhood (after the architectural and engineering rehabilitation).*

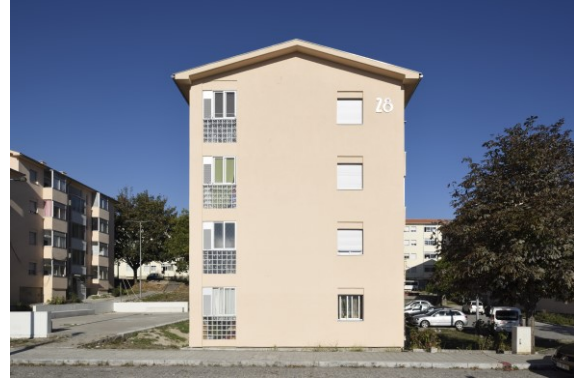
**Figure 12:**

Also, part of the estate's exterior areas were requalified to serve as a leisure area and small games field (Fig. 12).

*The Machado Vaz Neighbourhood (after the architectural and engineering rehabilitation).*

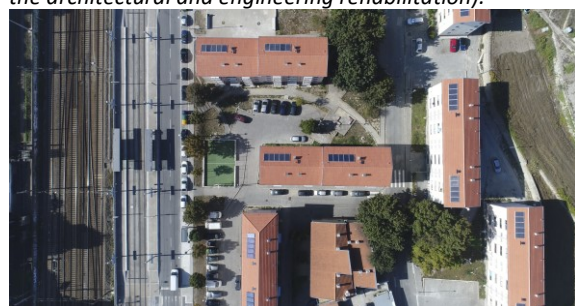
**Figure 13:**  
*Solar panels view at Machado Vaz Neighbourhood (after the architectural and engineering rehabilitation).*

Regarding the rehabilitation of the present study case - the Machado Vaz Social Housing - solar thermal panels were integrated in the buildings (as mention before, this was a pilot intervention where for the first time, a housing estate in Portugal has been equipped with this technology) (Fig. 13). Considering the production of domestic hot water throughout the year, it was found that the installation of solar panels allowed a final significant energy reduction.
