Minimum Intervention Options in the Constructive System of Porto Bourgeois Houses

Towards an environmentally sustainable action

Rui Fernandes Póvoas
Joaquim Teixeira

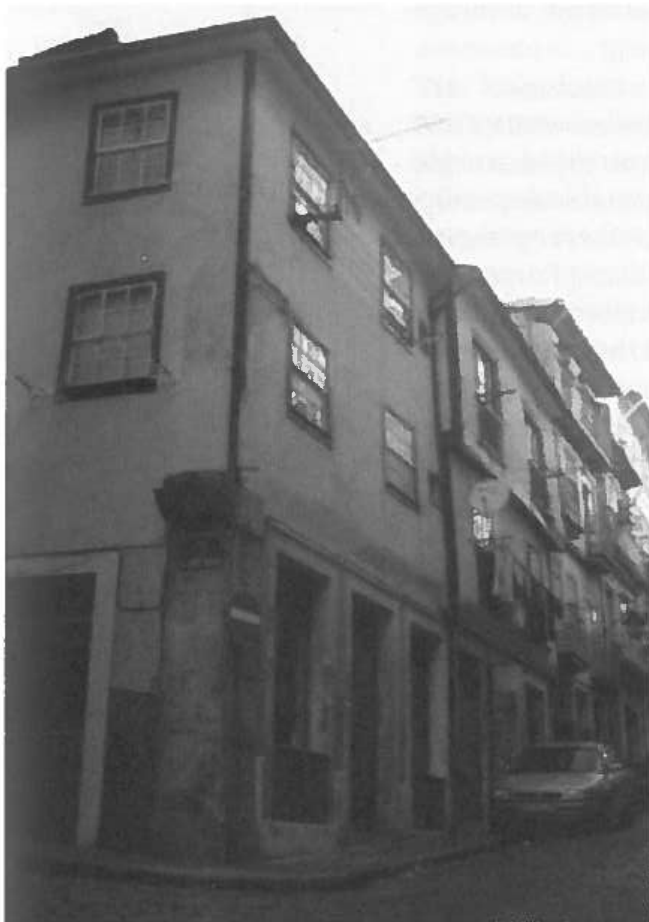
FIG. 2 Example of mercantile houses.

The mercantile house originated in the medieval, walled and densified city, characterized by narrow and winding streets. This type of house occupies little floor area and developed in height up to five floors. Its multifunctional typology reconciled the family's subsistence activity (located on the ground floor) with housing in the remaining floors. Its organization does not observe any specification of the spaces, which are generally large and intended for various housing functions, with the kitchens being located on the upper floors, under the roofing (FIG. 2).

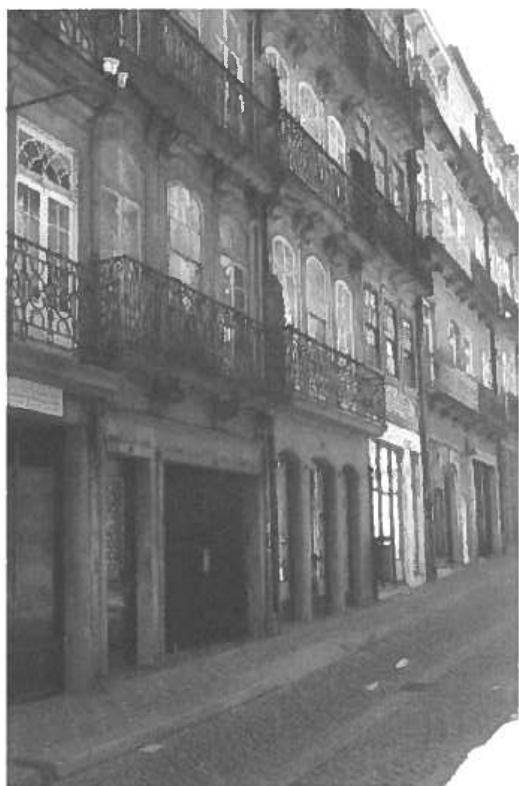
FIG. 3 Examples of Illuminist houses.

The Illuminist house is an example of this novelty, resulting from a parceling of narrow lots. It presents an average width of 6 m, great depth and a tendency to develop in height. They form blocks of large dimensions and present a novel feature, the curtilages, some of which with great depth. Its functional organization maintains the essentials of the mercantile type with some additional specification of functions, with the most important rooms located on the first floor and yet another novelty with the interior compartments lit from the stairwell (FIG. 3).

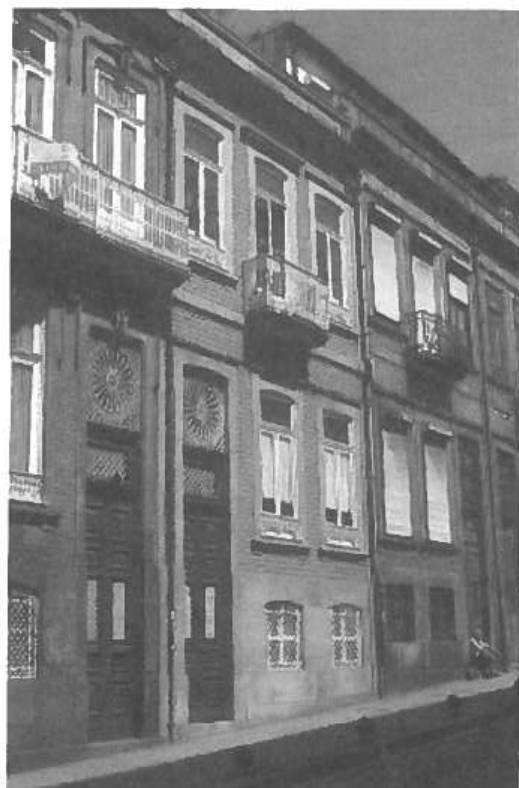
FIG. 4 Examples of liberal houses.

Basically, the Liberal house is a refinement of the Illuminist house model, not only in functional but also in constructional terms, although a slight increase in its dimensions, both in width and height, is observed. From the second half of the nineteenth century on, a typological variant exclusively destined for housing functions appeared, characterized by an elevation of the ground floor in relation to the street to provide greater privacy, and by a greater, well marked and hierarchical specificity of the interior spaces. Thus, on the ground floor there were now social rooms and the kitchen, the bedrooms on the upper floors, with storage and lodging spaces for employees on the lower floors and basements. Its aesthetic expression and taste maintained the cultural influence of the English community, as evidenced by the presence of some features of Georgian houses (FIG. 4).

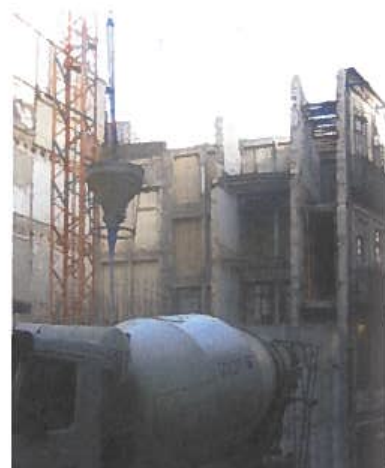
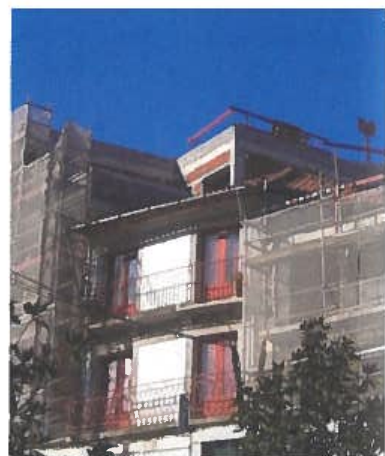
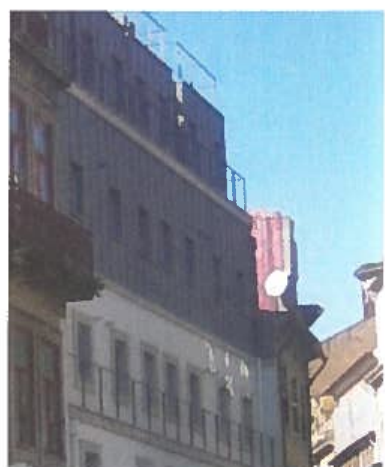
FIG. 6 Three early large-scale interventions carried out by SRU Porto Vivo.

construction systems, without assessing their compatibility with the scarce preexistence (FIG. 6); promotion of gentrification via the option for high standard housing or housing almost exclusively destined for tourism and similar activities.

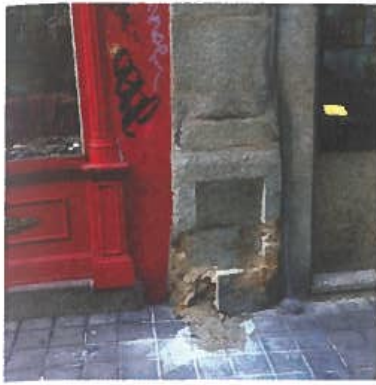
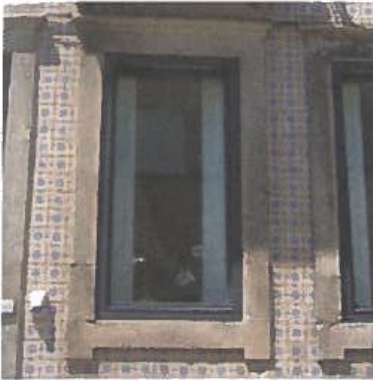
FIG. 7 Once-off interventions that, when replicated on a larger scale, cause considerable damage to urban ensembles.

Although the damage caused by small interventions was occasional, the replication of such interventions tended to create significant dissonances and ruptures that compromised the heritage integrity of the ensembles. This is what happened with the destruction of stone-work elements for the installation of infrastructure, or the replacement of existing painted wooden frames with new ones made of aluminum or PVC, with a different geometry and function from the original ones (FIG. 7).

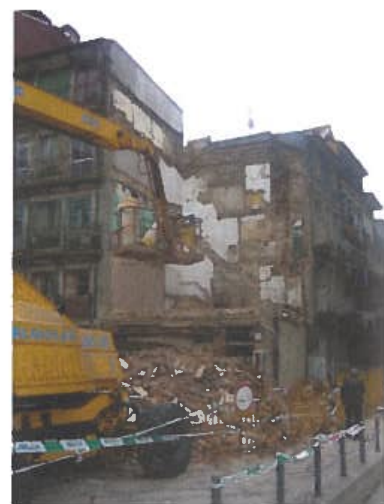
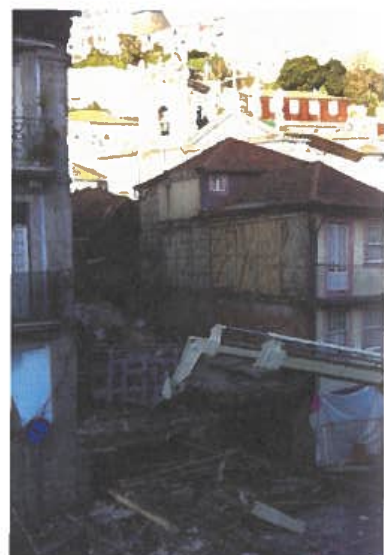
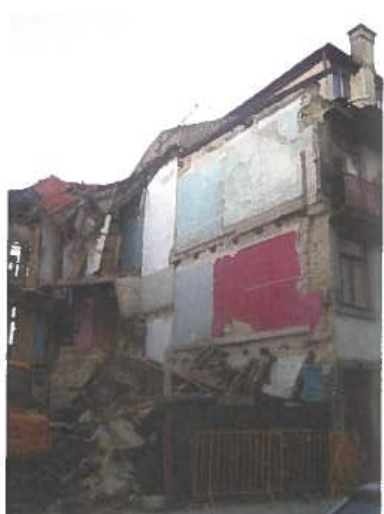
FIG. 8 Abandonment has led to the collapse of several buildings.

In order to comply with the principles for minimal intervention, it is necessary that the building be in a reasonable or moderate state of conservation. Unfortunately, this is not always the case, mainly due to the state of degradation of the buildings as a result of lack of maintenance due to the freezing of rents for several decades, which caused not only the decapitalization of the owners, but also the (intentional or purposeful) negligence motivated by poor urban management, which is captured by speculative interests and is responsible for the serious urban interventions carried out.
