## **The efficiency of seismic plus energy retrofitting to prevent the masonry infill walls out-of-plane collapse**

**Keywords:** seismic plus energy retrofitting, masonry infill walls, out-of-plane, experimental testing

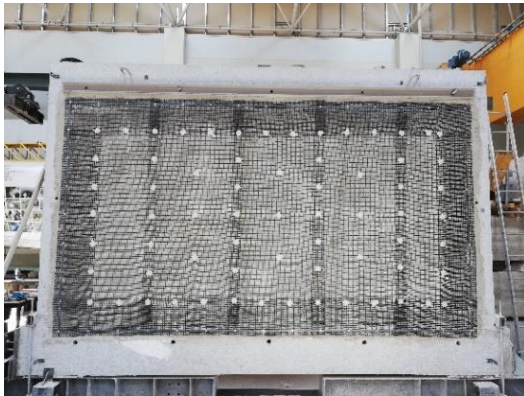
Fig. 2 – Specimens' retrofitting: a) General view of wall S; b) Detail of the mesh-frame connection; c) Detail of the positioning of the EPS plates; d) Detail of the application of the non-structural mesh; e) detail of the EPS application and e) layout of the structural mesh application.

The specimen “S” was retrofitted with textile-reinforced mortar technique, using a glass-fiber reinforced mesh with a tensile strength equal to 40kN/m, a ultimate strain of 3.4% and a grid equal to 16.7x16.7mm<sup>2</sup>. The application procedure of this strengthening strategy started with the application of 1 cm plaster. Then plastic connectors were applied throughout the infill panel to position and fix the reinforcing mesh. The plastic connectors have been used for the tested specimens to place and fix the mesh. The roll of mesh was provided with 1 m width and 50 meters length. Five vertical strips (1 m width) were used to strengthen the wall overlapped to each other. The application of vertical strips resulted easier with respect to the application of horizontal strips (whose length can also be very different depending on the bay length). The overlap length used between each vertical strip was 10 cm. The mesh was extended for 15 cm both on the beams and columns. Then, in the overlapping regions for the transition RC frame-infill panel, a duplicated mesh was assumed with an overlap equal to 30 cm (15 cm for the RC frame and 15 cm for the infill panel). The layout of the mesh application is shown in Fig. 2a. Concerning the mesh connection to the envelope RC frame, a steel plate (3mm thick and 30mm width) was used along the perimeter of the wall (10cm from the external face of the RC element). Ø10mm holes were drilled in each location defined for the anchor to insert M8 steel connectors, as shown in Fig2b. Thus, the mesh was placed between the frame and the steel plate, which was anchored with the steel connectors

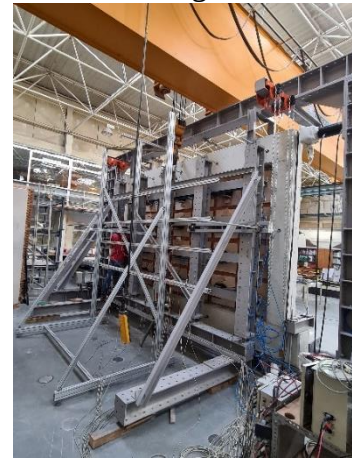
Fig. 3 – Test setup: a) schematic layout; b) lateral view; and c) front view.

The experimental test consisted of applying a uniform OOP load applied by 28 pneumatic actuators, which are linked to a self-equilibrated reaction steel structure composed of four horizontal alignments made with HEB140 steel profiles and five vertical alignments made with HEB220 steel profiles (Fig. 3). The vertical alignments are hinged, allowing their rotation during the tests. The steel reaction structure is attached to the envelope frame in twelve points (five in each top and bottom beam and one in each column). In each of these connections, a load cell was placed that allowed to monitor the loads during the tests.

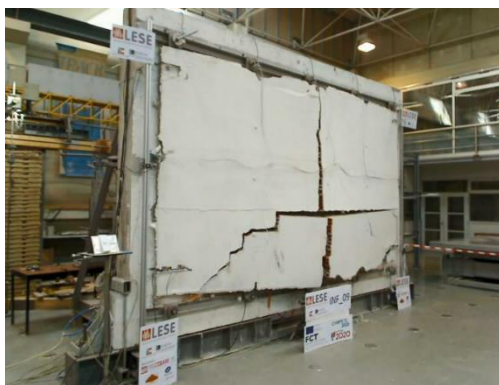
Fig. 4 – Specimen Ref: a) Cracking pattern; and b) Force-displacement curve.

During the testing of the reference specimen, it was not observed damage until the OOP displacement equal to 5mm. At this level of OOP displacement occurred the plaster detachment in some parts of the panel. After that, at the OOP displacement equal to 7.5mm, the beginning of a horizontal cracking was observed at 1/3 of the panel height. When the panel reached the OOP displacement equal to 15mm, the horizontal crack became more pronounced and, at the same time appeared a vertical crack at the middle of the panel, from the top until the horizontal crack. When the OOP displacement reached 25mm diagonal cracks were visible, which started in the same alignment of the horizontal crack until the bottom of the panel. At the end, at the OOP displacement equal to 30mm, the panel collapsed. The cracking pattern was essentially trilinear, as evidenced in Fig. 4a. Fig. 4b presents the force-displacement response curve, from which it is possible to observe that for the OOP displacement equal to 2mm occurred the first decrease of strength, which was quickly recover and followed by a progressive increase until the 6mm (instant where it was visible the beginning of plaster detachment). After that, a progressive increase of the OOP strength can be verified until a maximum peak load equal to 61.2kN occurred for an OOP displacement equal to 29mm. After that, at the OOP displacement equal to 29.8mm, the panel suddenly collapsed without any visible previous decrease of the OOP strength.
