EXPERIMENTAL CHARACTERIZATION OF INFILL WALLS RETROFITTED WITH NOVEL HOLISTIC TECHNIQUES

Abstract: *The renovation and refurbishment of existing reinforced concrete (RC) buildings typically focus on enhancing either the structural or thermal energy characteristics of their envelopes. However, growing global concerns regarding the sustainability and resilience of these structures necessitate the development of retrofitting techniques that address both aspects simultaneously. This study aims to validate the effectiveness of novel seismic plus energy retrofitting techniques through a comprehensive testing campaign. To achieve this objective, three full-scale specimens were constructed for experimentation. These three specimens were retrofitted using seismic plus energy retrofitting techniques. Pure out-of-plane (OOP) quasi-static loadings were applied until collapse or partial collapse. The efficiency of each retrofitting solution was assessed by comparing the results of the retrofitted walls with the reference specimen. The findings revealed that the novel combined retrofitting approach significantly improved the thermal transmittance energy efficiency of the walls by approximately

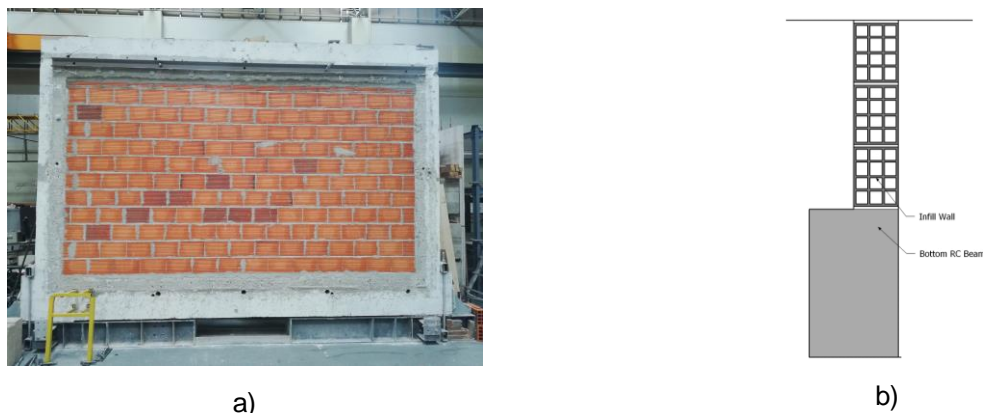
Figure 1. Infilled RC frame without retrofitting: a) general view before retrofitting; and b) profile view.

Regarding the characteristics of the specimens under study, the geometric dimensions of each masonry infill wall are 4.2m in length and 2.30 in height. A general view of the wall before retrofitting is presented in Figure 1a. All the infill panels have equal geometry with the above-mentioned in-elevation dimensions, made of hollow clay horizontal brick units with 150mm thickness. No reinforcement was used to connect the infill panel and the surrounding RC frame since it represents a common construction practice in Southern European Countries. Also, no gaps were used between the panels and the frame elements and no openings. The walls were built aligned with the outer side of the RC beam, as shown in Figure 1b.

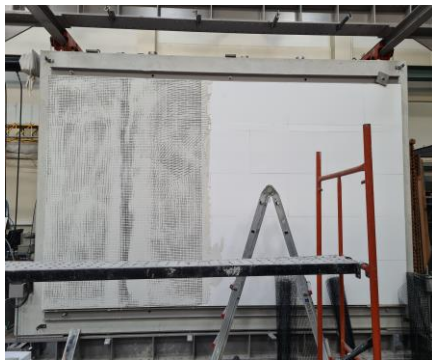
Figure 2. Retrofitting process of specimen ES1: a) general view of application of GFRP mesh over the EPS plates; and b) detailed view of the connectors used.

The retrofit process for specimen ES1 started by securing a 8cm thick EPS plate to the RC frame elements in staggered rows with an adhesive layer, ensuring a 150mm overlap over the RC elements. Subsequently, a new layer of adhesive mortar, approximately 5mm thick, was applied over the external surface of the EPS plate. Next, the Glass-Fibre Reinforced Polymer (GFRP) mesh, assuming the same disposition adopted in the following study (Furtado, Rodrigues *et al.* 2021) (i.e., overlapping frame-wall, with mesh stripes). The main goal was to reinforce the wall-frame interface. The GFRP mesh was fixed to the wall and to the RC elements using connectors constructed of plastic bushings with steel screws, as illustrated in Figure 2b. These connectors were spaced at 500mm intervals in both horizontal and vertical alignments. To further enhance the structural integrity and prevent cracking, a fresh layer of adhesive plaster was applied to the wall surface, creating a base for the nonstructural mesh. The retrofitting process was completed with the application of approximately 10mm of adhesive plaster.

The GFRP mesh has a tensile strength equal to 40kN/m, an ultimate strain of 3.4% and a grid equal to $16.7 \times 16.7 \text{ mm}^2$. No mechanical tests were performed to the nonstructural mesh used.

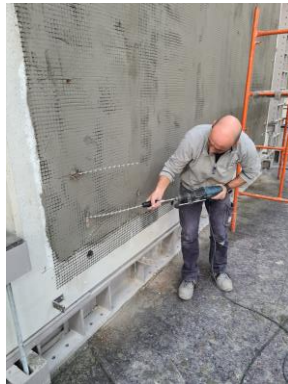
Figure 3. Retrofitting process of specimen ES2: a) general view of application of helicoidal connectors; and b) application of ETIC system over the TRM material.

connector was defined to be 500mm. First, the hole was drilled for each connector and then pushed in the hole with a hammer-vibration-based equipment. The impact of the equipment in the connector ensured that the connector was well fixed. After that, the connector was folded and directed to the wall interior until it touched the mesh. Figure 3a shows the application of these connectors.

After this critical step, 15 days interval were adopted to continue with the application of a ETIC system over the existing TRM retrofitting material. In this case, EPS plates were affixed using adhesive mortar. Subsequently, plastic connectors were introduced, at a rate of 4 per square meter, to secure all the EPS plates to both the wall and frame elements. The final touch involved the application of nonstructural mesh using a thin layer of adhesive mortar, approximately 0.5mm thick. Figure 3b presents the final application of the ETIC system over the TRM material.

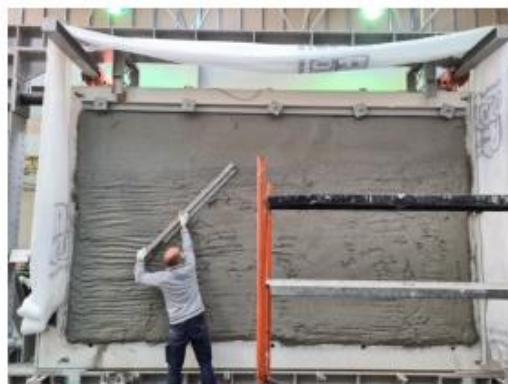
Figure 4. Retrofitting process of specimen ES3.

The retrofitting of specimen ES3 was carried out using a Reinforced Thermal Insulation Mortar technique. The retrofit process initiated with the application of an initial layer of plaster, approximately 10mm thick, designed to enhance bonding properties. Subsequently, a GFRP mesh boasting a tensile strength of 921MPa and a matrix measuring 30x40mm² was applied. Connectors were strategically positioned to secure the mesh to both the wall and RC elements. The connectors chosen for this specimen were crafted from a combination of plastic bushings and steel screws, identical to those employed in ES1. These connectors were evenly spaced, maintaining a 500mm interval in both horizontal and vertical dimensions. The next step involved the application of thermal insulation plaster across the entire panel and frame elements, culminating in a total thickness of approximately 70mm, as represented in Figure 4. Following the plaster application, the nonstructural mesh was introduced, and a final layer of plaster, with a thickness ranging from 5 to 10mm, was added to complete the retrofitting system.

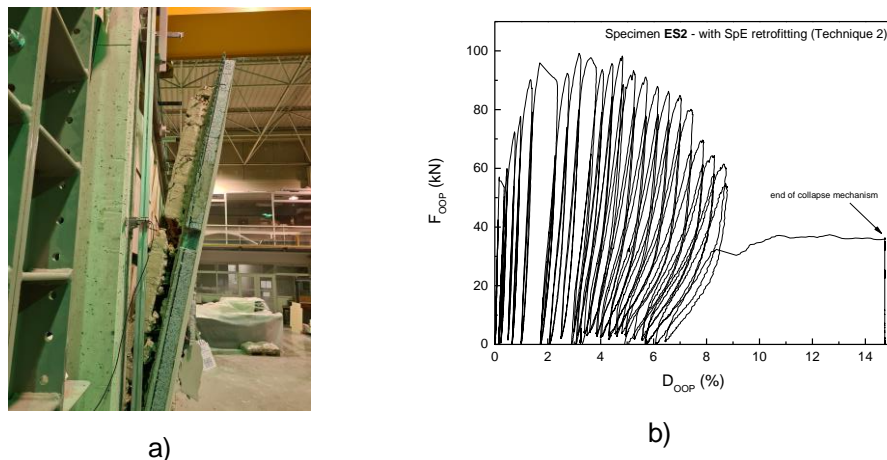
Figure 6. Results of specimen ES2: a) view of the partial collapse; and b) force-displacement curve.

The detachment of the wall initiated at the top interface, visible in Figure 6a, under relatively low displacement demands, approximately 3mm. This detachment gradually increased in thickness, exceeding 20mm. At this point, there was a noticeable collapse of the bricks on the inner face of the wall (i.e., the side facing the pneumatic actuators). Simultaneously, there was a slight detachment of the wall at the bottom interface until the connectors positioned in the upper RC beam experienced rupture. Subsequently, the wall transformed into a rigid body, with support primarily on the bottom RC beam. The remaining connectors within the RC elements prevented the wall's complete collapse up to this stage. After reaching significant deformation, the wall underwent a partial collapse characterized by three key features: i) division of the wall into two half-span sections; ii) complete separation of the wall from the top RC beam; and iii) partial support remaining along the side edges and the bottom RC beam. The remarkable efficiency of the connectors used in this strengthening solution was evident, as they effectively prevented the wall's collapse even when subjected to high drift values.

In Figure 6b, the force-displacement curve is presented, revealing an initial stiffness of 31.89kN/mm and a peak load of 99.17kN at an Out-of-Plane (OOP) drift of 3.19%. After reaching the peak load, the detachment of the wall at the top interface led to a reduction in the panel's strength. Conventional failure transpired at an OOP drift of 7.48%. As previously mentioned, the complete collapse of the wall did not occur; instead, the test was halted at an OOP drift of 14.74%.

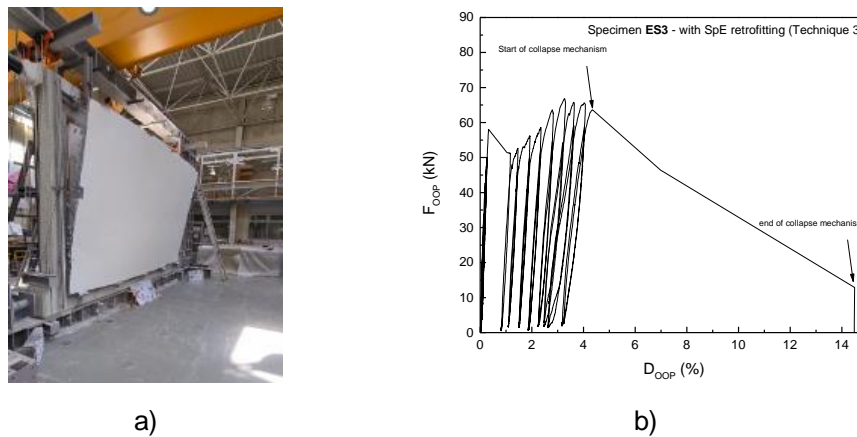
Figure 7. Results of specimen ES3: a) view of the collapse mechanism; and b) force-displacement curve.

During the first cycle, an accumulation of the OOP deformation primarily concentrated in the central region of the wall, along with the initial appearance of cracks in the thermal plaster. These cracks were limited to the left and right sides of the wall, as the cracking mesh on the external face of the composite retrofitting system effectively prevented further propagation. The comparatively lower tensile strength of the thermal plaster rendered it more prone to cracking, especially when compared to stronger materials like fiber-reinforced plasters. The observed cracking continued to grow in thickness until the wall ultimately detached at the top interface. This detachment became increasingly pronounced as the test progressed, culminating in the collapse of the wall, shown in Figure 7a. The collapse occurred without any visible significant structural damage or preceding reduction in strength as can be seen in the force-displacement curve plotted in Figure 7b. The wall's collapse was attributed to the connectors positioned at the end (edge) of the reinforcing, which could not prevent local mesh failure and the detachment of the retrofitting composite material. Filaments at the ends of the mesh were inherently more fragile and prone to breakage. This fragility was exacerbated by the fact that the frame net had larger grid dimensions compared to the net used in walls ES_1 and ES_2, which diminished the efficiency of the anchorage. Consequently, the mesh failed at the ends around the connectors affixed to the RC elements, leaving the wall without any element anchoring it to the frame. The collapse mechanism initiated once a substantial detachment occurred at the top interface. The factors contributing to the fragile wall's collapse at low displacement demands were identified as follows: i) the absence of overlapping of the mesh along the interface between the wall and frame elements; ii) mesh rupture near the connectors located in the RC frame elements; iii) the larger mesh matrix dimensions, leading to a higher likelihood of generating extremely high stresses in the mesh strands when they came into contact with the connectors.

From the analysis of the force-displacement curve, illustrated in Figure 7b, it can be extracted an initial stiffness of 18.54kN/mm and a peak load of 66.91kN at an OOP drift of 3.16%. Conventional failure did not occur before the initiation of the collapse mechanism, which commenced at an OOP drift of 4.11%.
