Structural survey and diagnosis of historical constructions the experience of the Construction Institute

*Esmeralda Paupério¹, Xavier Romão², António Arêde², Aníbal Costa³,
Humberto Varum², João Guedes², Nelson Vila Pouca²*

¹ CONSTRUCT-LESE, Construction Institute, Faculty of Engineering, University of Porto (IC-FEUP)

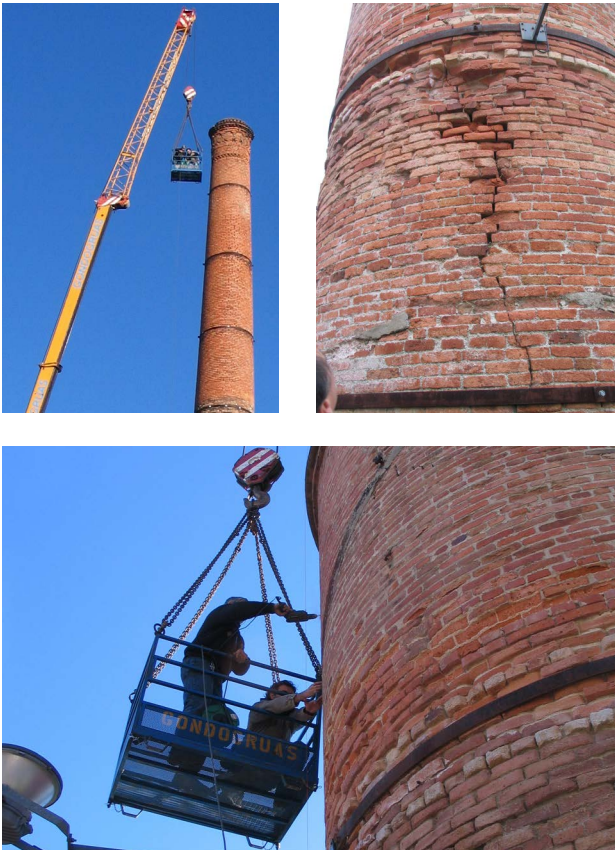
Figure 2.

Visual assessment of the chimney damages

visual assessment of the damages found across the structure was also performed (Fig. 2). To establish the structural behaviour characteristics of the structure, environmental vibration tests were performed to identify the natural frequencies and vibration modes of the structure. This information was then used to calibrate the numerical model that was developed to simulate the behaviour of the chimney and analyse its structural safety (Fig. 3). Based on this assessment, critical areas of the structure were identified which then led to the design of a strengthening solution. This solution consisted in an interior steel structure which, simultaneously, served as a ladder to access the top of the chimney for maintenance operations.

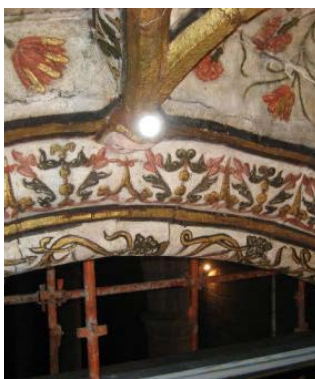
Figure 6.a

View of the triumphal arch and of the chancel vault of the church of Freixo de Espada-a-Cinta (a); detail of the springing area of the vault (b); joint openings in the vault and temporary shoring of the ribs (c); location of the critical deformations of the vault (d); original roof structure supported by the vault (e) and (f); consolidation of the vault stones from the extrados (g).

The fourth case study presented herein involves a retrofitting intervention carried out in the church of Freixo de Espada-a-Cinta, Portugal, (Costa et al., 2009). The construction of this church began in the XVIth century and lasted for almost a century. The church was built according to the Portuguese Manuelino style and has three naves, a chancel, two apsidal chapels and a sacristy. The chancel has a square-shaped plan and is covered by a granite ribbed vault with valuable paintings in the intrados, Figs. 6 a) and b). Over the course of conservation and maintenance operations being performed, joint openings were found between several components of the ribs and panels of the chancel vault. The intensity of the damages indicated that the vault already exhibited a significant level of deformation. The damages were found to be located at about a quarter of the span of the vault and, as a precautionary measure, the structure was temporarily shored until the results of a detailed structural inspection were able to provide a more certain

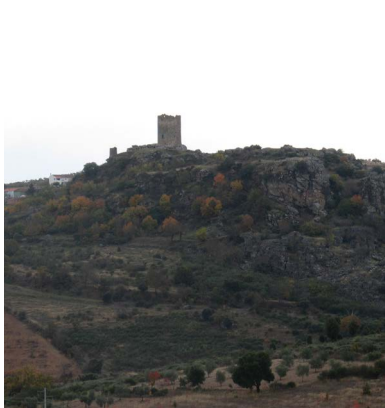
Figure 7.a

View of the Penas Róias castle (a); keep of the castle (b); circular tower of the castle (c); remaining part of the castle wall with loss of material at the base (d); cracks in the North and East elevations of the keep (e); steel structure confining the keep from the inside (f); consolidation of the supports of the circular tower (g); new stone wall built to fill and smooth unstable rock areas (h).

vault. Moreover, the stone components of the vault were also consolidated, which included repositioning some of the stones and filling the joints with led strips to create additional friction, Fig. 6 g). The vault stones were also tied and clamped from the extrados and a consolidant agent was then applied to enhance the global behaviour of the vault. The actions that were carried out in the structure also included the design of a new timber self-supporting roof structure that provided lateral confinement to the top ends of the walls in order to restrain the displacements of the vault. The last case study that is addressed herein involves the survey and analysis of the remains of the Penas Róias Castle, Portugal (Costa et al., 2008), Fig. 7 a). This castle was built in 1172 on top of a granite outcrop affected by a complex network of faults with many natural cavities which is believed to be an important prehistoric natural site (Groba and Quintas, 2008). Currently, however, only a keep with a diamond-shaped octagonal plan (Fig. 7 b)), a small solid circular
