Vulnerability assessment of churches under earthquake hazard

ABSTRACT: The development of a framework for the quantification of the seismic vulnerability of churches is presented. Given the advantages of having different areas of expertise contributing for the assessment of vulnerability, the proposed framework involves a multidisciplinary approach for the definition of the vulnerability of churches. The general scope and the conceptual definition of the proposed framework are discussed and it is established that vulnerability assessment must be carried out with respect to three fundamental components: the building, the collections and the building surroundings. Implementation details of the framework are then presented for the specific case of church heritage under seismic hazard. The applicability of the vulnerability assessment approach is illustrated using real case scenarios.

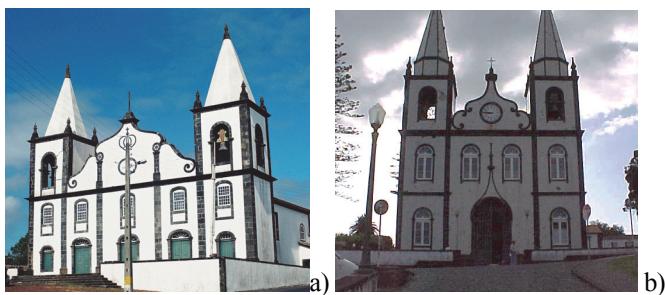
Figure 1. The Bandeiras (a) and the Madalena (b) churches. (Photo credits: Costa, A.).

To illustrate the proposed framework, implementation details are discussed in the following for the case of churches under seismic hazard. Specific methods are proposed for the quantification of the vulnerability indicators $V_{I,B}$, $V_{I,C}$ and $V_{I,S}$ based on existing methodologies (with minor adaptations in some cases). The proposed indicators are then quantified for a case-study application involving two neoclassical churches of the Pico Island, Azores, Portugal (figure 1).

The churches under study are the two neoclassical buildings illustrated in figure figure **Error! Reference source not found.**. The Bandeiras church (figure **Error! Reference source not found.a**) was built in 1860. The original Madalena church (figure **Error! Reference source not found.b**) was built in the fourteenth century. In the mid seventeenth century,

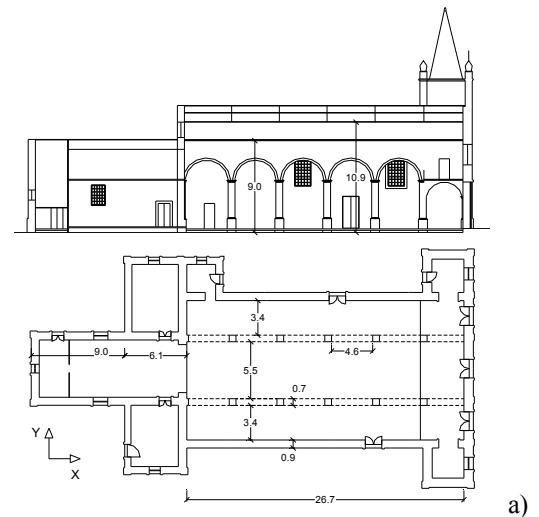
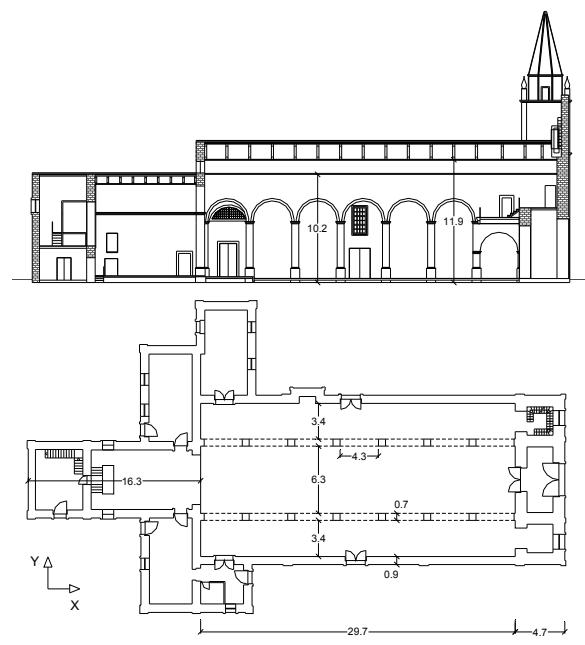
this church was rebuilt and it was completed in 1891. The Bandeiras and Madalena churches have a similar typology and are made of three bodies that can be identified in figure 3: the first is the main entry, which includes the entrance lobby, the upper choir and the two lateral towers; the second is the main body with three longitudinal naves; finally, the third one includes the central altar, the lateral sacristies and the altar backside. The churches also have similar structural characteristics. The main structure is made of walls, arches resting on top of columns, and a roof which made of wood, such as the floor of the upper choir above the main entry. The exterior walls are made of two-leaf stone masonry, with a total thickness of 0.90 m, and are the main structural elements. The tiles of the two-ways roof structure are laid on a liner supported by a wooden structure which, in turn, is supported by the exterior walls and interior longitudinal archways.

Figure 3. Plan and longitudinal cross section views of the Bandeiras (a) and the Madalena (b) churches

With respect to $V_{I,B}$, as previously noted, it was analysed for the X and Y directions of the church indicated in figure 3, thus leading to indicators $V_{I,B,x}$ and $V_{I,B,y}$. Based on the authors' knowledge about the referred churches and on values proposed by the Italian Code (OPCM 3274, 2003), the cohesion of the walls f_{vk0} was estimated to be 35kPa for the Bandeiras church and 50kPa for the Madalena church, while their volumetric weight γ was considered to be 18kN/m³ (Arêde *et al.*, 2012). Based on Eq. (3), indicators $V_{I,B,x}$ and $V_{I,B,y}$ were found to be 0.51 and 0.79, respectively, for the Bandeiras church, and 0.43 and 0.66, respectively, for the Madalena church. Given that $V_{I,B,x}$ and $V_{I,B,y}$ must be between 0 and 1, it can be seen that, as expected, both churches are more vulnerable for the Y direction. Still the vulnerability values obtained for direction X are significant and should not be disregarded. Furthermore, according to the analysis of the damage of these two churches after the 1998 Azores earthquake presented by Azevedo and Guerreiro (2008), the values of $V_{I,B,x}$ and $V_{I,B,y}$ are seen to correlate well with those results which refer that the level of damage of the churches resulting from the earthquake required structural repair interventions before being able to reuse them.
