# Managing the conservation of 20<sup>th</sup> century cultural heritage

### 3. Case study: the São João National Theatre

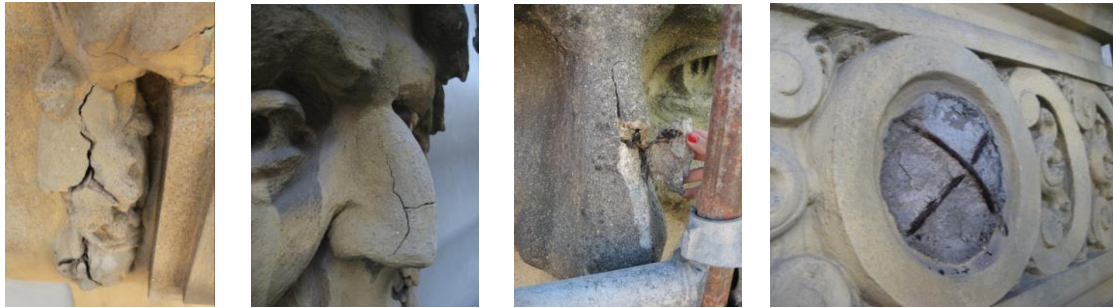
Figure 1 – Examples of reinforced concrete decorative elements and sculptures exhibiting some level of material degradation.

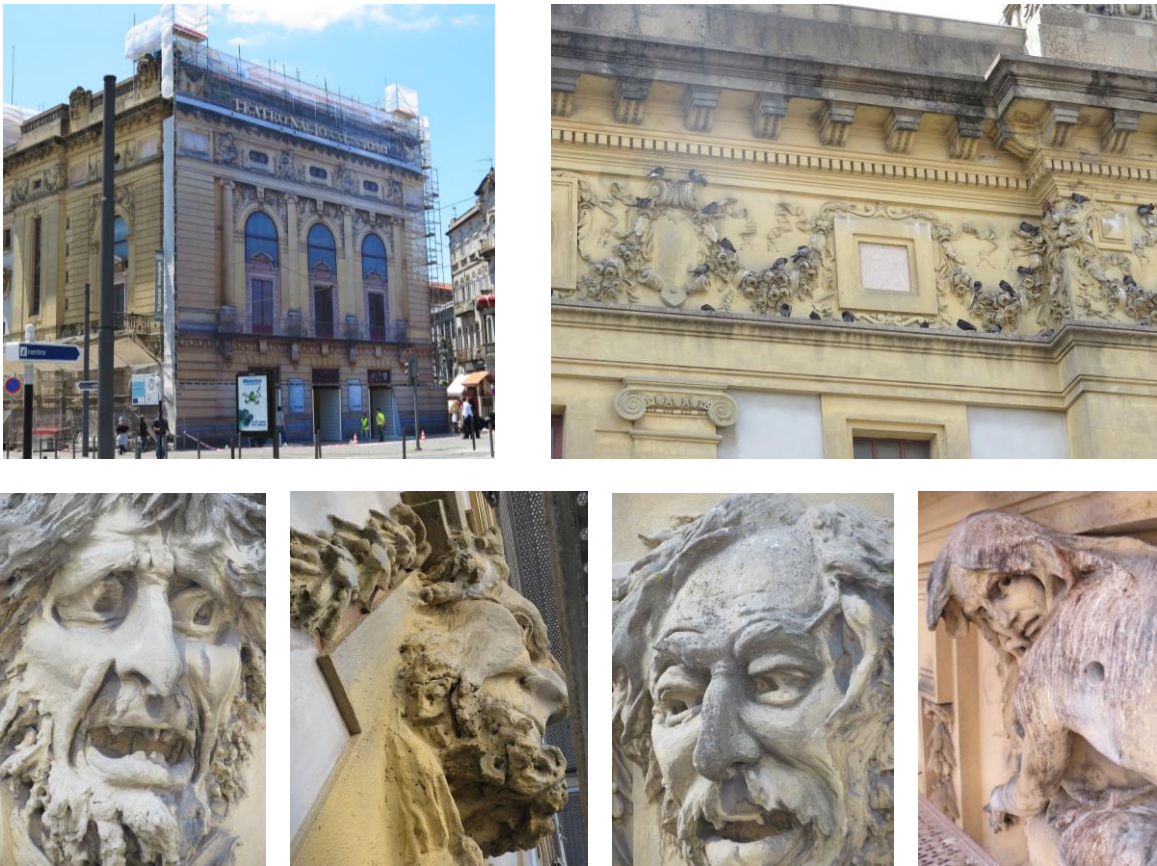
Figure 2 – Façades and reinforced concrete decorative elements of the São João National Theatre.

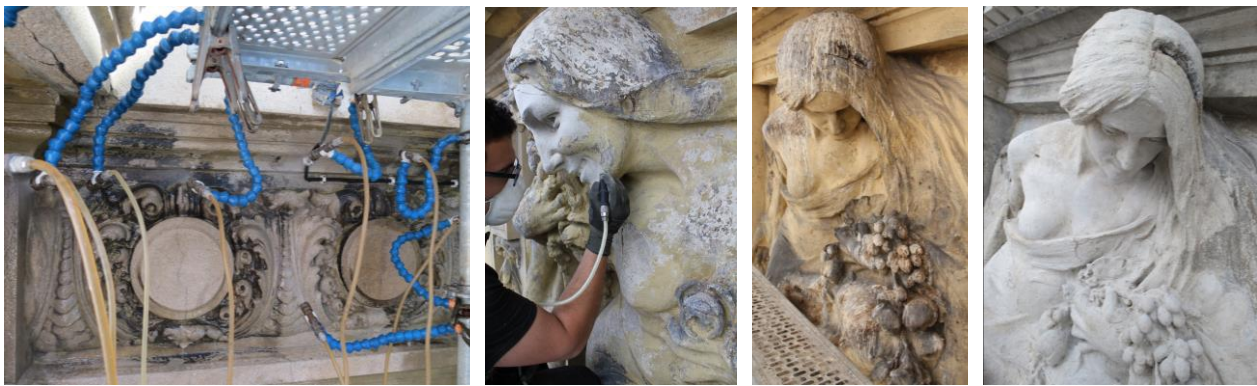
Figure 4 – Cleaning operation to remove limewash (left), cleaning operation by micro-abrasion (centre left), example of a decorative element before (centre right) and after (right) the cleaning operation.

To adequately plan and prepare these interventions, a survey of the damages and degradation levels found on the façades and their decorative elements and sculptures was needed. A first assessment of their state of degradation was carried out before the cleaning operations of the façades took place, which resulted in an incomplete characterization of the elements' condition. A reliable assessment was only possible after the cleaning operations (Fig. 4). In addition to the damage survey, several concrete samples were taken from the façades for laboratory analysis and testing in order to determine the components and mix proportions of the original concrete, thus enabling the development of a repair mix with properties compatible with the original concrete.

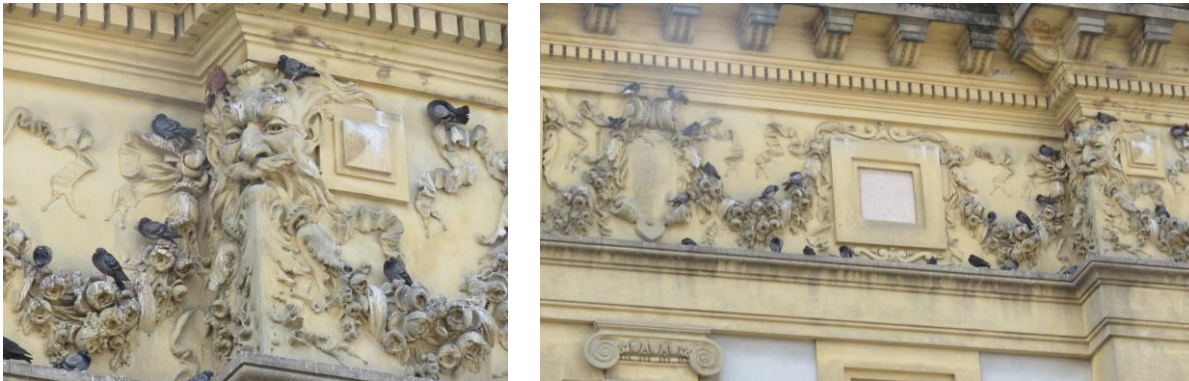
Figure 5 – Examples of the high level of interconnection between consecutive decorative forms.
