Seismic Retrofitting of Structural Elements. An Experimental Characterization

P. DELGADO¹, V. RODRIGUES², P. ROCHA¹, M. SANTOS³, A. ARÊDE², N. POUCA², A. COSTA²
AND R. DELGADO²

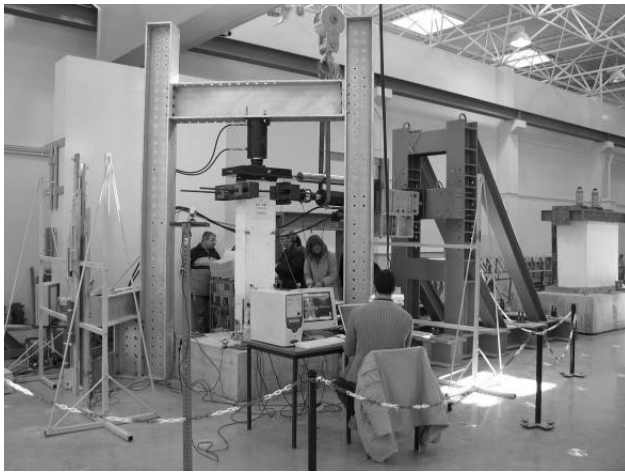
Fig. 3. View of the test setup at LESE Lab.

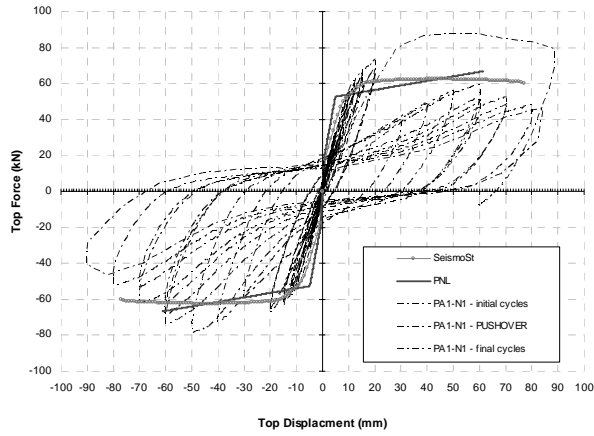
The experimental results and the Seismostruct and PNL model monotonic predictions are illustrated in Figure 9. During the first cycles the experimental envelope curve agrees well with both numerical curves. However, the subsequent experimental pushover reached about 20 % more strength when compared with the numerical models. This could be justified by some additional force on the horizontal actuator due to the setup conditions. That aspect is intended to be developed further on future tests to accurately assess it with this setup environment. The setup structure, more precisely the vertical steel frame, supporting the vertical actuator and the corresponding steel plate system for the axial force transmission, as well as one load cell connected to the referred steel plate with a “dywidag” bar, were carefully observed and instrumented to understand the stiffness of each element and the corresponding distribution of forces and displacements. This procedure plays an important role due to the friction force developed in the interface of the steel plates of the axial force transmission and to the top rotation of the column that leads to the same rotation on the steel plate of the axial load system, thus producing a horizontal component of the axial force. During the tests, the load cell measurements give the force transmitted to steel plate (due to the referred effects) that should be subtracted from the horizontal actuator force to yield the force actually applied in the column.

Fig. 9. Experimental cyclic results of column PA1-N1 and Seismostruct and PNL model monotonic predictions.

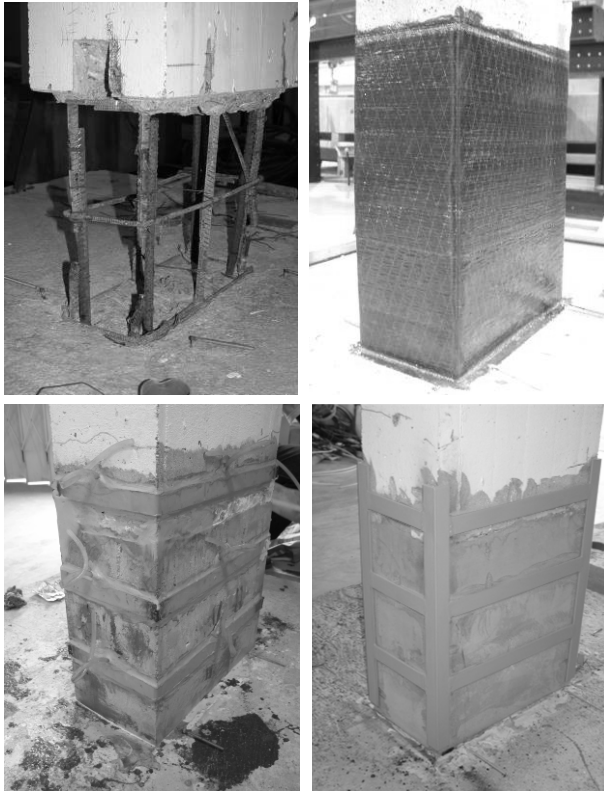
To have an idea of the damaged column, the following pictures illustrate the column during repairing and after retrofitted with the three techniques used in this project (Fig. 13).

Fig. 13. Lap spliced zone (up-left); retrofitted column with CFRP sheet jacket (up-right); steel plates (down-left); and steel plates connected by equal leg angle steel profiles (down-right).

After the cyclic test of the "as built" specimens took place up to failure, they were repaired and retrofitted with three different techniques: CFRP jacket; steel plates; and steel plates connected by equal legs angles steel profiles.

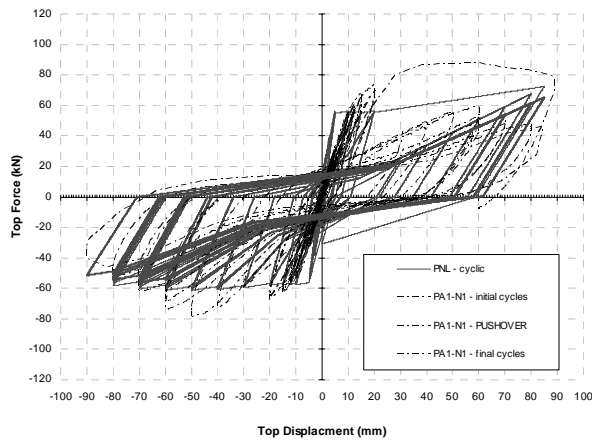
The PNL modelling shows a reasonable agreement with experimental results, with the exception of the maximum resisting force value. However, the hysteretic behaviour, both in stiffness degradation and pinching effect, was satisfactorily obtained, as illustrated in Figure 17.

Fig. 17. Comparison between PNL model and experimental cycles for the retrofitted column.
