EXPERIMENTAL IN-SITU TESTING OF TYPICAL MASONRY CONSTRUCTIONS OF FAIAL ISLAND - AZORES

The present paper focuses on an *in-situ* testing campaign recently developed in the Faial island, Azores, Portugal, aiming at the assessment of the out-of-plane behaviour of traditional stone masonry walls. This experimental activity, carried out by the Laboratory for Earthquake and Structural Engineering (LESE, FEUP, Porto), started developing some years after the Faial/Pico earthquake on July 9th 1998, in order to provide adequate characterization of the structural response under loading types likely to induce out-of-plane motion of walls as the case of the seismic action. A general description is included concerning cyclic tests carried out to date, complemented with the presentation and discussion of the most important results. Numerical predictions of strength based on simple models are also provided for one tested wall indicating good agreement with experimental findings. This *in-situ* programme involved a second stage for structural strengthening according to schemes similar to some of those adopted during the reconstructions process in Faial Island. Further tests were then performed in

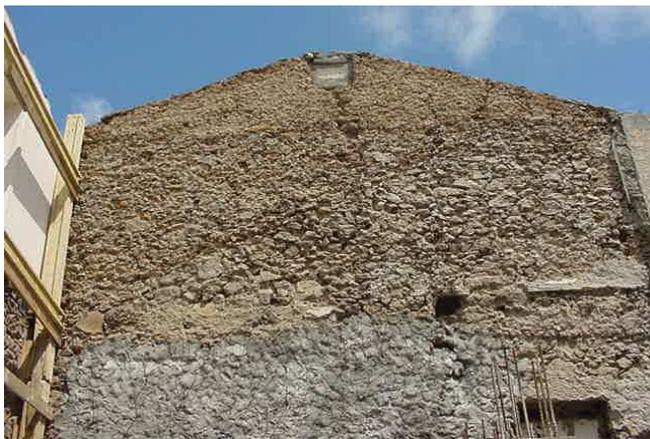
Figure 1 Stone masonry types: (a) irregular with poor mortar; (b) essentially regular, with dry joints.

- Irregular masonry, made of stones of several types, dimensions and shapes, randomly placed and using poor mortar generally made of several types of materials, commonly clay based material (Figure 1(a)).
- Dry joint stone masonry, occurring quite frequently in Faial and Pico islands, usually consisting of regularly shaped stone blocks without mortar between them (Figure 1(b)).
- Two leaf masonry walls, with the outer faces made of essentially irregular stone blocks and the inner cavity filled with poor rubble material (Figure 2(a)).
- Upper quality stone masonry, quite regular and frequently with straight sides, parallel faces and adequate strength (Figure 2(b)).

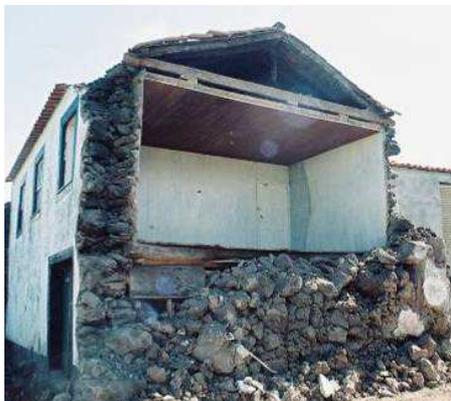
Figure 2 Stone masonry types: (a) two leaf with poor filling material; (b) upper quality regular stone block masonry

In this context, the present study mainly concerns experimental testing of masonry constructions existing in rural areas hit by the referred earthquake. The typical and most available types of constructions fit within the typologies shown in Figures 1(b) and 2(a), and further illustrated in Figures 3(a) and 3(b) that refer to the masonry of two houses effectively tested within this experimental campaign.

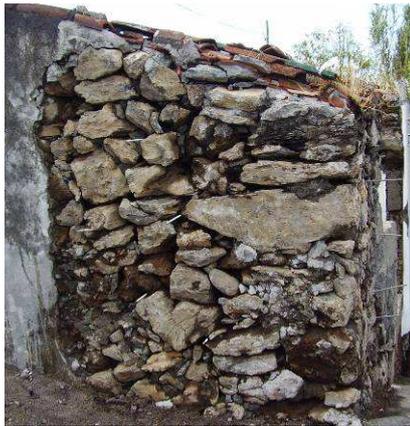
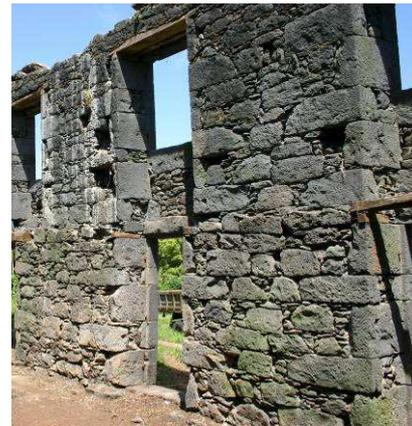
Figure 3 Effectively tested masonry types: (a) two-leaf irregular masonry with poor fill material; (b) two-leaf regular masonry with dry joints.

Houses 1 and 3 have two-leaf walls made of basalt stone masonry, quite irregular and of poor quality. House 1 has also a more recent annex made of unconfined hollow brick masonry panels. In turn, house 2 exhibits a much better and regular masonry construction of two-leaf walls without any signs of mortar in the joints.

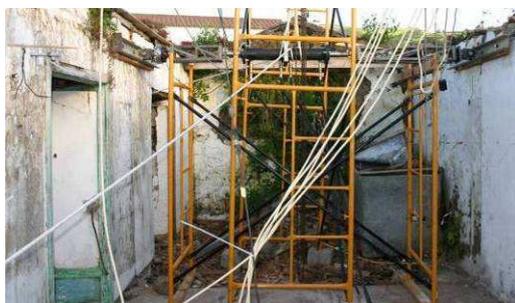
Figure 4 Basics of the testing layout in house 1: (a) general inside view; (b) plan layout and test locations.

The basic idea of the adopted experimental system relies on simultaneous testing two opposite walls of a given house, by applying horizontal forces one against the other and resorting to a pair of hydraulic actuators operating under displacement control. Loading has been applied at the top of walls in the form of quasi-static increasing forces during repeated and alternate cycles, in order to simulate the horizontal action of roofs on masonry walls. Figure 4(a) provides an overall view of the experimental set-up in one tested house, where two experiments were performed on the locations indicated in the plan layout shown in Figure 4(b).

Three houses were available for testing throughout this campaign, namely two single storey houses in the Salão parish (Horta district) and a two-storey house in Cedros location. The one-storey house 1 is illustrated in Figure 4, while house 2 refers to that shown in Figure 6(a) corresponding to the horizontal layout depicted in Figure 6(b). An outside view of house 3 (similar to house 1) is included in Figure 6(c), for which only one test was made in the same location as for the first test on house 1.

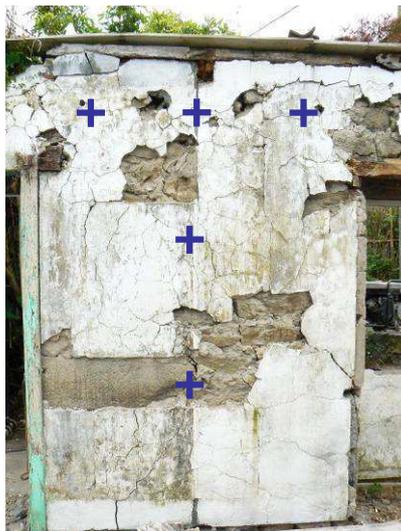
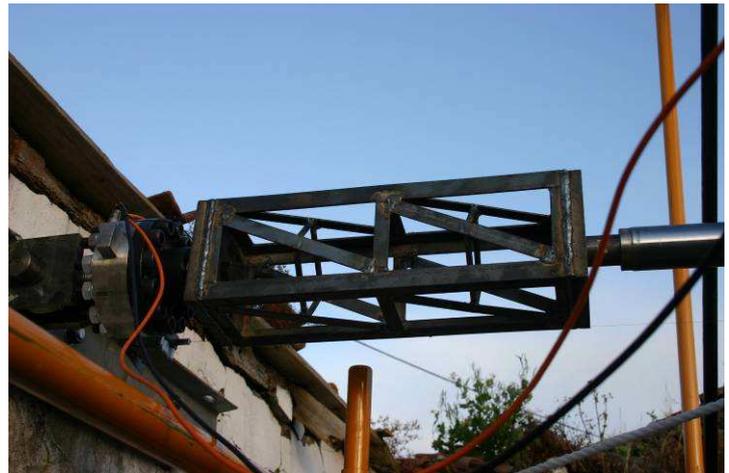
Figure 5 Measurement details: (a) layout of displacement measurement; (b) load cell.

Measurement points were always chosen according to a T-configuration in the plan of the tested wall as shown in Figure 5(a); this allowed obtaining the vertical deflected shape of the wall panel as well as any torsion movement that could occur at the top level due to different boundary conditions in the left and right sides. This measurement configuration was adopted for both opposite walls involved in the test which provided force-displacement information concerning two different walls for each test. As shown in Figure 5(b), the force was measured resorting to a load cell inserted in the loading system where appropriate hinged bearings have been include to avoid any bending moments.

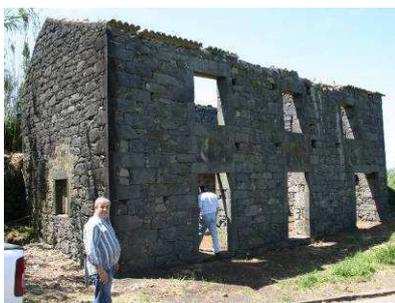
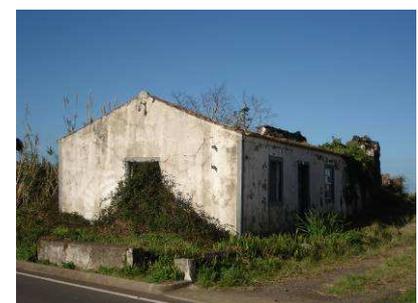
Figure 6 House 2: (a) general outside view and (b) plan layout with test locations. (c) House 3: outer view

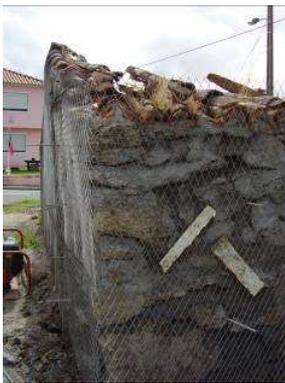
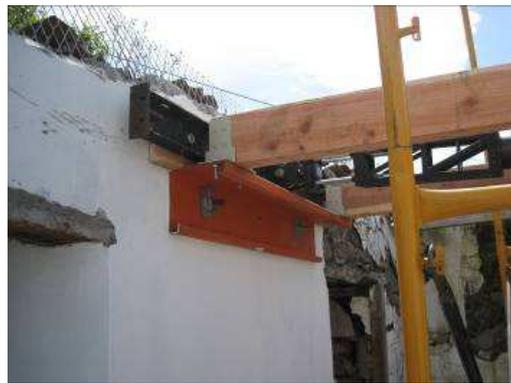
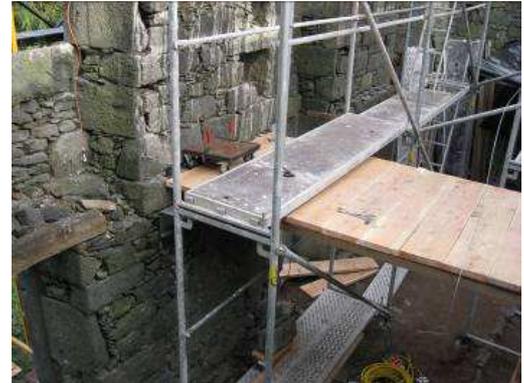
Figure 7 Strengthening schemes: (a) steel reinforced mortar cover in masonry walls; (b) wood beams supported and fixed to opposite walls; (c) wood boards nailed to floor beams to include pavement contribution

In order to pursue these main objectives, masonry walls were strengthened with steel reinforced mortar cover, about 3-4cm thick as shown in Figure 7(a), placed in the outer and inner wall faces (Costa, 2002). Transversal steel rods were included to ensure a more monolithic behavior of the wall cross section by improving the shear connection between the new mortar covers and the existing wall core. This technique leads to a sort of “poor” reinforced concrete wall section, while preserving the original material inside that is quite suitable for hygrothermic and acoustic purposes.

Aiming at simulating the presence of wooden floor/roof structures effectively connected to the walls, two or three criptomera wood beams (9x20cm², cross section) were placed between opposite walls, supported and bolted to right angle steel shapes fixed to each wall by steel rods crossing its total section (Figure 7(b)). This procedure was adopted at the roof level of houses 1 (loc. 1) and 2 (loc. 1 and 2). Where floor presence should be simulated, wood boards were also nailed to the beams as adopted in house 2 (loc. 1) and shown in Figure 7(c).
