EXPERIMENTAL TESTS ON SEISMIC RETROFIT OF RC BRIDGE PIERS

The main purpose of this paper is to present an experimental campaign of different strategies for the seismic retrofit of reinforced concrete bridge piers and evaluating benefits concerning their structural behaviour under the cyclic loading.

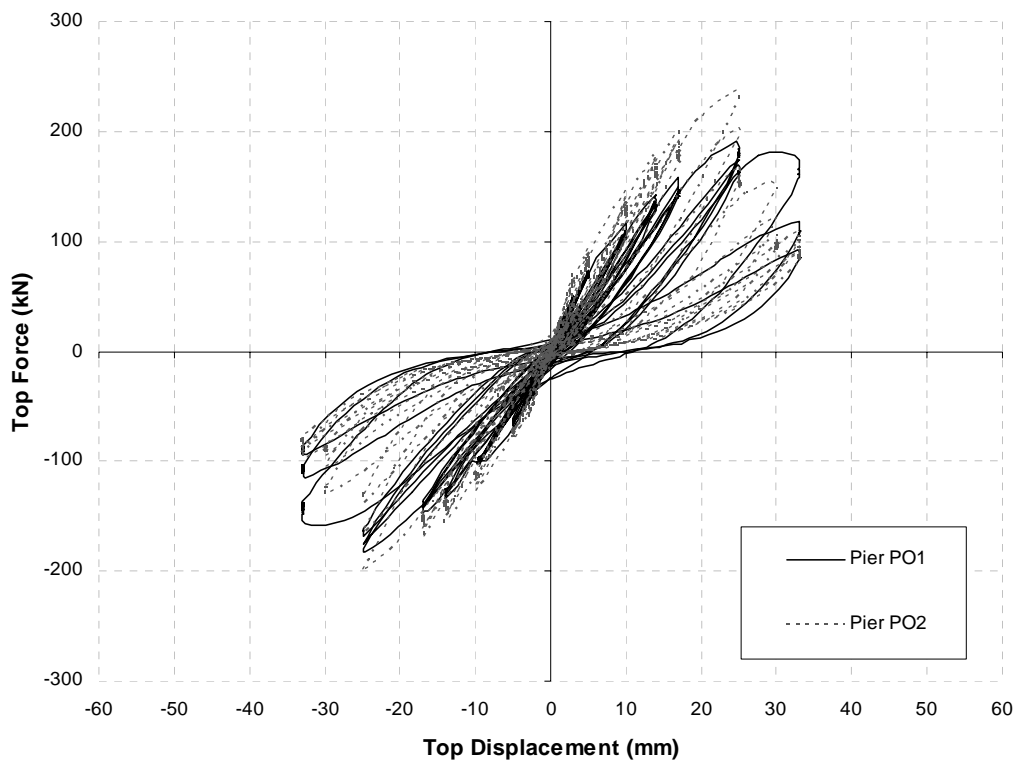
Fig. 11 Experimental results comparison of piers PO1 and PO2.

Fig. 11 show the experimental responses of both pier PO1 and PO2 where it is visible that, as expected, the rectangular section (PO2) achieved higher maximum forces, due to the significant increase of the longitudinal reinforcement and concrete area, when compared with the square pier.

However, these higher forces in the pier PO2 (only about 1,2 times those of from PO1) is not proportion with the increase of longitudinal reinforcement of pier PO2, about 2 times more when compared with pier PO1, which is related with the shear lag effect quite apparent from the damage pattern really observed.

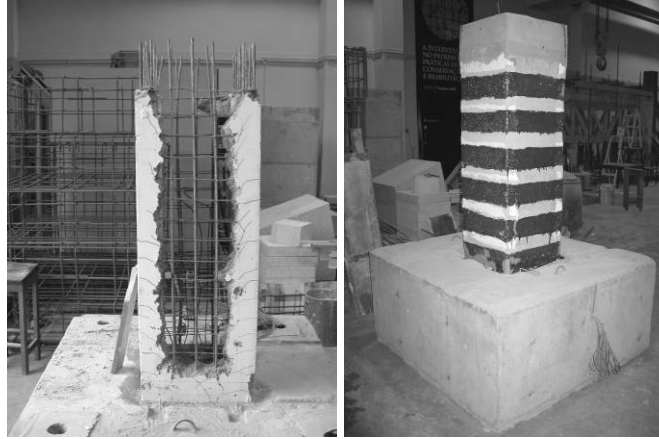
Fig. 12 Hollow square section pier (PO1) before and after the shear retrofitting with CFRP sheet

After the cyclic test of the “as built” specimen up to failure, it was repaired and retrofitted by an external contractor (S.T.A.P.) as can be summarized in the following steps: 1) delimitation of the repairing area; 2) removal and cleaning of the damaged concrete; 3) application of formwork and new concrete (Microbeton, a pre-mixed micro concrete, modified with special additives to reduce shrinkage in the plastic and hydraulic phase); 4) retrofit with the CFRP sheets. To have an idea of the pier damage, the following photographs illustrate the pier during repairing and after being retrofitted with CFRP sheets jackets (Fig. 12).

where V_c , V_s and V_p are the shear force components accounting for the nominal strength of concrete, the transverse reinforcement shear resisting mechanism and the axial compression force. Thus using Eq. 2, one layer strip of CFRP sheet of 0.117mm thickness by 100 mm width and 100 mm spaced along the height of the pier was applied, to retrofit the PO1 specimen, as can be seen in Fig. 12.

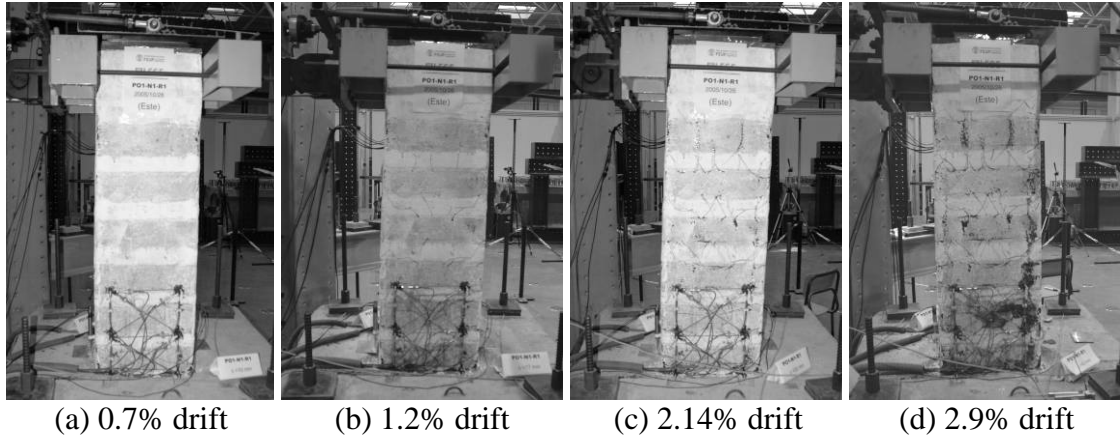
The damage evolution during the experimental test of the retrofitted specimen is illustrated in Fig. 13, for the east side of the pier. The first cracks, with dimension about 0.1mm, were visible at 0.35% drift, at the pier base. In the subsequent cycles the dimensions of these cracks increased and new cracks were developed along the pier height (Fig. 13a). For the top displacement of 17mm (1.2% drift - Fig. 13b), only the base crack has grown to about 0.5mm. Shear cracks appeared in the next cycles of 1.8% drift and

generalized damage started to become visible. In the right hand side of Fig. 13c (2.14% drift), a vertical crack is visible over almost the entire pier height, which caused global damage to the CFRP sheets. Failure of some of the fibres was audible. During the cycles of 40mm top displacement (2.9% drift - Fig. 13d) the bottom carbon sheets failed completely, leading to a drastic collapse of the pier on the compression side of the section, with buckling of the longitudinal reinforcement bars, due to lack of concrete confinement (see also Figs. 14 and 15).

(a) 0.7% drift (b) 1.2% drift (c) 2.14% drift (d) 2.9% drift
Fig. 13 Retrofitted pier PO1 damage from east side view.

As can be seen in Figs. 13 and 14, the retrofitted specimen showed a good behaviour in comparison with the “as built”, exhibiting very distributed cracking along the CFRP spacing.

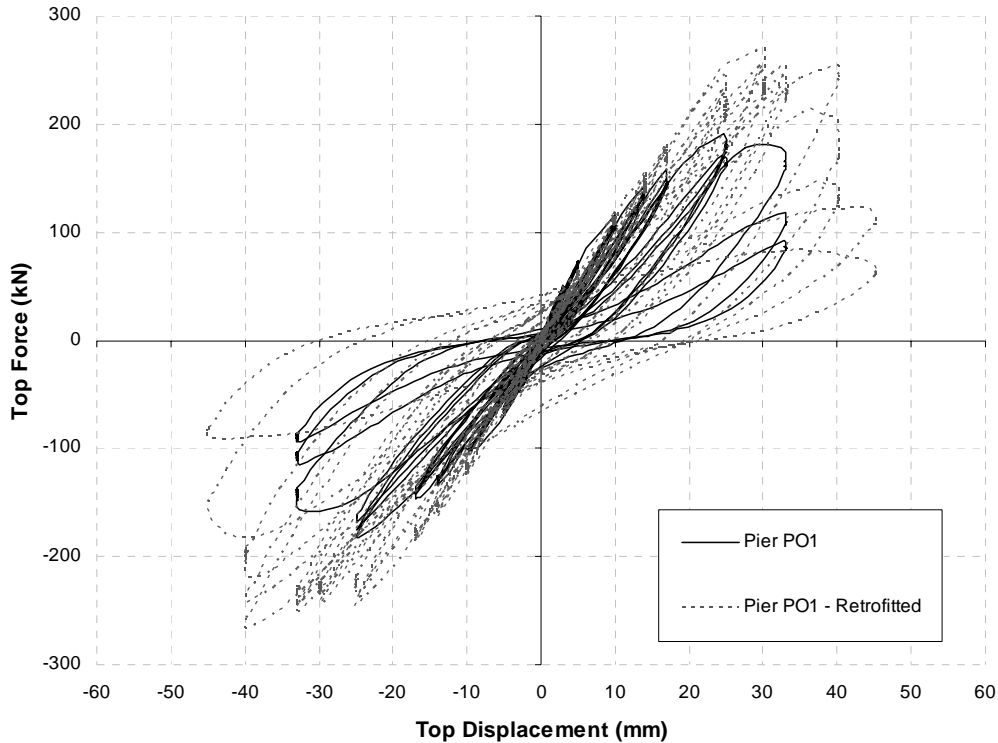
Fig. 16 Experimental results of pier PO1 before and after retrofit.

The shear retrofit design, used on this pier, showed an excellent performance because the shear failure mechanism was partially prevented and the flexural collapse with buckling of the reinforcement bars was achieved. In Fig. 16 the comparison between the original and retrofitted pier is illustrated, where an increase on 30% of the top force and an increase of 20% at the maximum displacement obtained, without significant reduction of the resistant force.

The CFRP retrofit showed excellent benefits on the pier behaviour since it avoided the shear collapse and a mixed shear-flexure mechanism was achieved. The ultimate drift increased from 2.4% to 3.2% and a well cracking distribution was obtained. The adopted retrofiting strategy has evidenced good ability for the improvement of the seismic pier behaviour both in ductility and strength.
