SCREENING PROCEDURE FOR THE RISK ANALYSIS OF CULTURAL HERITAGE ASSETS

X. Romão⁽¹⁾, E. Paupério⁽²⁾, N. Pereira⁽³⁾

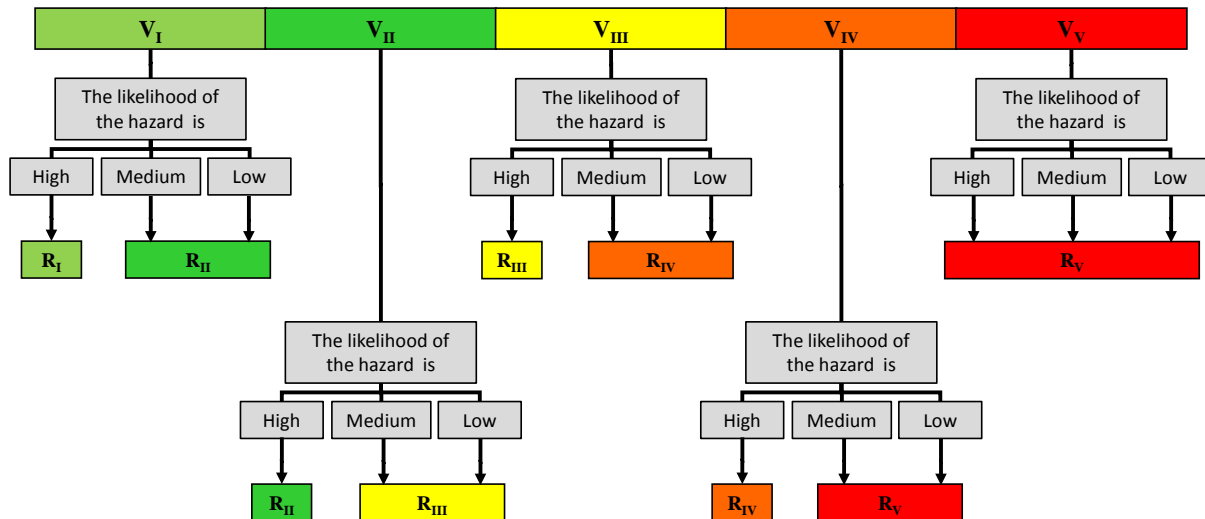
Fig. 2. Proposed risk analysis methodology: assessing the risk of the cultural heritage (CH) unit.

The proposed framework considers three categories of expected hazard likelihood which are termed High, Medium and Low. These hazard categories depend on the type of hazard but must reflect the fact that an event with a High likelihood is expected to have a lower hazard intensity while a Low likelihood event is expected to have a higher hazard intensity. For example, for the case of earthquakes, a High likelihood event is expected to have a lower average return period and also a lower magnitude, while for a Low likelihood event it is the opposite. From Fig. 2 it can be seen that, for a given vulnerability level, when the expected likelihood of the hazard is High or Medium, the subsequent risk level is the same. This conservative approach was considered in order to reduce the number of risk categories that result from the proposed framework. Furthermore, it can also be seen that when the vulnerability level is V_v , the subsequent risk level is always R_v , irrespective of the expected likelihood of the hazard. In this case, the framework assumes that if a cultural heritage unit exhibits the

Based on this level of damage, the next step of the framework analyses the reparability of those damages. Although for *High* damage the construction is expected to develop severe structural damage that can make it unstable, given the simplicity of the structural configuration and the type of mechanism that is usually developed in this type of construction, these can be considered to be fully repairable. However, the framework also needs to account for the reparability of the damages to the frescoes that are attached to the building. Due to the severity of the structural damage, the damage to the frescoes are only expected to be partially repairable (Fig. 10). Given these damages, the function of the church is not expected to be easily restored (at the end of 2015, restoration works were still ongoing) and a significant loss of value is foreseen. Based on these considerations, the vulnerability level of the construction is found to be V_v (Fig. 1) which automatically leads to a risk level R_v , no matter the likelihood of the selected earthquake scenario (Fig. 2).

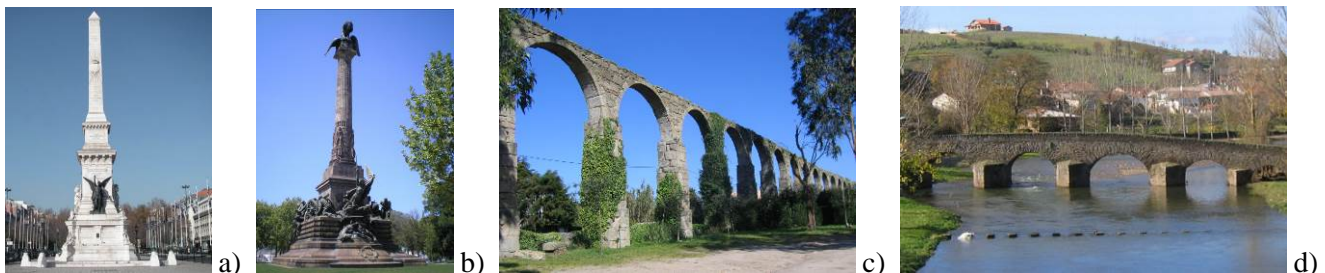
Figure 4 – Examples of constructions from the architectural CA3 a), b); and CA4 c), d).

As previously referred, the risk analysis framework was further developed for the particular case of earthquake hazard. Given that different types of constructions exhibit different behaviours under earthquakes, cultural heritage units need first to be assigned to architectural classes reflecting those differences. Based on these classes, analysis procedures can then be defined for each class which account for their specific behaviour under earthquakes. In the context of seismic analysis, a general classification of cultural heritage units has been defined in [10] that proposes six classes accounting for the construction morphology and the building technology. Since the detailing of the proposed framework for earthquake risk analysis was not developed for all types of constructions, a classification is proposed herein establishing only four architectural classes (CA1 to CA4) partially based on [10]. The architectural classes considered herein only involve masonry constructions and a different method was defined for each class to analyse the expected level of earthquake damage. The architectural classes that were considered are described in Table 1 and Figs. 3 to 6 present a few examples of cultural heritage units of each class.

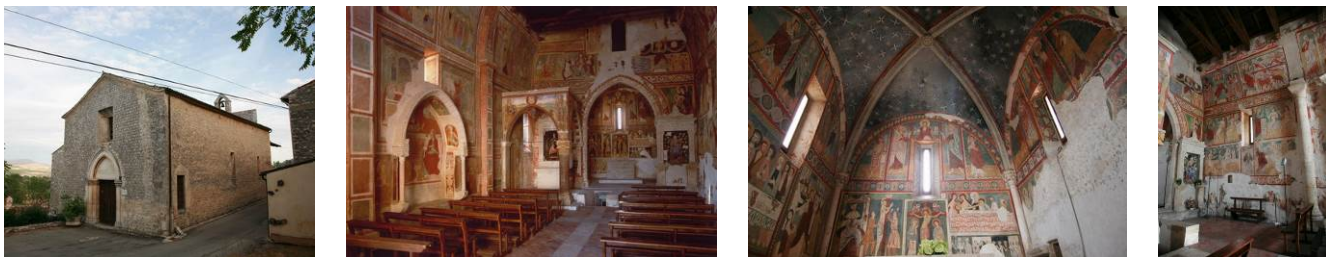
Figure 6 – External view of the of the Church of Santa Maria ad Cryptas (left) and interior views of the frescos.

The church of Santa Maria ad Cryptas is located about 1 km away from the centre of Fossa, an old village 12 km East of L'Aquila (Italy). This church was built in the second half of the 13th century, probably on the remains of a previous 9th century temple, and is among the best examples of Gothic art in the Abruzzo region. The very simple church configuration (Fig. 5) has two buttresses on the left side to strengthen the church that stands on a sloped hillside on that side. The entrance of the church shows some Romanesque influences but it is one of the first Gothic examples in Abruzzo. The interior follows the Cistercian model with a single nave divided into three bays and a square apse located on the south-east side. In front of the presbytery, a ladder leads to the small crypt, which according to historians was originally an underground dedicated to the worship of the goddess Vesta. A wooden truss roof covers both the nave and the apse. The ceiling of the apse is a 12th century cross vault with stone ribs and brick infill panels. The simple architectural layout of the church and its external simplicity (Fig. 6) are in high contrast with the richness of the frescoes decorating the walls, arches and vaults (Fig. 6) [11]. As can

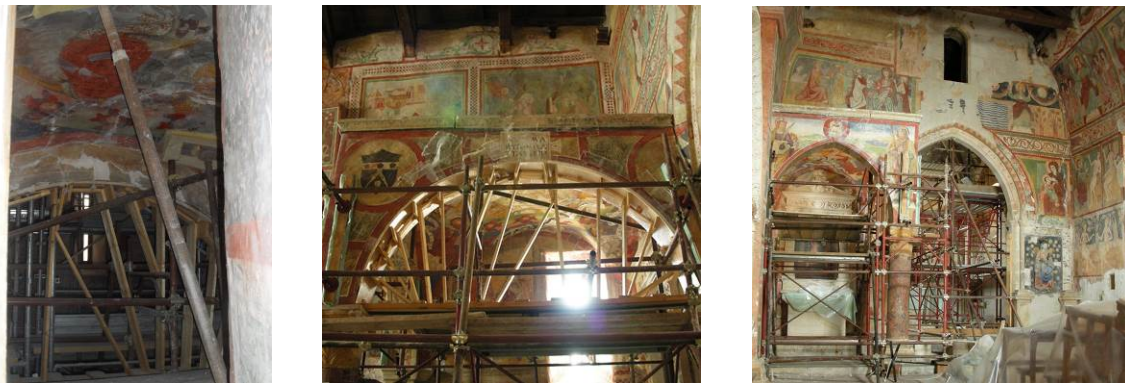
Figure 10 – Damages suffered by the frescoes of the Church of Santa Maria ad Cryptas during the L’Aquila earthquake.
