# Modern Building Reuse: Documentation, Maintenance, Recovery and Renewal

Proceedings of the Advanced Training  
Seminar *Architecture: Sustainability,  
Conservation and Technology*

## Some considerations on the preservation of 20<sup>th</sup> century architectural heritage

Teresa Ferreira

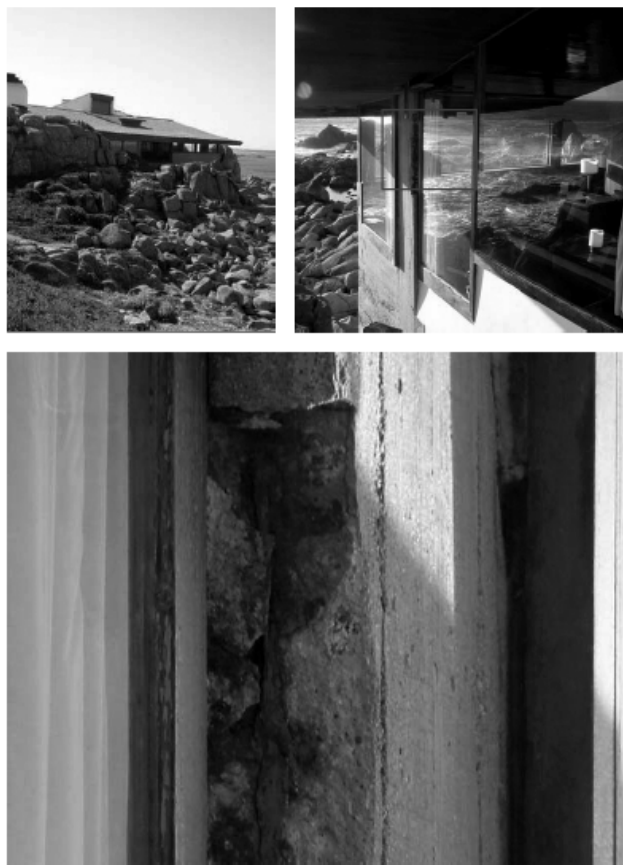
FIG.8 Francesca Albani; Teresa Ferreira; “Casa de Chá da Boa Nova” in Calorina DI BIASE (a cura di), *Il degrado del calcestruzzo nell’architettura del Novecento*, Santarcangelo di Romagna: Maggioli, 2009.

*Casa de Chá da Boa Nova*  
Leça da Palmeira, Porto  
(Portogallo)

*Calcestruzzo cementizio*  
Muratura gettata in opera a vista. Prospetto settentrionale.

*Classe di esposizione ambientale: XSI* esposizione alla salinità, ma non in contatto diretto con l'acqua marina (UNI EN 206-1:2006).

*Descrizione del fenomeno*  
Perdita di materia in prossimità del contrafforte del serramento in legno.  
*Sensazione visiva:* discontinuità della superficie. Barre d'armatura a vista. Presenza di macchie di colore rosso/bruno sul calcestruzzo nelle aree adiacenti alle barre corrose. Fessurazione ad andamento verticale nella parte più prossima alla superficie del manufatto in calcestruzzo.

*Degradi compresenti:*  
Disgregazione.  
*Degradi correlati:* macchie, fessurazioni.

*Tipo di indagine*  
osservazione macroscopica.

*Probabili cause*  
Carbonatazione del calcestruzzo, presenza di cloruri, corrosione delle armature.

Interesting research is being undertaken in this field: for example, an interdisciplinary study on exposed concrete (involving both engineers and architects) by the *Politecnico di Milano* that seeks to improve knowledge and identify possible causes of its deterioration, thereby providing better technical solutions for its conservation and repair (Di Biase, 2009).<sup>9</sup> Among other aspects, an important contribution of this research is the definition of a specific and shared glossary on the manifestations of decay,<sup>10</sup> illustrated with images and examples from different European and non-European countries, such as India and Brazil.

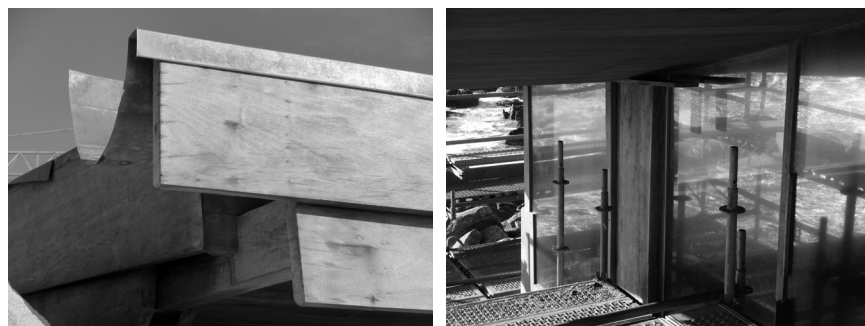
FIG.9 – 10 Casa de Chá da Boa Nova during conservation intervention, 2014. Photos by Teresa Ferreira.
