# **Short-term tensile behaviour of three geosynthetics after exposure to recycled Construction and Demolition materials**

Castorina Silva Vieira<sup>1, #</sup> and Paulo M. Pereira<sup>1</sup>

<sup>1</sup>CONSTRUCT, Faculty of Engineering, University of Porto

**KEYWORDS:** Geosynthetics; Construction and demolition waste; Recycled aggregates; Geosynthetics degradation; Tensile behaviour.

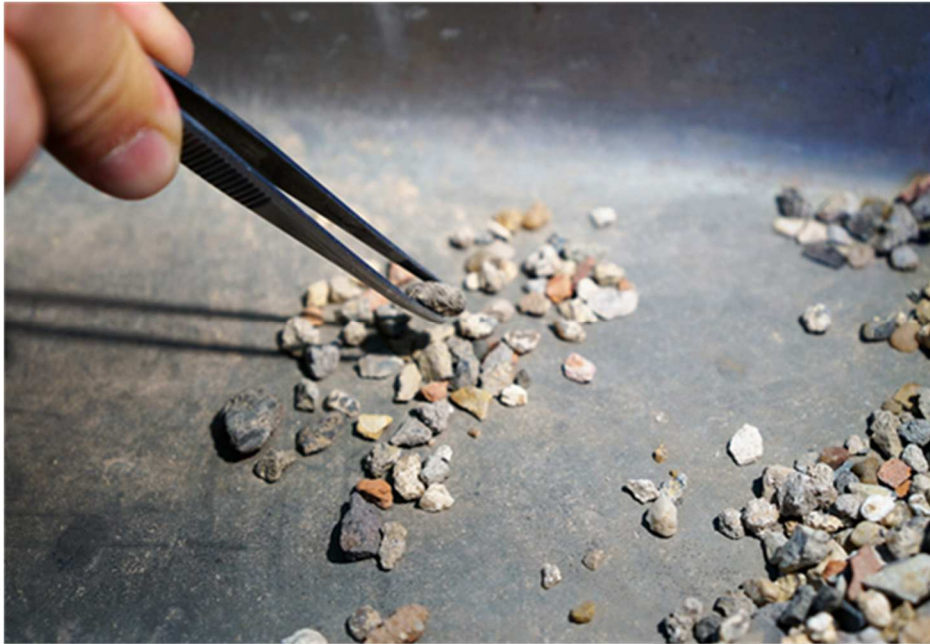
696 Figure 2 - Manual sorting of recycled C&D material to determine its constituents.

The recycled C&D aggregate is a fine grain material, coming mainly from maintenance and demolition works of residential buildings and removal of C&D waste from illegal waste disposal sites. This recycled material was provided by a Portuguese recycling plant and results from an initial sorting process (to remove contaminating materials such as steel, plastic, wood, ...), followed by crushing and grain size separation. The resulting materials are mixed recycled aggregates, consisting of concrete, mortar, bricks, stones and others. The constituents of the C&D material were determined in accordance with the European Standard [34], following a manual sorting process of the particles larger than 4 mm (Figure 2). Table 2 presents the constituents of the recycled C&D material (only for particles above 4mm). It is mostly composed of concrete, mortar, unbound aggregates and soil. It should be noted that the volume of floating particles exceeds the desirable value ( $< 5\text{cm}^3/\text{kg}$  of dry matter according to [35]), meaning that some wood and polystyrene are still present in the recycled material.

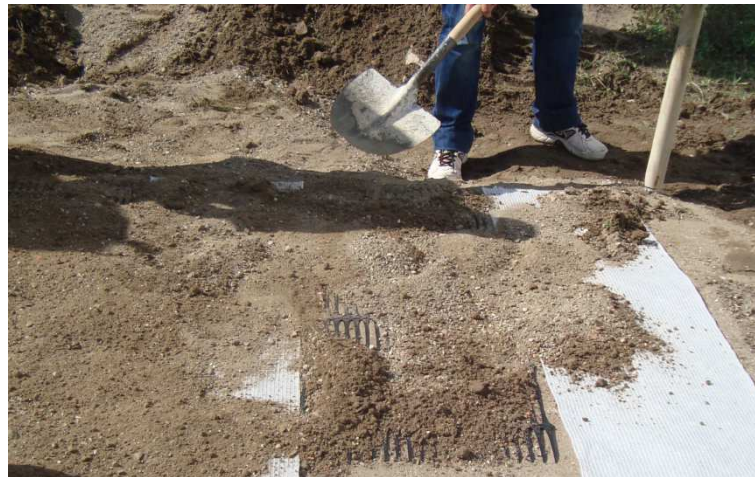
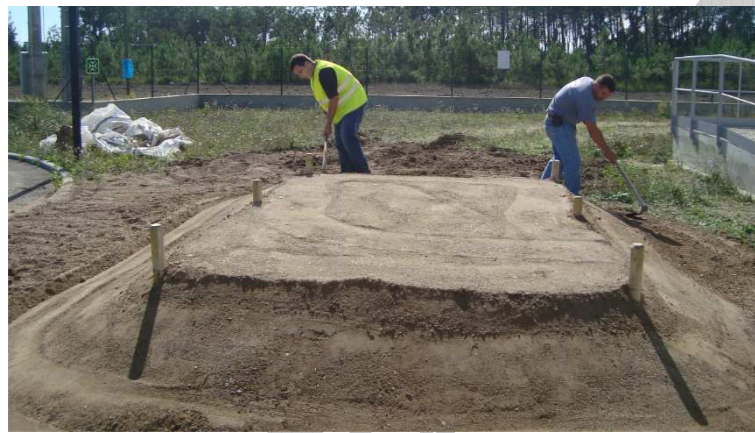
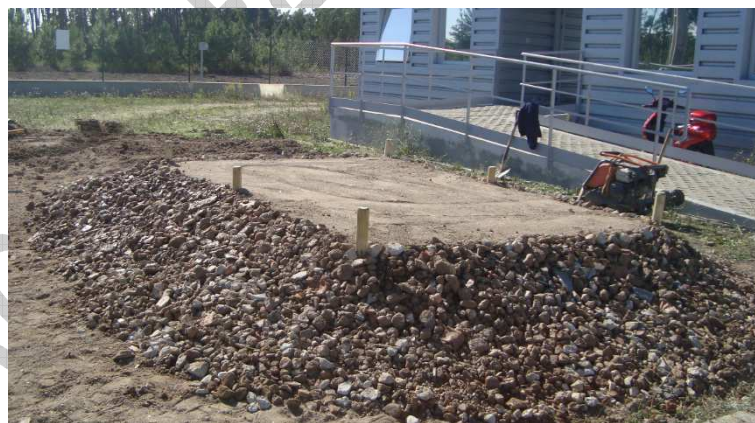
Figure 4 - Trial embankments construction: a) manual placement of the recycled C&D material over the geosynthetics; b) end-of-construction before lateral protection; c) lateral protection of the slopes with coarse aggregates.

Inside the embankments the geosynthetic samples (aprox. 0.45 m × 1.5m) were distributed in 2 levels vertically spaced of 0.20 m. After cleaning the foundation from the existing vegetation, a 5 cm-thick layer was placed and compacted and the geosynthetic samples of the first level were carefully positioned without overlapping. Geosynthetic samples were then covered with a first layer of C&D material (soil in Embankment 3) placed manually to prevent mechanical damage (Figure 4a). Additional quantities of filling material were disposed, evenly spread and compacted to reach a lift with final thickness of approximately 0.20 m. The second layer of geosynthetic samples was positioned and the compaction process was repeated.

The lateral slopes of the embankments were also compacted (Figure 4b) and coarse recycled C&D aggregates were disposed to prevent erosion by rain water (Figure 4c).

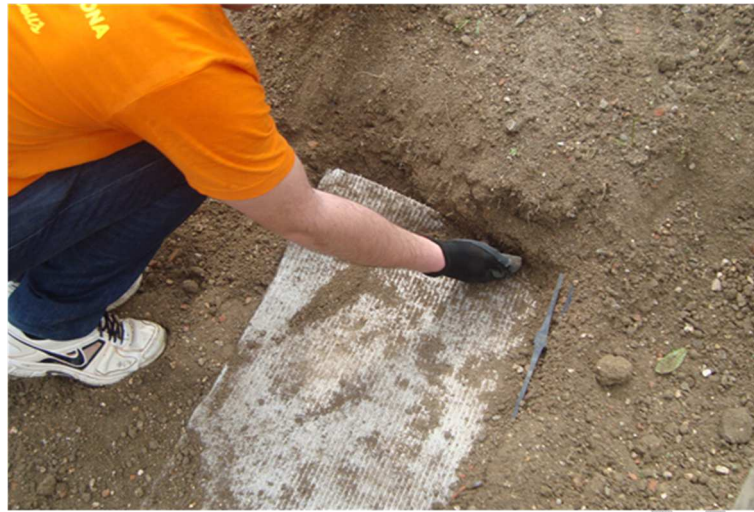
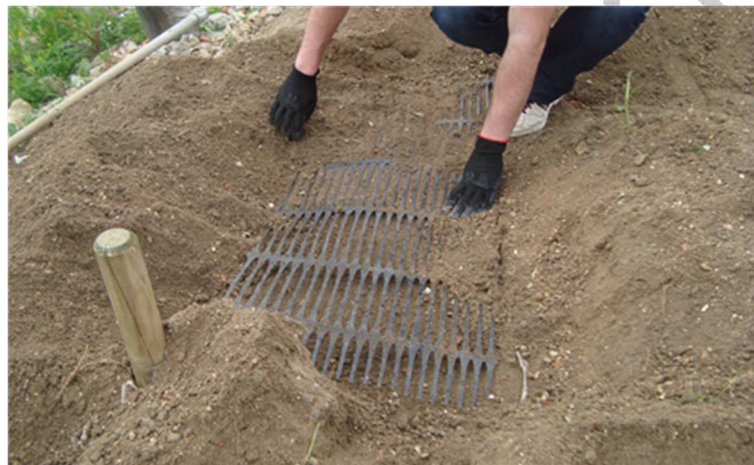
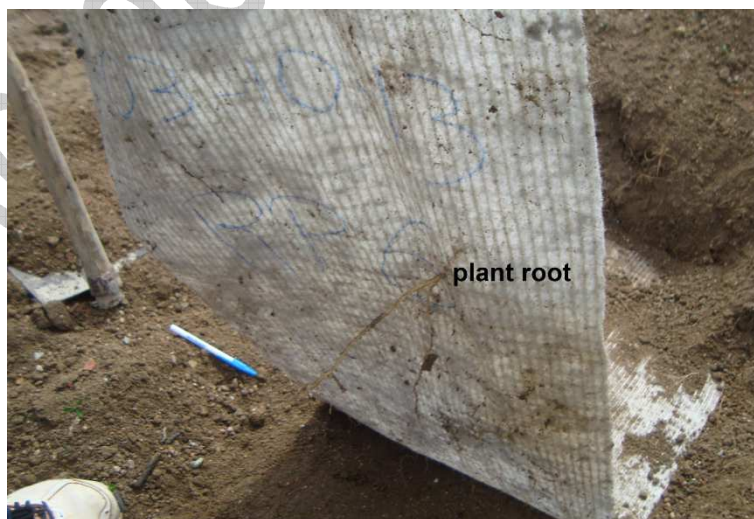
Figure 5 – Geosynthetic specimens' exhumation: a) and b) careful exhumation of the specimens; d) plant roots crossing the geotextile.

lateral slopes, as well as the vegetation that grew up over the embankments. Fill materials were manually removed with hoes and shovels, being the material just above the geosynthetics removed gently with the hands (Figure 5a and 5b).

From visual inspection after exhumation, the geogrids did not show damage visible to the naked eye. Geotextile samples were crossed by plant roots, either in the Embankment 1 (recycled C&D material) or in the Embankment 3 (clayey sand), some of them with a few millimetres in diameter (Figure 5c).

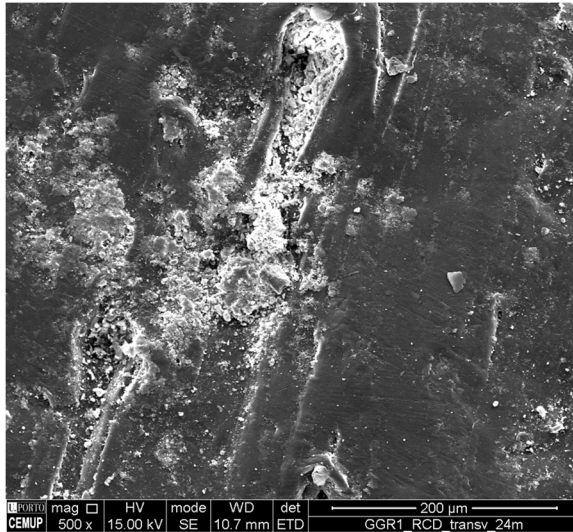
739 Figure 9 – SEM images of the transversal bars of the Geogrid 1 (×500): a) intact  
740 specimen; b) exposed to recycled C&D material; c) exposed to soil.

The absence of significant damage was also proven by SEM images. Figure 8 and Figure 9 exhibit SEM images with 500 times magnification for longitudinal and transversal bars of the geogrid, respectively. There is no visible damage, only appearing microscopic particles that remained gummed to the geogrid after exhumation.
