ARCHITECTURAL ENGINEERING IN REHABILITATION AT SOCIAL HOUSING QUARTERS

VITOR ABRANTES¹, NUNO ABRANTES², and FERNANDO BRANDÃO ALVES¹

¹*Faculty of Engineering, University of Porto, Porto, Portugal*

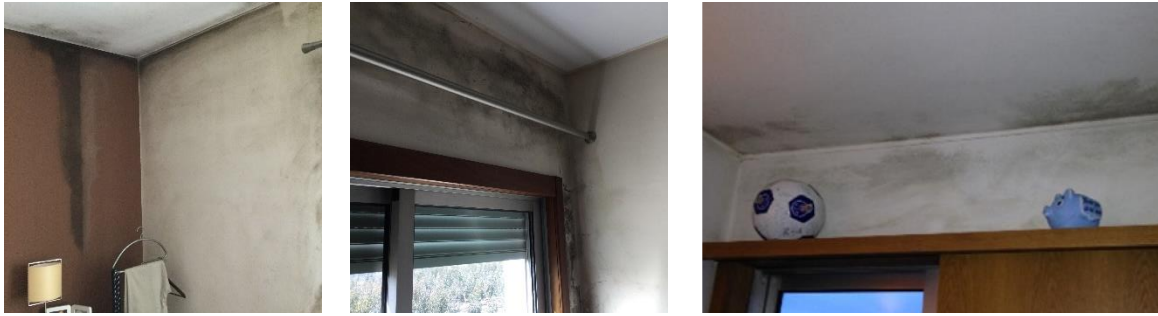
Figure 2. Examples of observed anomalies (condensation, humidity).

Condensation comes from water vapour within the buildings - people, cooking, bathing... Buildings with poorly insulated walls are very prone to this problem.

Due to the lack of thermal resistance, condensation occurs, which leads to water damage in the indoor environment. These results in condensation and risk for mold growth.

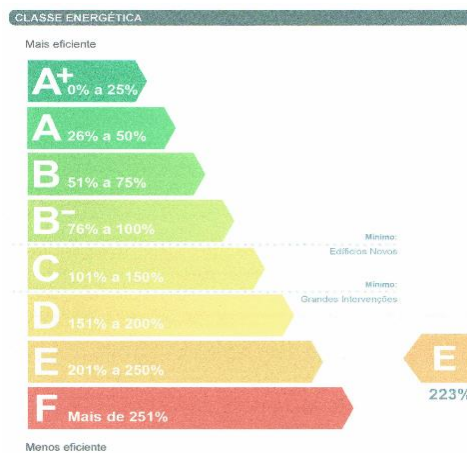
Figure 3. Example of a result of an energy efficiency evaluation (classification E).

The EU program of investment forces that the housing after the rehabilitation reach more two levels.

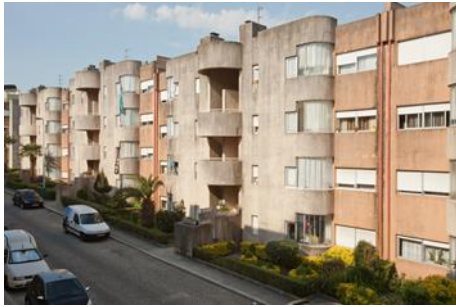
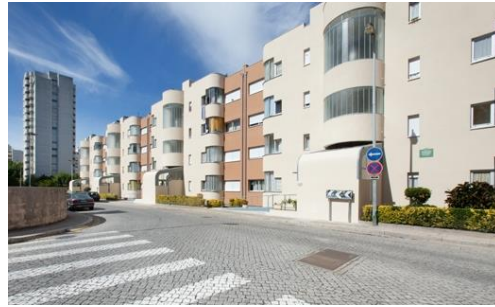
Figure 4. Neighborhood of Santa Luzia. Porto (640 Dwellings).

Before the architectural engineering in rehabilitation

After the architectural engineering in rehabilitation

The analysis of the neighborhood of Santa Luzia, at the present time and its redevelopment project, allowed to study the factors that compromise the urban integration and how the requalification met such conditions.

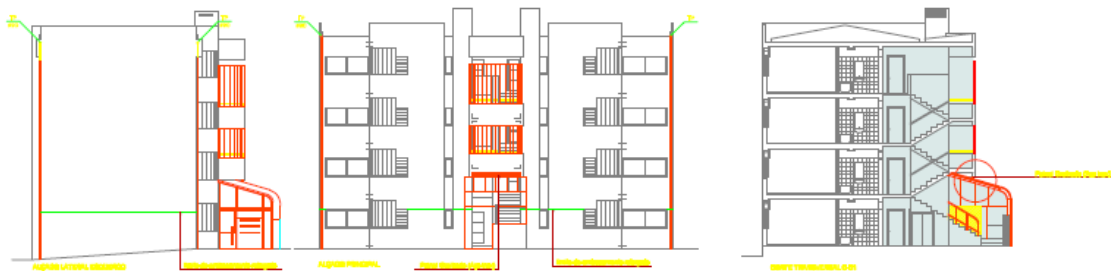
Figure 5. Project of Rehabilitation of Santa Luzia. Porto.

Each component of the urban space tries to be designed so that the assembly formed by reclassified zones in the shown design, can be understood as a unit - and not the current sum of road sections more or less dispersed buildings and voids between both building an urban fabric.

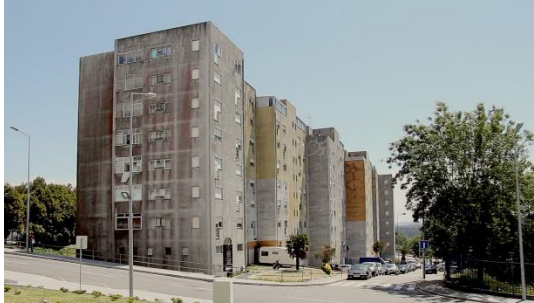
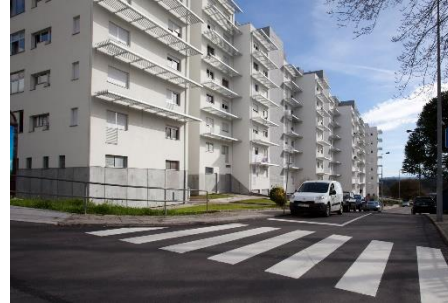
Figure 6. Neighborhood of Vila d'Este. Vila Nova de Gaia (2085 Dwellings).

Before the architectural engineering in rehabilitation

After the architectural engineering in rehabilitation

The analysis of morphological characteristics of the Vila d'Este urbanization in two stages, before and after the physical rehabilitation - allowed us to study the factors that compromised the urban integration, architectural quality and residential satisfaction of residents.

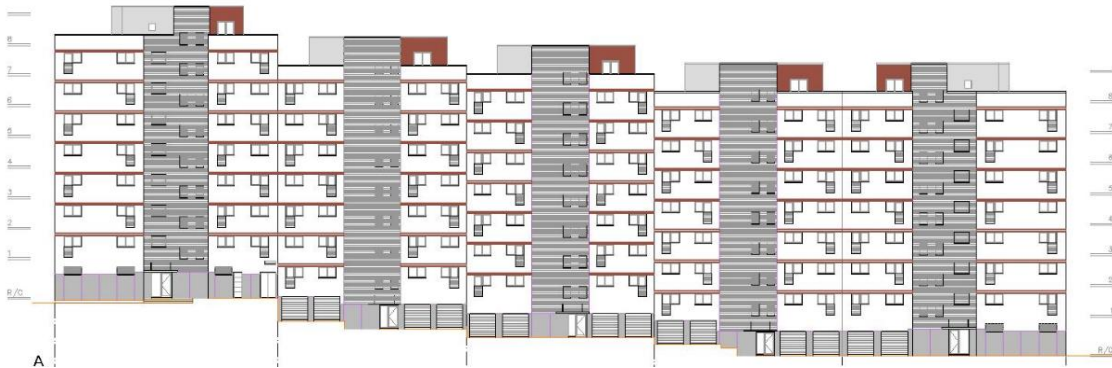
Figure 7. Project of Rehabilitation of Vila d'Este. Vila Nova de Gaia .

The redevelopment meets the full range of objectives which must meet the physical rehabilitation of public space in affordable housing sets. Like in the previous case, each element of the urban space was designed together with all other elements, so that all the parts reformulated in the rehabilitation work can be seen as a unit. Before upgrading, urban set was only a sum of empty spaces between buildings scattered and fairly disjointed road sections, buildings without quality.

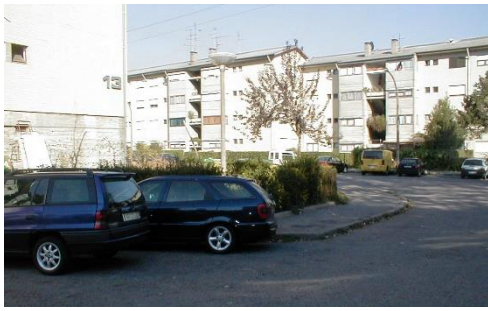
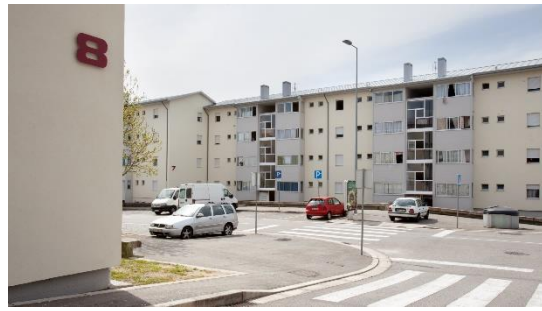
Figure 8. Neighborhood of Contumil. Porto (248 Dwellings).

Before the architectural engineering in rehabilitation

After the architectural engineering in rehabilitation

The intervention in Contumil neighborhood responds to the most critical issues of its urban space and meets the full range of objectives which must meet the physical rehabilitation of public space in the social housing context. Our first goal was to understand the relationships between the different spatial components in the design of the urban form of the whole and the contribution of each part to the overall quality of the intervention.

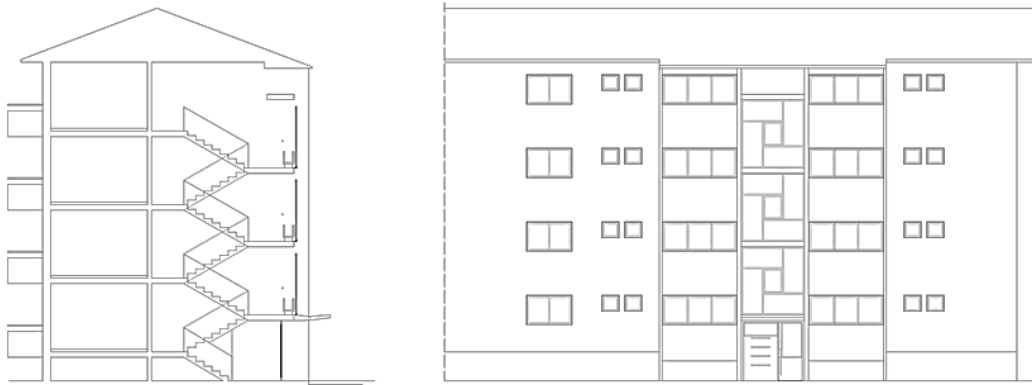
Figure 9. Details. Project of Rehabilitation of Contumil. Porto.

Each part of the urban space is designed so that the whole can be understood as a unit and not as a sum of distinct elements or empty spaces between them; buildings that does not assure continuity if it doesn't benefit from the complementarity between them and the adjacent spaces. Recasting of accessibility plays a very important role.

The restructuring of the redesigned road network with orthogonal paths and new links that regulate the mesh of the remaining spaces can resolve the gaps in accessibility and proximity of parking.
