SACoMaTiS 2008
International RILEM Conference
1-2 September 2008 Varenna (LC)
Como Lake – Italy
POLITECNICO DI MILANO
www.sacomatis.org
on Site Assessment of
Concrete, Masonry and Timber

NUMERICAL ANALYSIS OF A MASONRY CHIMNEY SUPPORTED BY IN SITU ASSESSMENT TOOLS

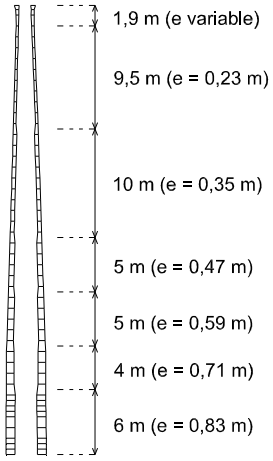
Figure 4: Vertical cut on the chimney structure - different thickness values

The chimney height measured by the laser scanning (39,90m) was increased in 1,50m due to the consideration of the lower part of the chimney base, nowadays partially exposed and surrounded by a thin reinforced concrete wall built 10 years ago (figure 3). Due to unexpected problems, the complete scanning couldn't be done at the same time: the scan of the exterior was done in August (summer) and the interior was scanned in November (autumn). The superposition of the two point clouds showed that they weren't concentric. Moreover, the deviation increased from the bottom to the top where a maximum of 7cm eccentricity was measured. This fact is most probably related with seasonal structural deformations of the chimney, as no such permanent deformations were expected to have occurred during that 4 months period. Nevertheless, the laser scanning of the chimney will be repeated in August in order confirm this effect. The finite element mesh was built based on the exterior geometry given by the first laser scanning, and on the average thickness measured by the point clouds superposition (figure 4).

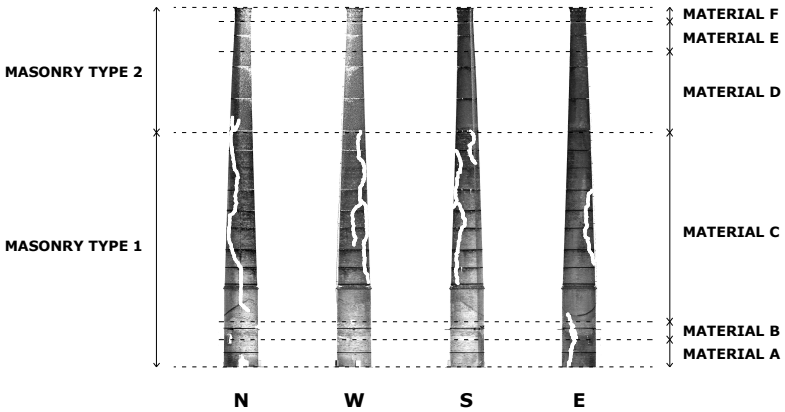
According to the visual inspection, different zones were also identified inside each category M1 and M2 based on the brick and/or mortar degradation state, allowing the identification of a total of 6 material types (figure 9). Major cracks were identified and represented in white in figure 9. Figure 10 shows the photographic record of each of these zones. As for the steel rings, they presented important levels of corrosion (figure 11). Moreover, some of these rings were not working and there were opened cracks crossing them (figure 12). Therefore, they were not considered in the numerical model.

Figure 9: Material and damage identification – North, West, South and East view

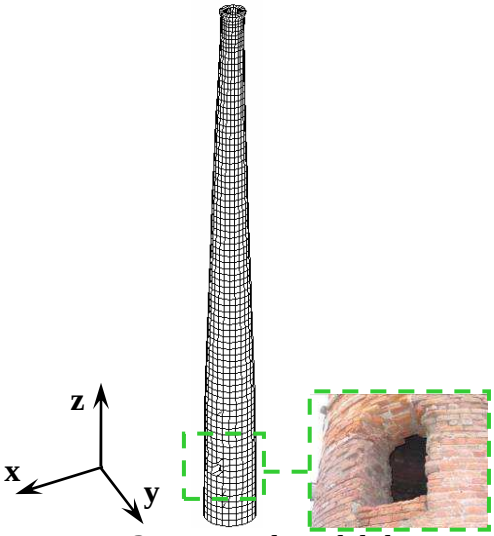
Figure 13: Principal modal directions

A preliminary numerical modal analysis showed that the principal directions were dominated by the opening at the bottom of the chimney (figure 13). The test setup was decided based on this previous analysis. The accelerometers were then placed along the already referred to directions (figure 13 and figure 14). Figure 14 shows the position of the accelerometers on 5 levels, dividing the chimney in 5 equal parts, approximately 8m long each. Each of the 9 setups corresponded to 15 minute data acquisition and using 2 fixed accelerometers at the top (marked in blue in figure 14) and 2 others in each one of the green positions marked in figure 14.

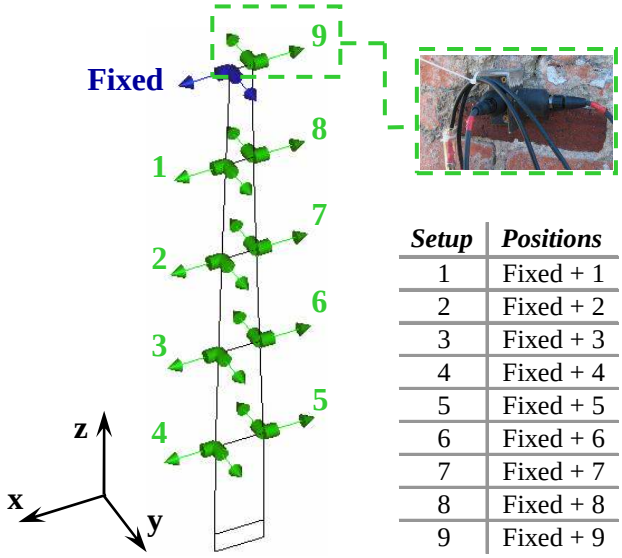
Figure 14: Test setups

In order to obtain torsional and circumferential modes, the setups included accelerometers on the *yy* and *xx* directions on both sides of the chimney (figure 14). The accelerometers were bolted on steel pates, and then fixed on the chimney wall. The connecting wires were protected with plastic sleeves to avoid interferences and connected to the acquisition system.

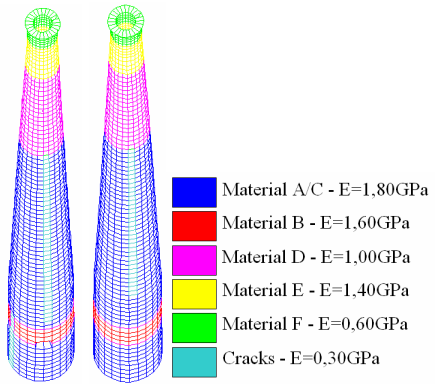
Figure 16: The Young modulus in Model 2: (a) +X view; (b) –X view

The Young modulus obtained for Model 1 was 1,425GPa, while figure 16 shows the Young modulus obtained for each of the 6 materials considered (see figure 9). In both models, the Poisson ratio was 0,20 and the density 1650kg/m^3 [2].

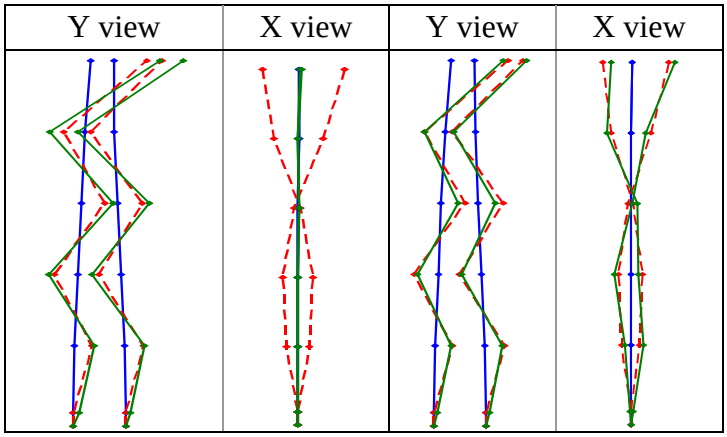
Figure 17: 9th experimental mode (dashed red) versus numerical mode (green): (a) Model 1; (b) Model 2

In figure 17, the 9th mode shape is compared for Models 1 and 2, showing in blue the zero reference line, in dashed red the experimental mode shape and in green the numerical mode shape. The results show how Model 2 is much more effective reproducing torsional-bending effects, in comparison to Model 1. The consideration of cracks in Model 2 is the most likely cause to this effect. For lower modes, the differences between the models are quite small.

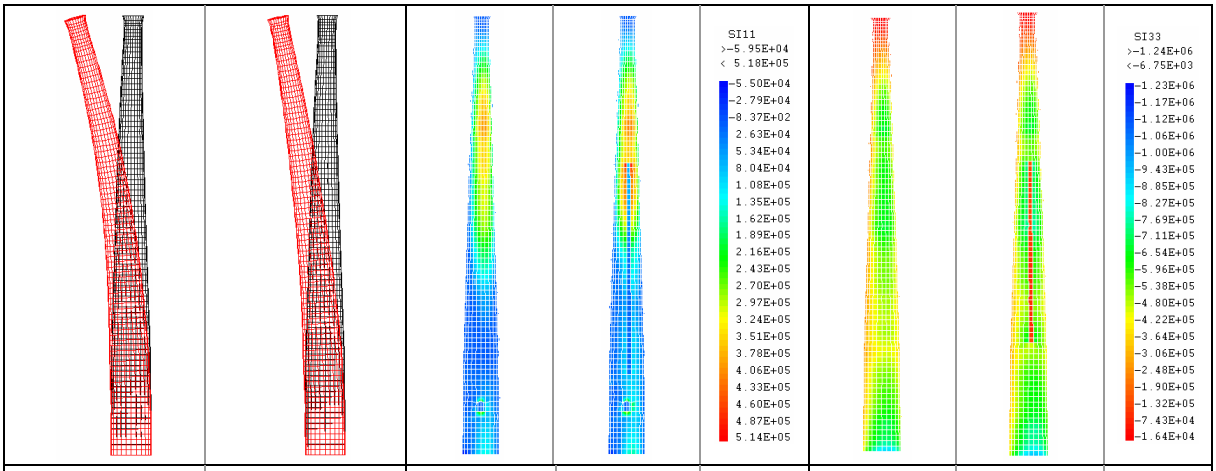
Figure 18: Comparison of the seismic analyses results for seismic action type 1

The deformed shapes for the maximum top displacement and the patterns for the principal stresses envelopes are shown in figure 18 and 19 for the two types of seismic actions. The results of the seismic analyses using both methodologies clearly show that, in the case of this chimney, the consideration of damages areas in the numerical model (Model 2), namely cracks, is responsible for the increase of approximately 20% on maximum principal stresses. Furthermore, stress patterns obtained for both models were quite different, with more stress concentration zones for Model 2, namely around the cracks. As for the displacement values, the differences between Model 1 and Model 2 were smaller, with slightly higher displacement values for Model 1.
