Strengthening of Structures Damaged by the Azores Earthquake of 1988

Aníbal COSTA
Associate Professor
FEUP
Porto

António Arêde
Assistant Professor
FEUP
Porto

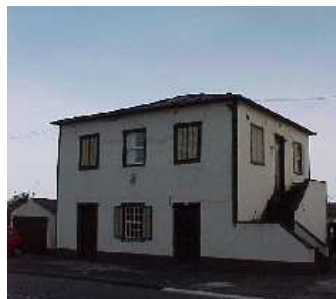
Fig. 2 – Semi-rural house

According to the aforementioned, the vibration modes were calculated for the semi-rural house (fig. 2), using first the material properties' values estimated from the *in situ* experimental tests [3]. Since for this structure the main vibration frequencies were also experimentally obtained in the transversal and longitudinal directions, these results were used to calibrate the stone masonry elasticity modulus in order to fit calculated and measured frequencies.

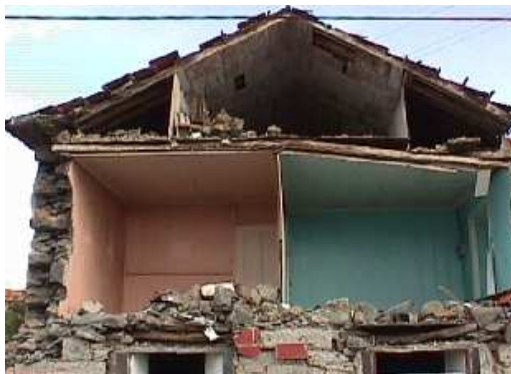
Fig. 4 – Aspect of the building's interior

Rural areas of Faial mostly have exterior walls of the second and third types, which are about 65 to 70 cm thick. Interior walls are normally made of wood plastered in both faces, either with a hollow interior or filled with 2.50 cm thick boards comprising a latticework that is plastered with lime, sand and clay mortar. Sometimes the interior walls are also used for structural purposes, fig. 4.

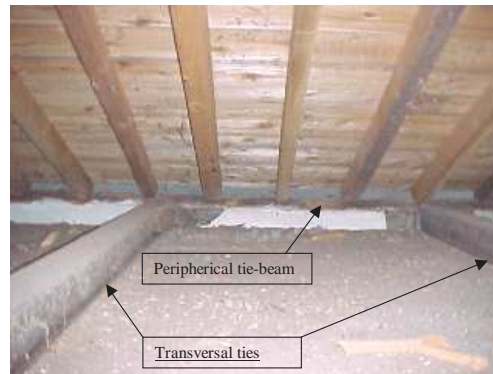
Fig. 5 – Structural “scissor” roof solution

Most houses have the same type of so-called “scissor” roof structure, fig. 5, with sloping beams (i.e. in the water flow direction) of various sizes, from 14x5 cm² to 19x7 cm², spaced at about 35 cm and supporting the roof lining. These beams are supported by a periphery horizontal tie beam, with about 10x10 cm² cross section, embedded in the top-end of the wall. The opposite walls supporting that tie beam are, in turn, connected by transversal ties, which may be wood trunks of irregular shape, somewhat round and with trimmed ends, or of a rectangular shape. A lining made of overlapping boards that support tiles, fig. 5, covers the roof frame.

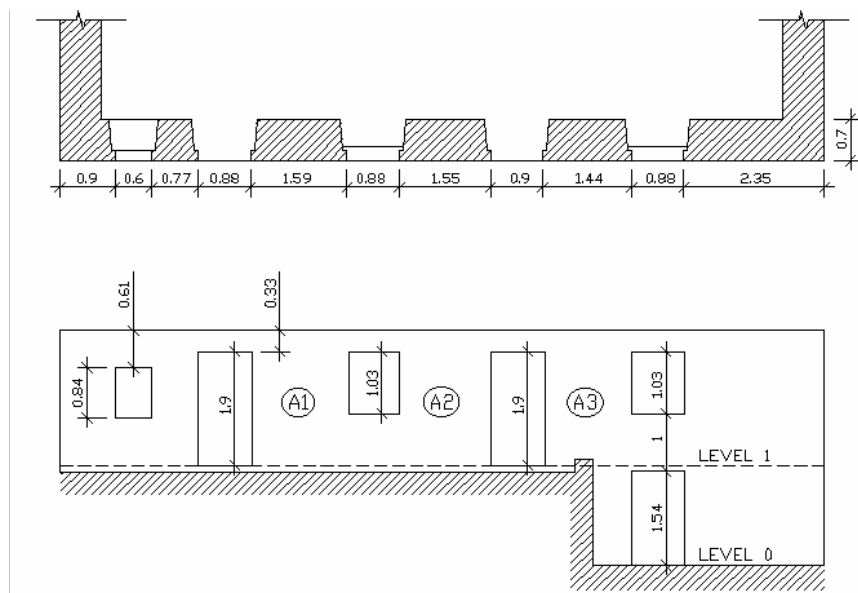
Fig. 6 – Partial schematic representation of the layout and elevation of house A

Results herein presented refer to tests on house A, which is partially schematized in fig. 6 both in plan view and in elevation. The panels are identified as: A1, for the original one; A2, for the steel mesh reinforced panel; and A3, for the poured grout reinforced panel.
