Survey of the Facade Walls of Existing Adobe Buildings

Dora Silveira, Humberto Varum, Aníbal Costa & Célia Neto

Adobe construction was very common in Aveiro district, Portugal, until the middle of the 20th century. At present, there are still many adobe buildings in use, a significant percentage of which have social, cultural, and architectural value. Many of these buildings, however, are in a poor state of conservation. The existing problems are partially the result of a lack of knowledge about the materials and building systems traditionally used. To contribute to this knowledge, a visual and dimensional inspection of the facade walls of twenty one adobe buildings located in Anadia, Murtoosa, and Aveiro municipalities, in Aveiro district, was conducted. This article presents a description and analysis of the construction details, common defects, and state of conservation of the facade walls studied. This work aims to contribute with preliminary information that may help support the preservation and rehabilitation of existing adobe buildings.

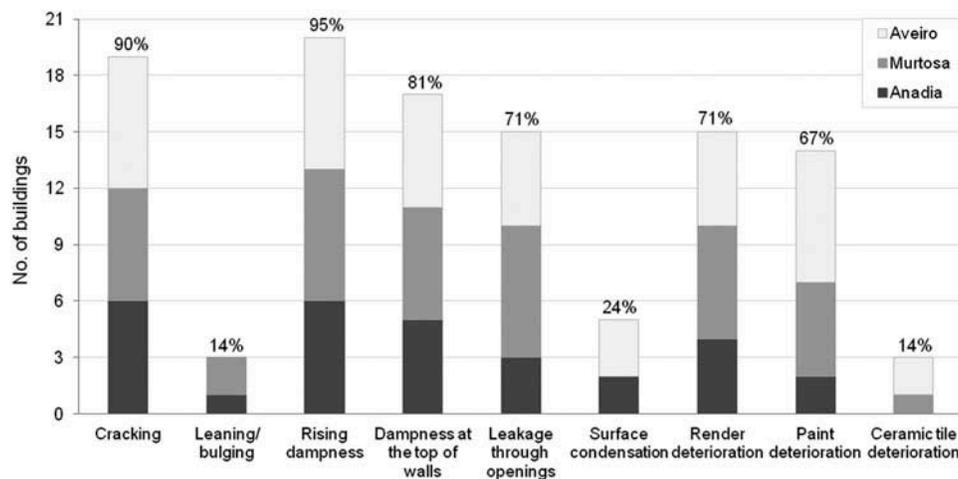
**Figure 5.** Common defects observed in facade walls.

The most common defects observed in the facade walls of the buildings studied are presented in Figure 5. The number and percentage of buildings, per municipality, that suffer from each defect are also indicated. The most common defects observed and their possible causes are described below.

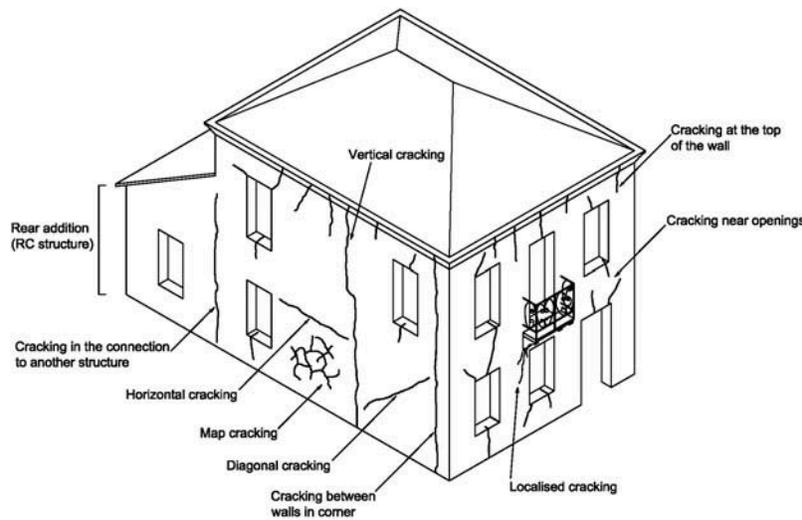
Cracking of facade walls was observed very frequently in the inspections conducted. In fact, 90% of the buildings studied have facade walls with superficial and structural cracks (Figure 5). The most relevant types of cracking observed are represented schematically in Figure 6. The number of buildings, per municipality, that suffer from each defect, is presented in Figure 7. For each type of cracking, the percentage of buildings, in relation to the total number of buildings studied, is also indicated. The different types of cracking observed and their possible causes are described below. A brief analysis of the damage that led to the partial collapse of two facade walls in building “H34” is also presented.

Figure 6. Schematic representation of the types of cracking observed in facade walls.

The cracks near openings observed in the buildings studied are mainly located above or below the openings, frequently near the corners, and generally have vertical or diagonal orientation (Figure 6). In some cases, cracking is thin and superficial, affecting only the coating, but it is more frequently thick and deep, affecting also the support structure. In one building (“H21”), intense cracking led to the partial disintegration of masonry above two openings. Common causes for cracking near openings are: excessive load (Thomaz 2003), generally imposed by the roof or floor structures; insufficient support of the masonry above the openings; stress concentration in the corners; and excessive percentage of wall area with openings. In some of the cases, differential foundation settlement is also a possible cause for the existing cracking (Richardson 2001; Thomaz 2003).

The cracking observed at the top of the facade walls of the buildings studied is mainly vertical or diagonal (Figure 6). In some cases the cracks are light and superficial, but in other cases the cracks are thick and affect the support structure. This type of cracking is generally caused by excessive load or deformation imposed by the roof structure (Thomaz 2003).

Map cracking is a network of thin and superficial cracks, oriented in a random pattern (Figure 6). It generally occurs as the result of the drying shrinkage of mortar (Marshall et al. 2014). This type of cracking was mainly observed in cement render, but a few cases in lime render were also identified.

Structural cracking between perpendicular facade walls, in corners, was observed in some of the buildings under study (Figure 6). This type of cracking is generally vertical, following along the area of connection between walls. In some of the cases observed, vertical cracking is combined with diagonal or scattered cracking along the corner. Possible causes for this type of cracking are: deformation of the walls due to variations in temperature or moisture content (Thomaz 2003); differential foundation settlement (Pagaimo 2004); and horizontal thrust imposed by the roof which leads to the rotation of one or both perpendicular walls (Pagaimo 2004). These factors can lead to cracking or even separation between facade walls, especially when combined with a weak connection between walls.

Localized cracking in the facade walls, due to stress concentration, was observed near the points of support of gutters, balconies (Figure 6), steel rods, and beams. This type of cracking is generally intense, affecting the support structure. The cracks are vertical or diagonal and sometimes are combined with crushing around the support points.

Cracking was observed in the connection of buildings to adjacent land dividing walls and in the connection of the original buildings to rear additions (Figure 6). In these cases, cracks are generally vertical or diagonal, following along the connection surface. Possible causes for this type of cracking are the differential movement of the structures due to variations in temperature or moisture content (Richardson 2001) and differential foundation settlement (Thomaz 2003).

Long horizontal cracking was observed in the facade walls of some of the buildings studied (Figure 6). In most cases, the cracks are thick and may affect the support structure. A possible cause for long horizontal cracking is excessive load imposed by the roof structure, causing flexion of the wall (Thomaz 2003). However, in the observed cases, the horizontal cracks may be the result of cracking that started in areas of structural fragility (such as near openings or near collapsed areas) and that extended horizontally along the bed joints. In one building (“H23”), horizontal cracking is located at the level of the first floor concrete bond beam and is likely the result of incompatibility between the behavior of the two materials (adobe masonry and concrete).

Long diagonal cracking was also observed in the facade walls of some of the buildings studied (Figure 6). In all the cases, the cracks are thick and appear to affect the support structure. In building “H39”, one diagonal crack is located near an opening, extending diagonally and downward towards a corner of the building, and seems to be caused by excessive load imposed by the roof structure. In the other cases where this type of cracking is observed, cracks appear to be caused by differential foundation settlement—in these cases, the diagonal cracks lean towards the point where the largest settlement occurred (Richardson 2001; Thomaz 2003). In building “H39”, one diagonal crack of this

Vertical structural cracking in the central area of the facade walls was observed in a few of the buildings under study (Figure 6). The vertical cracks are long, sometimes extending from the bottom to the top of the walls. Possible causes for this type of cracking are (Thomaz 2003): deformation of the walls due to variations in temperature or moisture content; differential foundation settlement; and excessive concentrated load imposed by the roof structure.

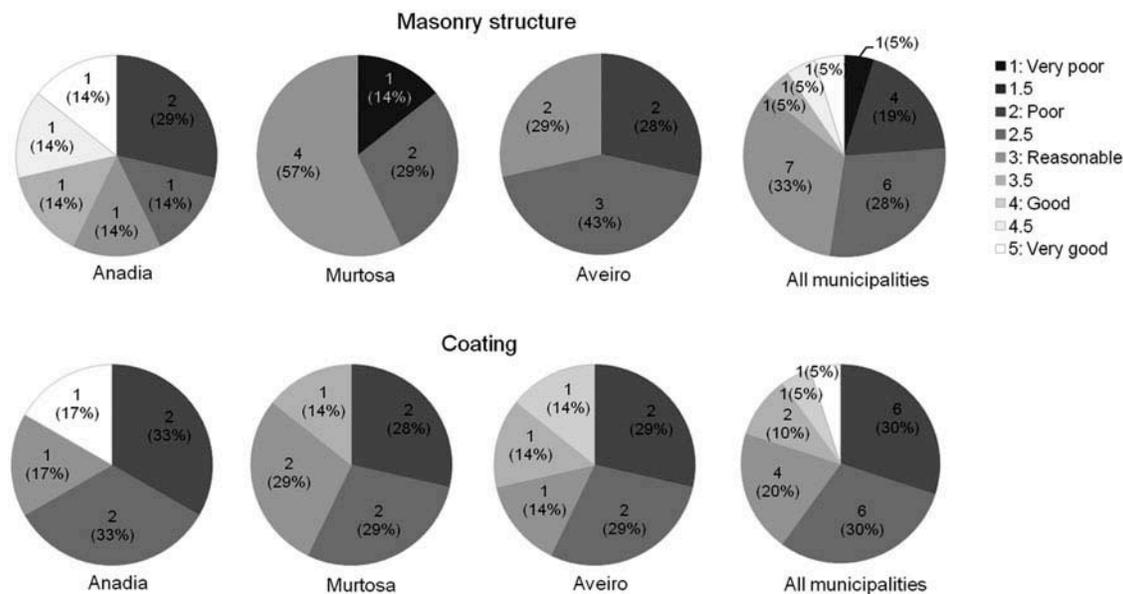
The state of conservation of the coating of each facade wall was evaluated as follows:

- 1 (“very poor”): the wall coating has severe defects that significantly compromise its function;
- 2 (“poor”): the wall coating has defects that compromise its function;
- 3 (“reasonable”): the wall coating has defects that do not affect—or only slightly affect—its function;

Figure 10. State of conservation of facade walls.
