Field observations of the structural performance of RC constructions in Nepal after 25th April 2015 earthquake

Abstract

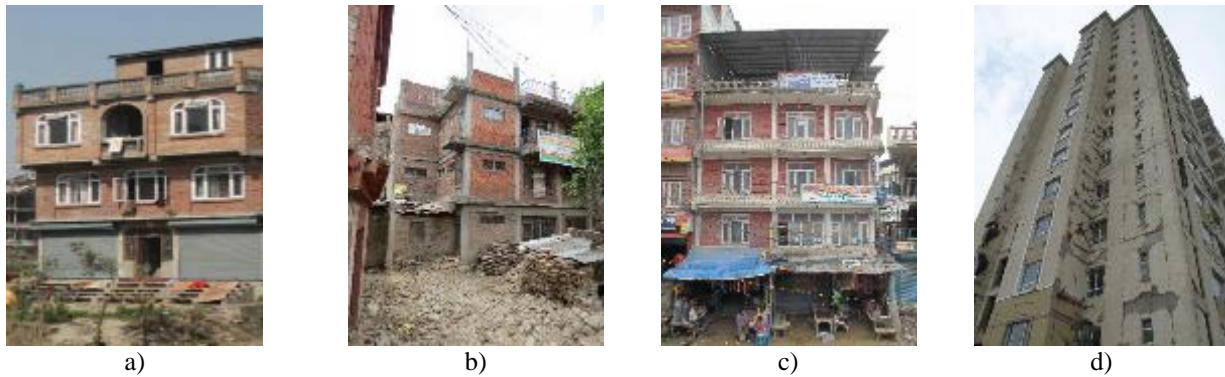
Fig. 3 – Typologies of RC buildings: a) Non-engineered residential with 2-3 storeys, b) Pre-designed residential with 2-3 storeys, c) Pre-designed residential with stores at the ground level with 4-6 floors, and d) Well-designed tall structures.

Regarding the observed typologies, most RC buildings have residential occupancy with 3-4 floors (Fig. 3a-b), or 4-6 floors (Fig. 3c) with stores in the ground floor. A few examples of larger structures with 10-18 floors (Fig. 3d) are located in isolated areas. Other RC structures are found serving social purposes with higher investment and quality, such as schools and hospitals.

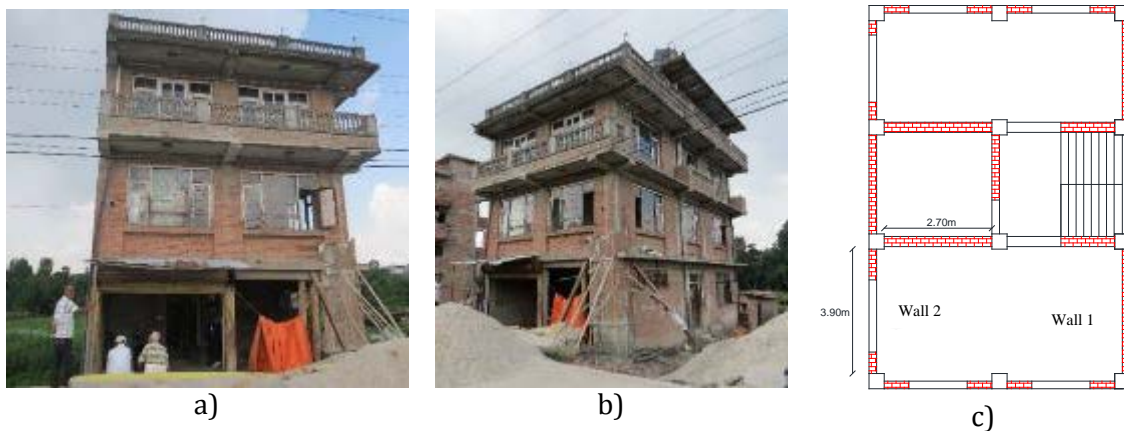
The building A under study is a non-engineered three storey damaged building, located in Bhaktapur. A general view of the building is illustrated in Fig. 8a and b, composed two longitudinal bays and three transversal bays, according to the building's plan as illustrated in Fig. 8c. The first and second natural period of the structure are 0.27s (transversal direction) and 0.38s (longitudinal direction) respectively. Two IM walls were selected, all in the 3rd floor of the building. They were selected according to different characteristics, namely: a large wall (Wall 1) and another with the same dimensions as the Wall 1 but with a central window (Wall 2), with locations illustrated in Fig. 8c.

Fig. 8 –General view of the building A under study a) Front view, b) Lateral view and c) Building plant and localization of the IM walls under study.

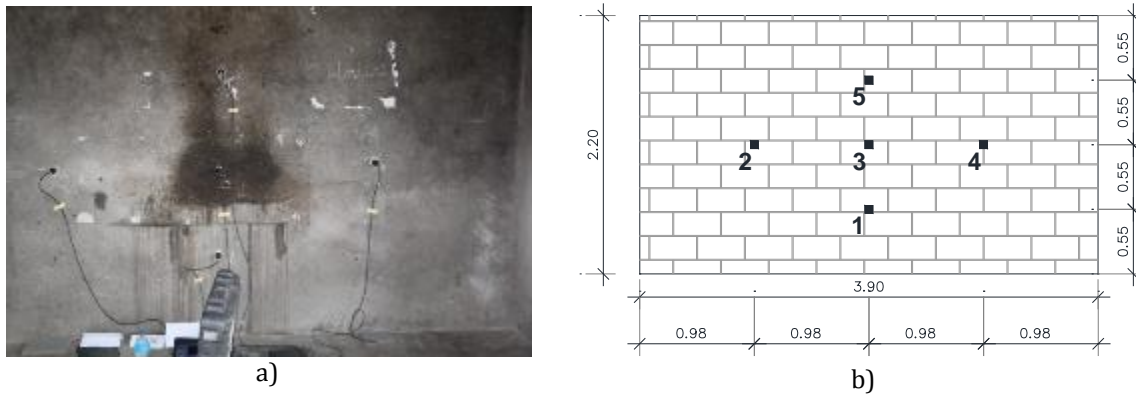
For the ambient vibration test it was used 5 accelerometers measuring the out-of-plane accelerations of the wall 1, and only one experiment test setup was adopted (Fig. 9a). The scheme is illustrated in Fig. 9b.

Fig. 9 – Wall 1 a) Geometric dimensions and b) Test setup.

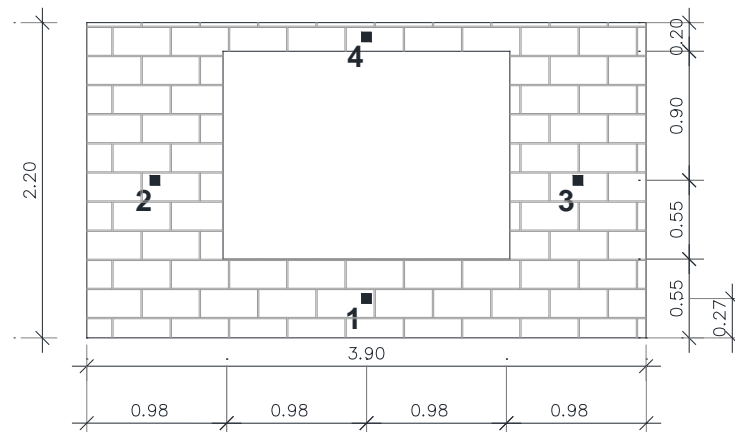
Wall 2 has the same geometric dimensions of the Wall 1, with a central window with the dimensions 2x1.45m in the centre of the wall as it can be observed in Fig. 11. Only 4 accelerometers were used for the ambient vibration test.

Fig. 11 – Geometric dimensions and test setup of the Wall 2.
