Access Viaducts to the Drawbridge of Leixões Harbour - Diagnosis of Concrete Deteriorations

ABSTRACT

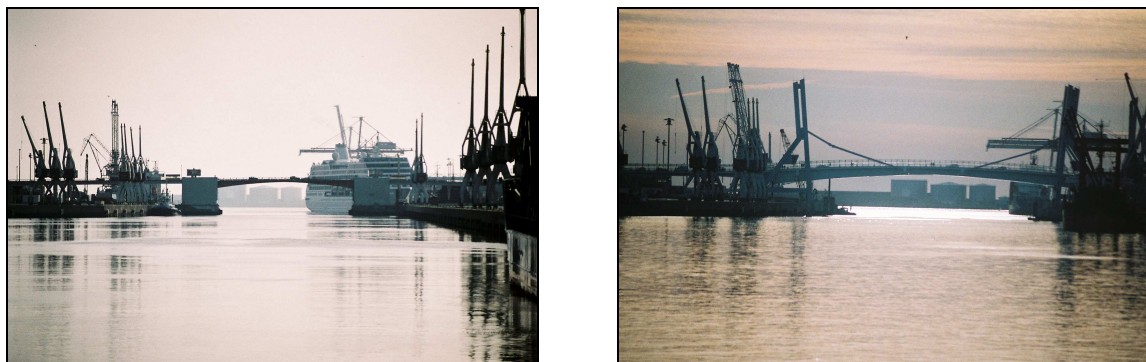
Figure 2. Access viaducts and drawbridge before and after the repair work in 2006.

The viaducts, built between 1957 and 1960, were repaired between 1991 and 1993. The repair work in the concrete consisted of a reconstruction of the concrete in the support zone, filling cracks in the beams and the application of grout repair and painting of beams, wall-columns and abutments. As the drawbridge was inadequate for both the road and the harbour traffic, it was replaced and some of the spans of the viaducts were demolished and all the concrete was repaired between 2006 and 2008 ('Fig.2').
