Review

A Review of the Performance of Infilled RC Structures in Recent Earthquakes

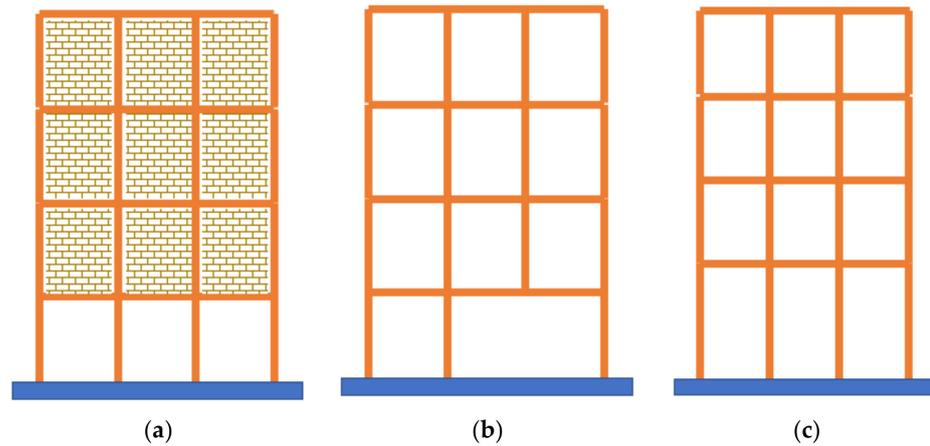
A very common structural irregularity is observed at the buildings bottom storey. The architects usually remove the infill panels for using these spaces for retail stores, garages or only due to architectural reasons. This type of construction practice often results in the deformation of these empty storeys under seismic action, triggering the soft-storey mechanism (Figure 11). Typically, this failure mechanism is characterised by the shear or bending failure of the columns and consequent collapse of the storey. In many situations, the destruction of the soft-storeys was observed while the remaining ones were intact (or just with very slight damage).

Figure 11. Structural configurations vulnerable to trigger out soft-storey mechanisms: (a) stiffness difference between storeys; (b) columns discontinuity; (c) height variations among the storeys.

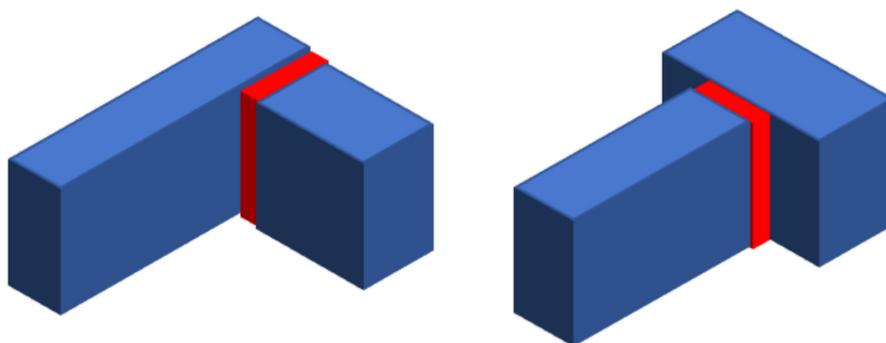
Another typical damage observed in the urban area is the absence of proper and designed gaps between building structures. This lack of space between adjacent buildings increases the probability to develop interactions between them during an earthquake event, commonly designated as pounding effect.

Figure 15. Examples of seismic joints to avoid pounding between the units.

Concerning the new constructions, a simple strategy that can prevent the pounding effect consists of subdividing the entire building with seismic joints (dynamically independent units) seismically designed to prevent the pounding between the units, as shown in Figure 15.

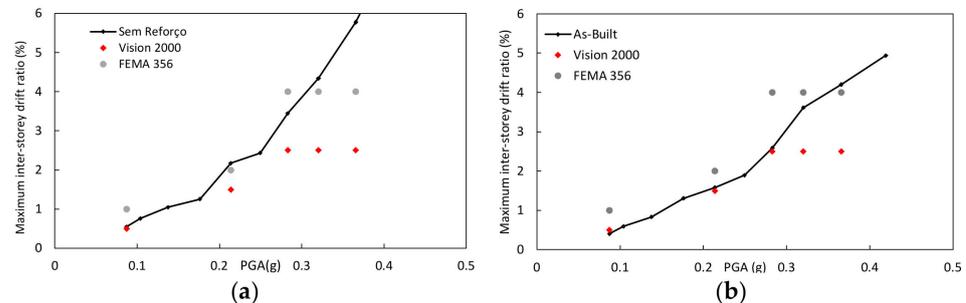
The maximum inter-storey drift ratio obtained in the non-linear dynamic analysis results is plotted in Figure 28. It can be noticed that the maximum inter-storey drift reached by the building exceeds the drift limits recommended by VISION 2000 [49] and by FEMA-356 [50]. The maximum inter-storey drifts were always reached at the first level of the structure due to the absence of the masonry infill walls. Concerning the longitudinal direction (Figure 28a), the drifts are always more significant than the limits imposed by

VISION 2000 [49], namely about +10% at 0.08 g, +45% at 0.21 g, +37% at 0.28 g, +74% at 0.32 g and +131% at 0.37 g. Moreover, the structure exceeds the FEMA-356 [50] drift limits for a PGA equal to 0.21 g (+9%), 0.32 g (+8%) and 0.36 g (+44%).

Figure 28. Non-linear dynamic analysis results: Maximum inter-storey drift ratio (a) longitudinal direction and (b) transverse direction.

Concerning the transverse direction, the drift limits reached during the analyses were slightly lower than those achieved in the longitudinal direction (22–39%), except for the PGA of 0.18 g where they get a similar inter-storey drift ratio of 1.26%. The FEMA-356 [50] drift limits were not respected since, for the PGA of 0.37 g, the structure exceeded the limit by about 5%.

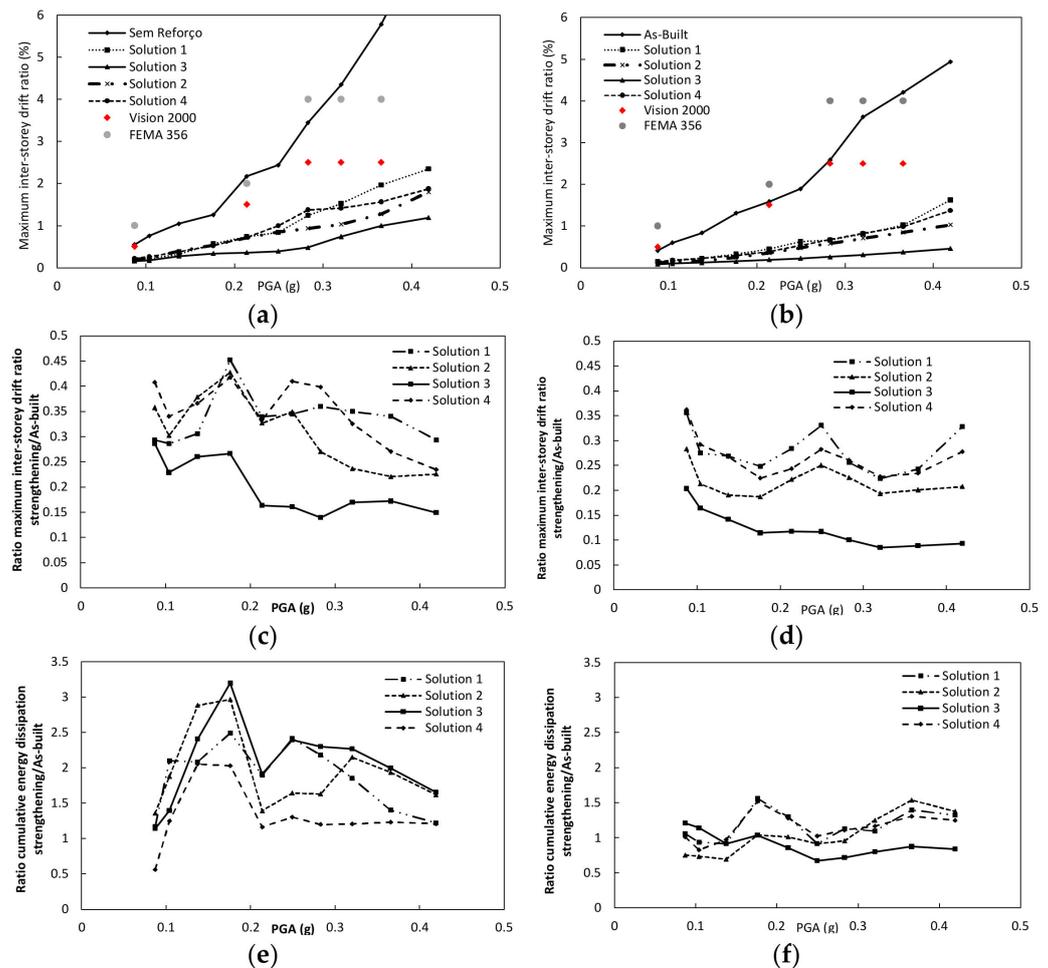
strengthening model and the as-built model and the cumulative energy dissipation reached by the strengthening model and the as-built one. Starting from the analysis of the maximum inter-storey drift ratio (Figure 30a,b), all the strengthening solutions were quite efficient to reduce the maximum drifts below the drift limits. The most efficient one on reducing the maximum drift was solution 3 in both building directions and the lowest efficient was solution 1 in the transverse direction. In the longitudinal direction, solution 2 was the most efficient until 0.27 g, and for PGA larger than 0.27 g it was solution 3.

Figure 30. Analysis of the efficiency of the strengthening solutions: (a) maximum inter-storey drift ratio (longitudinal direction); (b) maximum inter-storey drift ratio (transverse direction); (c) ratio between the maximum inter-storey drift (strengthening/as-built) in the longitudinal direction and (d) transverse direction; (e) ratio between the cumulative energy dissipation (strengthening/as-built) in the longitudinal direction and (f) transverse direction.

The ratio between the maximum drift reached by the strengthening models and the as-built one is presented in Figure 30c,d. From that, it can be noticed that the strengthening solutions had a higher impact on the transverse direction since the ratio varied between 0.1–0.35. In the longitudinal direction, the ratio ranged between 0.15 and 0.45. Finally, it is important to draw a final analysis of the strengthening efficiency in terms of cumulative energy dissipation (Figure 30e,f). It is possible to verify that the strengthening provided higher energy-dissipation capacity in the longitudinal direction, increasing between 1.1 and 3.5 times. The strengthening solution that provided more energy dissipation was the strengthening solution 2 until 0.14 g and strengthening solution 3 for PGA larger than 0.14 g. The strengthening solution 4 was the one that dissipated lower energy.
