Survey of churches damaged by the May 2012 Emilia-Romagna earthquake sequence

This report presents an overview of the damage that was observed in fourteen churches that were hit by the May 2012 Emilia-Romagna earthquake sequence. The data was collected over the course of a two-day reconnaissance mission that took place on the 9th and 10th of July 2012, and that involved researchers from the Civil engineering Department of the Faculty of Engineering of the University of Porto and of the University of Aveiro, both institutions from Portugal.

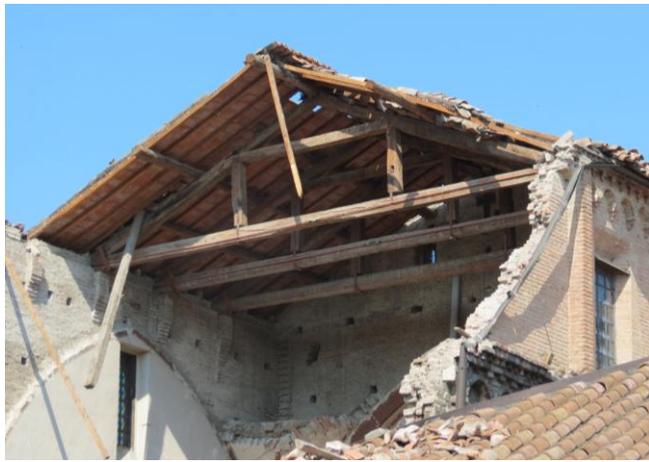
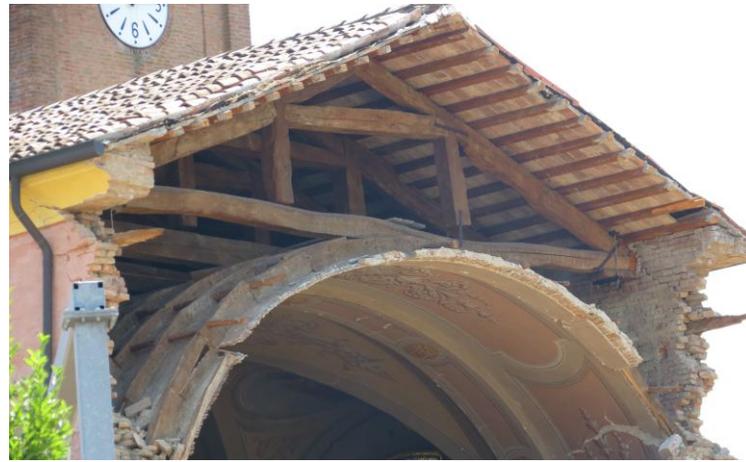
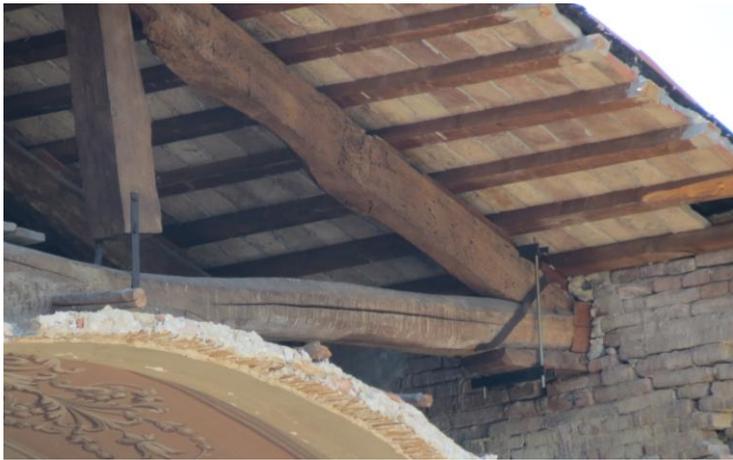
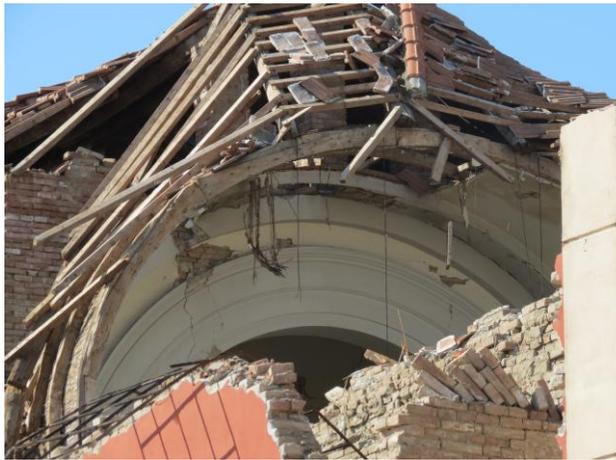
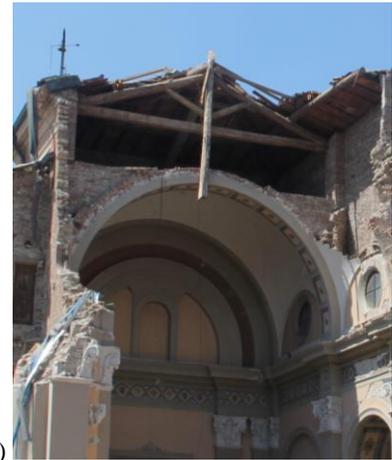
Fig. 10 – Examples of roof structures made of timber trusses in churches I9 (a), I10 (b) and (c), I3 (d), and I1 (e).

The roof structure of the churches was generally seen to consist of timber trusses (Fig. 10). Timber battens run transversal to the trusses over which there is a roof sheeting made of masonry elements, either hollow, Fig. 11a), or solid, Fig 11b). The roof tiles are then fixed to this masonry sheeting by mortar, Fig. 11b).

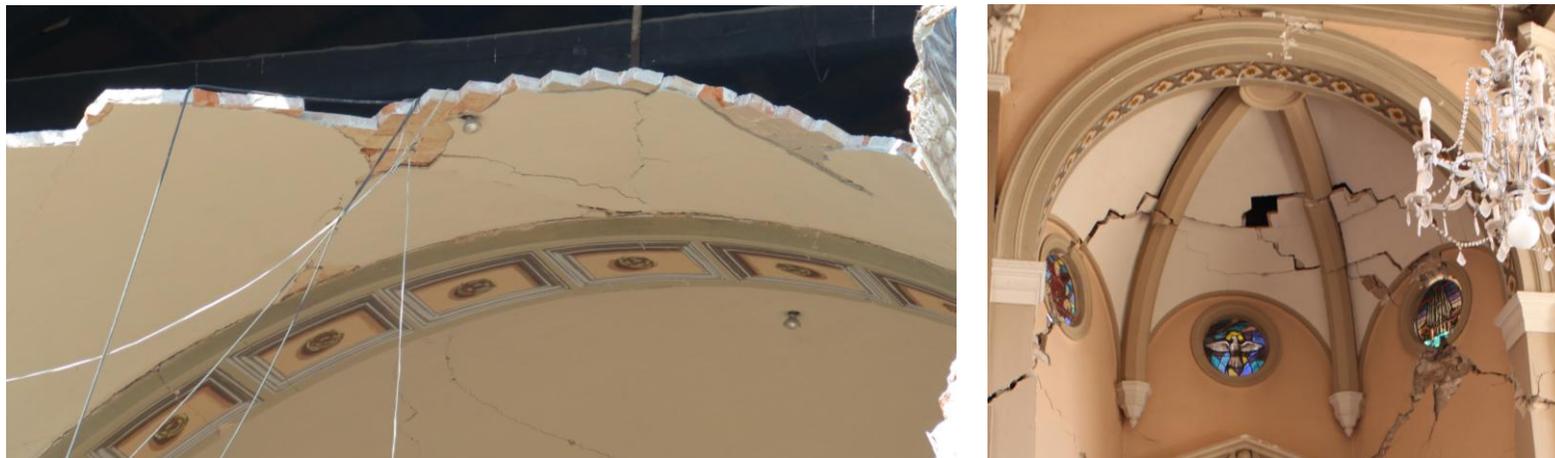
Fig. 12 – Examples of vault structures made of brick masonry laid flatwise in church I1.

Three types of vaults were observed in the churches: vaults made of brick masonry laid flatwise (Fig. 12), reed mat false vaults hanging from the roof timber trusses (Fig. 13), and vaults made of timber elements imbedded in mortar/plaster (Fig. 14).

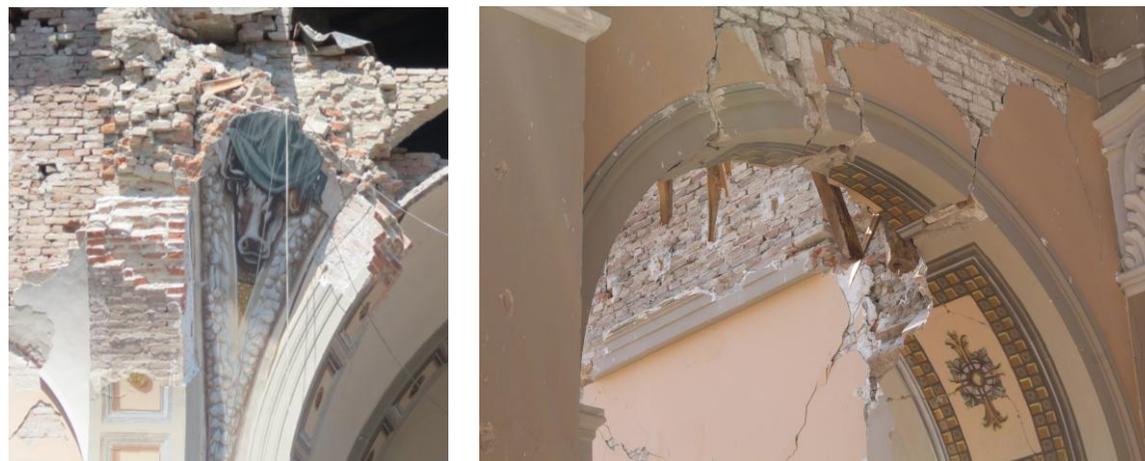
Fig. 15 – Examples of arches made of vertically stacked brick masonry in church I1.

With respect to the arches, those that were able to be observed were made of vertically stacked brick masonry (Fig. 15). The interior columns that were surveyed were also seen to be made of brick masonry (Fig. 16).

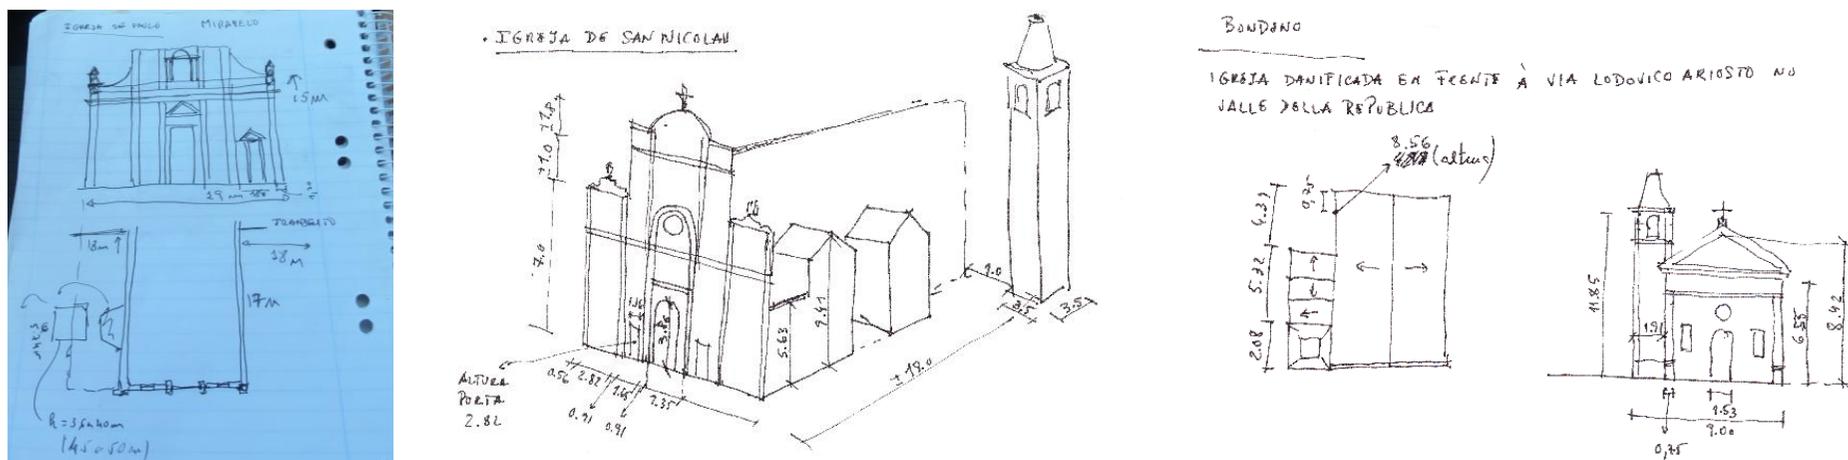
Whenever possible, general dimensions of the churches and towers were measured (Fig. 18). However, since the surveys were performed from safe positions, such dimensions should be considered to be approximate. Additional measures and data were also obtained from Decanini *et al.* (2012), Ioannou *et al.* (2012) and Rossetto *et al.* (2012).

Fig. 18 – Examples of general dimension surveys carried out for the churches and towers.
