**Damage suffered by  
Hanuman Dhoka after the  
2015 Nepal Earthquakes**

26 May 2015

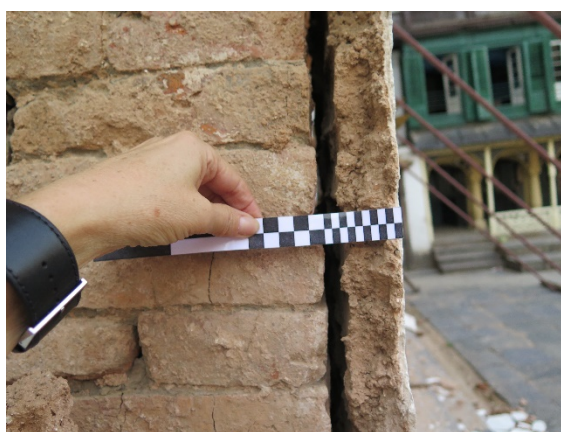
The assessment was essentially based on engineering judgment and visual/qualitative assessment of the damage to the exterior walls. From this analysis, it was seen that the mortar layer that covers the walls has a large thickness, 4 to 4.5 cm, and that many of the visible cracks on the walls do not reflect structural damage. Instead, these cracks only reflect damage to the exterior mortar layer which is also detached from the actual wall structure in many places. It was also seen in many parts of the walls that the cracks in the mortar layer do not extend to the bricks of the wall structure. Figures 1 to 3 show different examples of the cracks in the exterior walls of Hanuman Dhoka that were analysed, while Figs. 4 to 8 show cases where the mortar layer cracks do not extend to the bricks of the wall structure.

Figure 2 – Mortar layer of the walls with 4 cm thickness currently detached 1 cm from its support

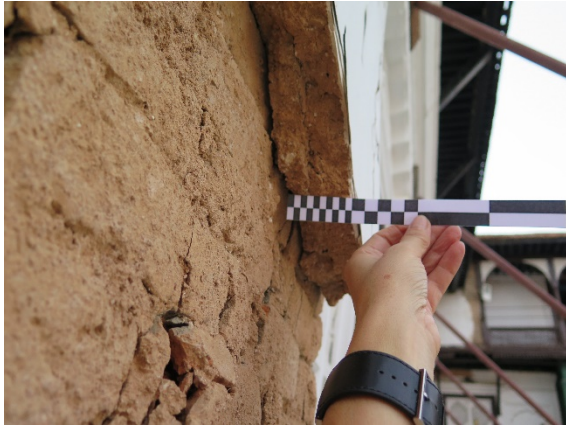
Figure 3 – Mortar layer of the walls with 5 cm thickness

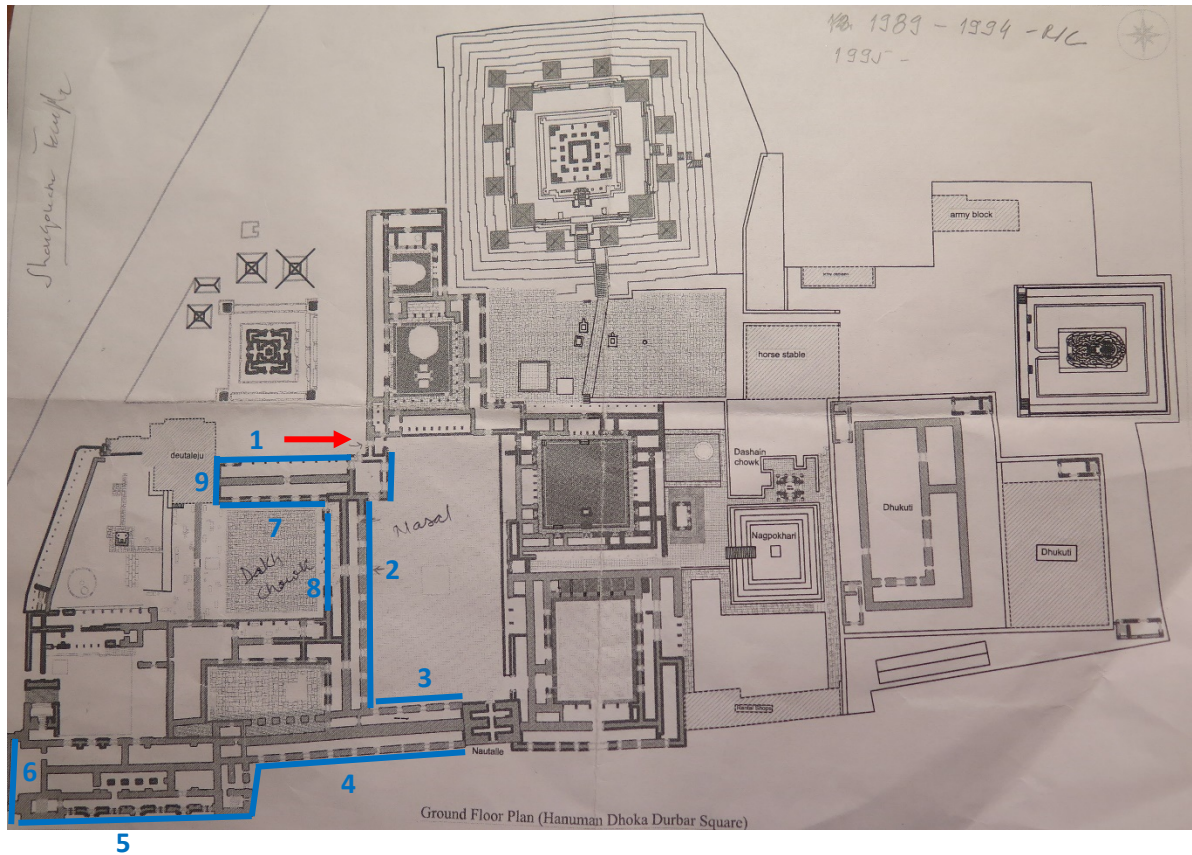
A general photographic overview of the damages suffered by the Hanuman Dhoka building is presented in the following in order to provide a global picture of the impact of the earthquakes. The information is presented using the general plan of the building shown in Fig. 9 which identifies the façades where damages were analysed. For reference, those façades are numbered 1 to 9 in the following.

Figure 9 – General plan of the Kathmandu Royal Palace Museum (Hanuman Dhoka) with a schematic indication of exterior façades where damages were analysed and the entry location to the Hanuman Dhoka site

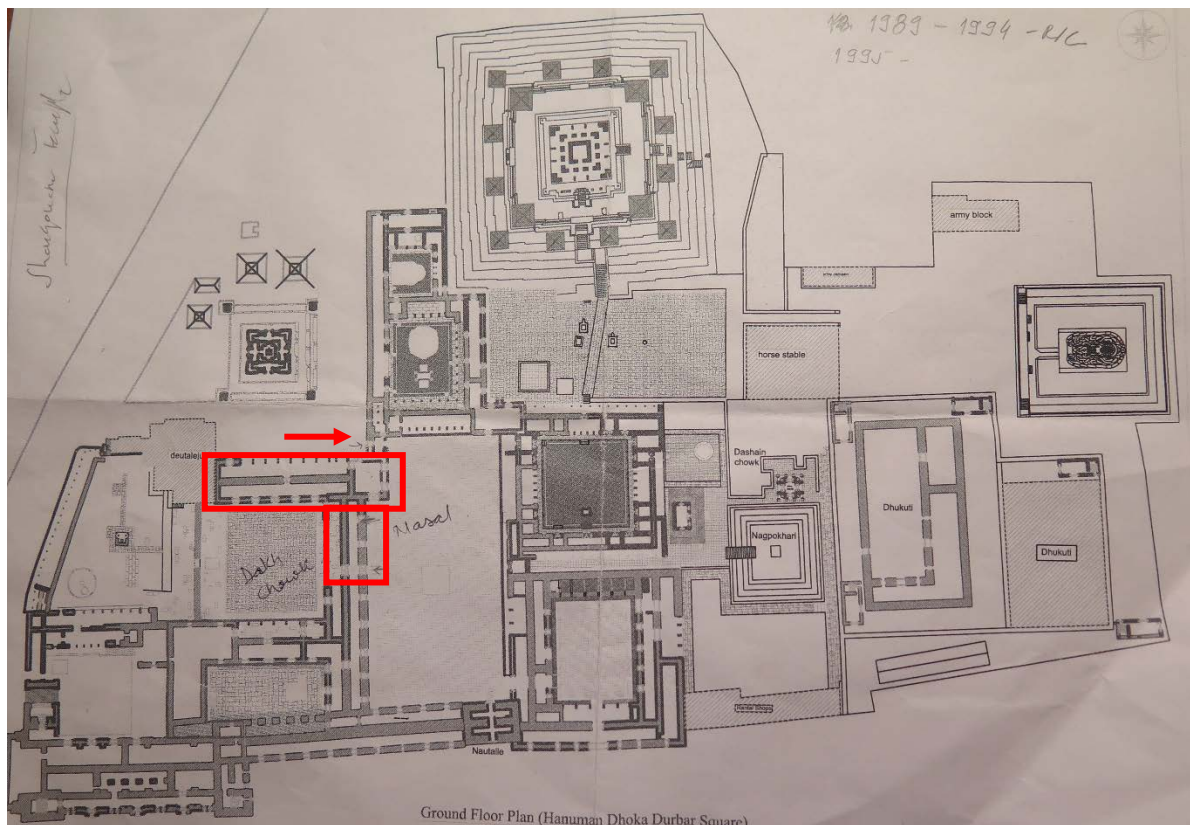
The interior areas of Hanuman Dhoka museum that were visited are those highlighted in Fig. 29 corresponding to the ground, 1<sup>st</sup> and 2<sup>nd</sup> floors. Fig. 29 also shows an arrow indicating the entry point to the Hanuman Dhoka site. Figures 30 to 32 detail the interior areas of the ground, 1<sup>st</sup> and 2<sup>nd</sup> floors, respectively, that were visited. Additional areas of those floors were not visited due to safety reasons.

Figure 29 – General plan of the Kathmandu Royal Palace Museum (Hanuman Dhoka) with a schematic indication of interior areas that were visited and the entry location to the Hanuman Dhoka site

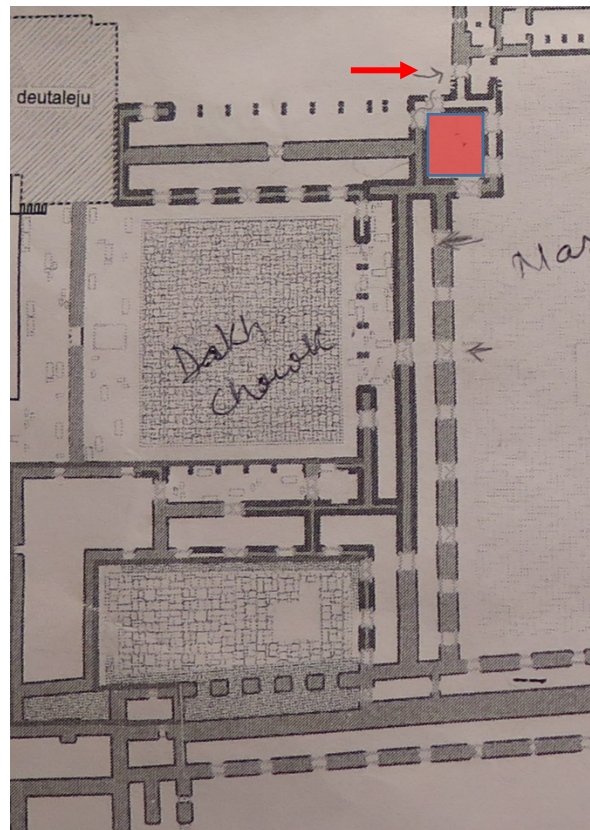
The area that was visited in the ground floor is only that of the entry hall (Fig. 33) and no particular movable heritage was observed in that area. In terms of the damage, some cracks with variable sizes were seen (Figs. 34 to 37). Based on visual assessment, the walls appear to be stable. The staircase did not appear to be unstable under the weight of people.

Figure 33 – Ground floor plan highlighting the visited interior areas

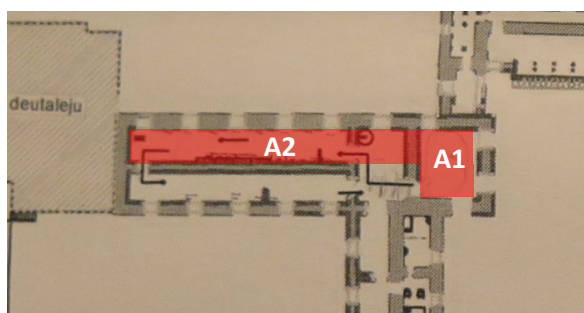
Figure 40 – 1<sup>st</sup> floor plan of areas A1 and A2

Area A1 corresponds to a small exhibition room (Figs. 40 and 41) which includes some movable heritage items which appeared to be undamaged. From the safety point of view, it is referred that the floor did not appear to have unsafe deformations when people walked on top of it. Furthermore, the walls and ceiling exhibited a few cracks but it was not possible to determine if they were structural or non-structural cracks.

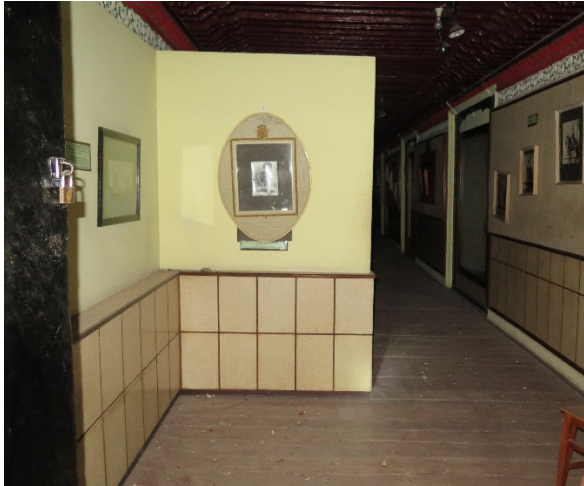
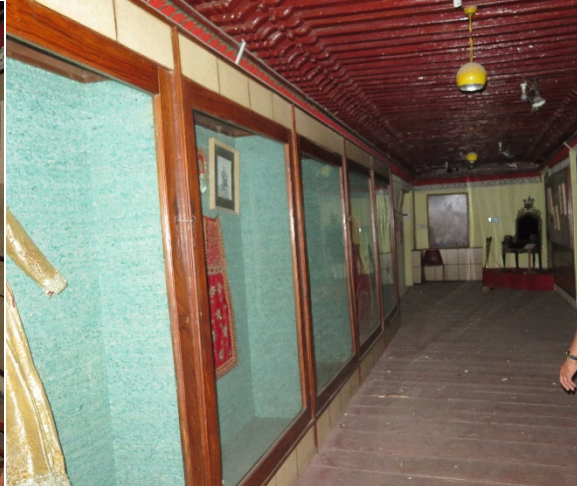
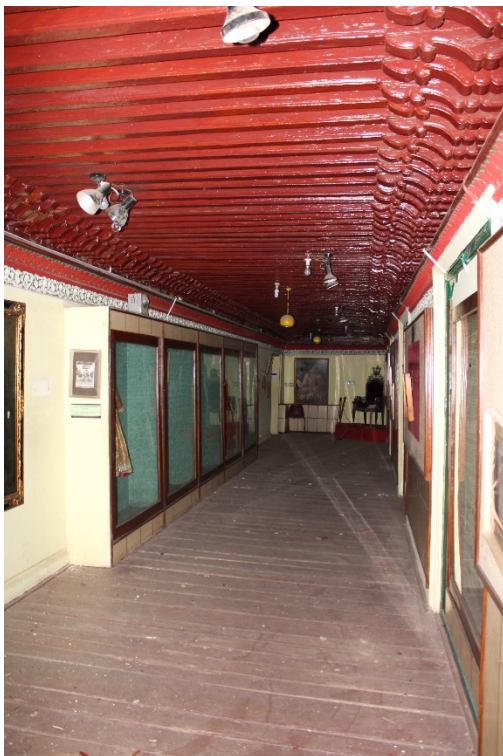
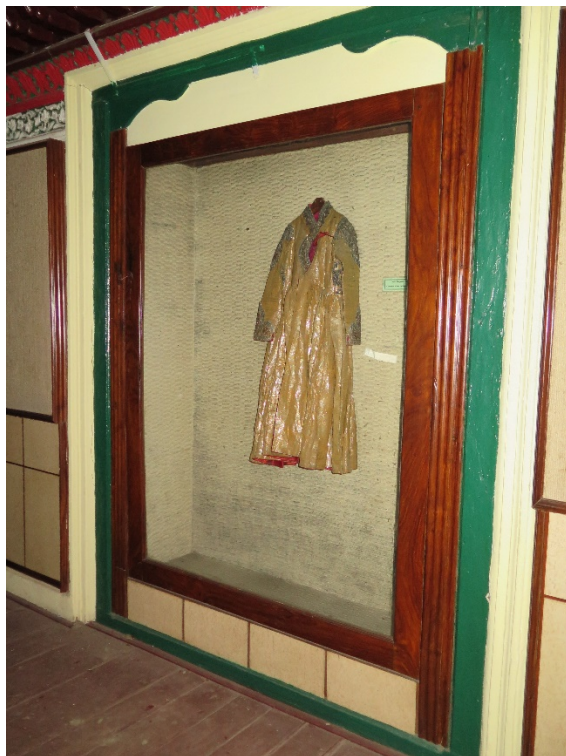
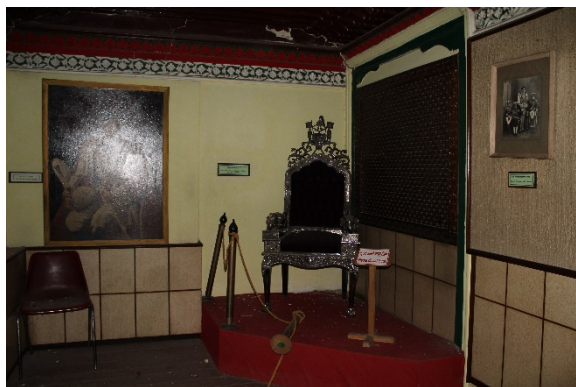
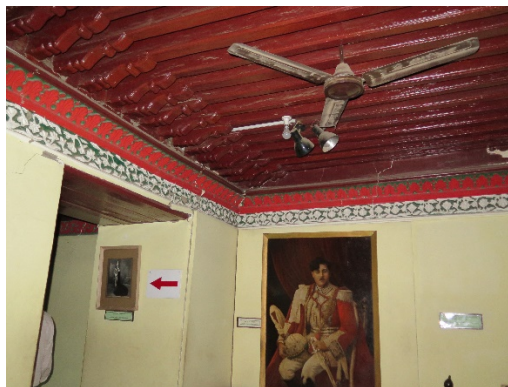
standing on their places and appeared to be undamaged. Display cabinets having glass windows were intact. From the safety point of view, it is referred that the floor did not appear to have unsafe deformations when people walked on top of it. Furthermore, the walls and ceiling exhibited a few cracks but it was not possible to determine if they were structural or non-structural cracks. In order to illustrate these findings, Figs. 42 and 47 present several photos of area A2 taken during the visit.

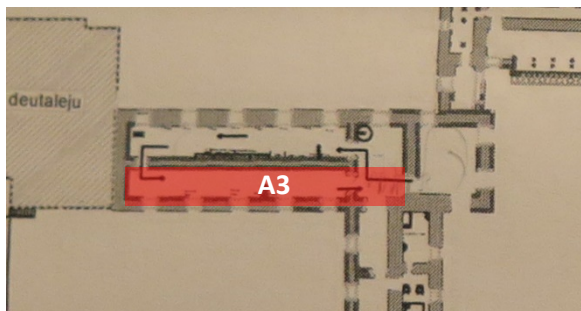
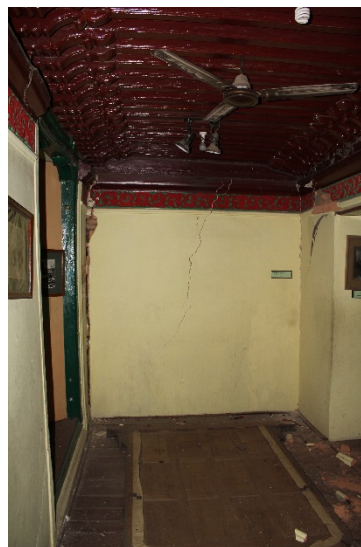
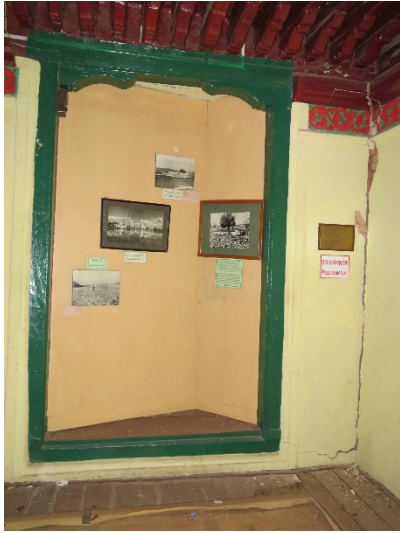
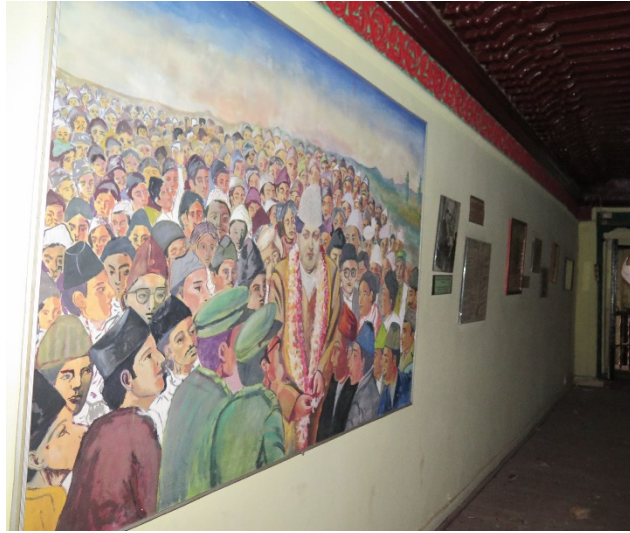
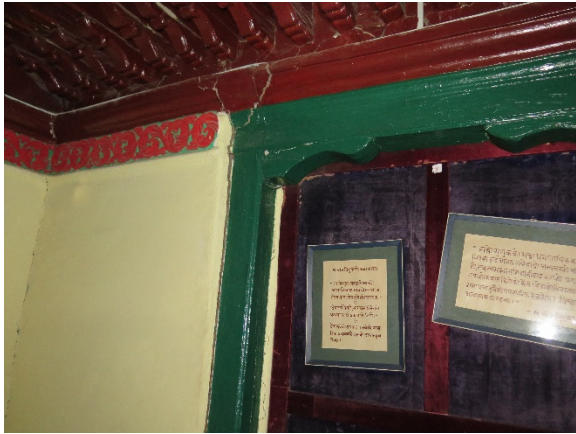
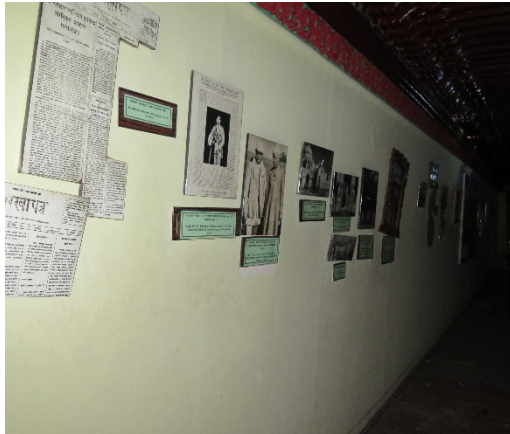
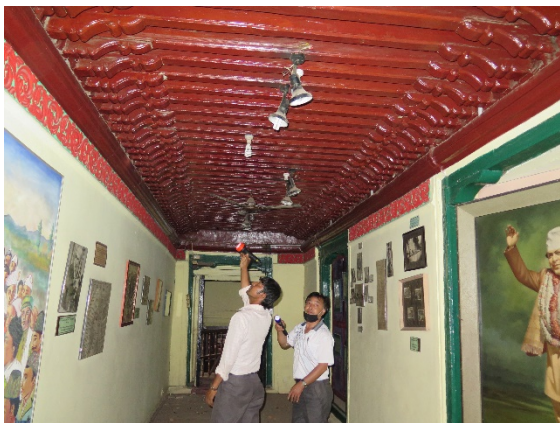
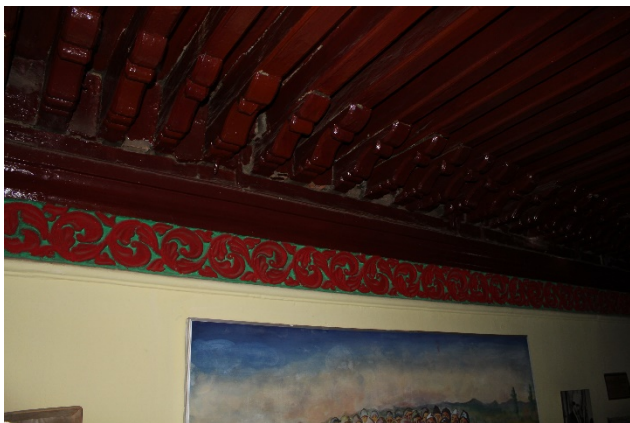
Area A3 corresponds to the south side of the exhibition wing on the west part of the floor (Fig. 48) which also includes several movable heritage items on display. As for area A2, most of the objects were seen to be standing on their places and appeared to be undamaged except for one painting that was seen to be on the floor in the area where A2 connects to A3. Display cabinets having glass windows were also seen to be intact. From the safety point of view, it is referred that the floor did not appear to have unsafe deformations when people walked on top of it. Furthermore, the walls and ceiling exhibited a few cracks but it was not possible to determine if they were structural or non-structural cracks. In order to illustrate these findings, Figs. 49 and 55 present several photos of area A3 taken during the visit.

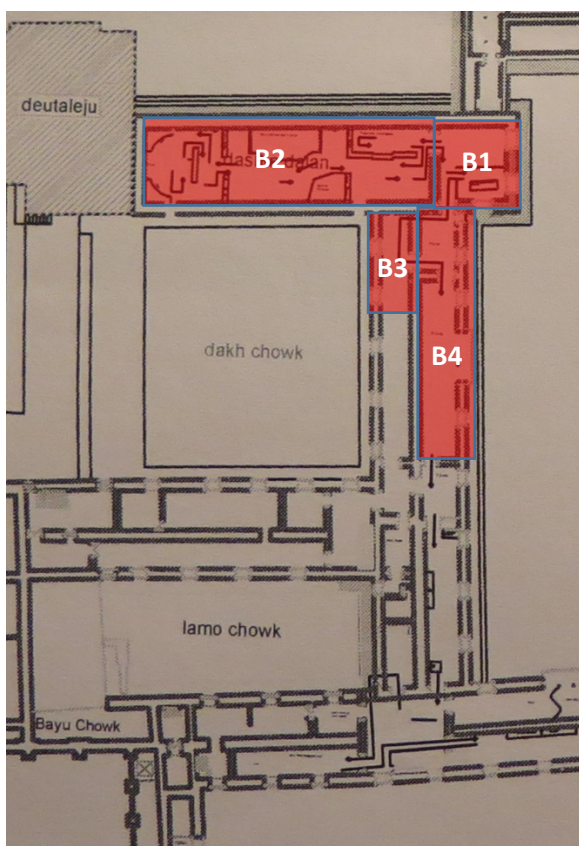
Figure 60 – 2<sup>nd</sup> floor plan of the visited areas divided into areas B1, B2, B3 and B4

Area B2 corresponds to a large exhibition room on the west part of the floor (Fig. 60 ) which includes several movable heritage items on display. Due to the size of the room and to the fact that part of the walls and ceiling exhibited important cracks which appeared to be structural, only part of the room was visited for safety reasons. On the part that was visited, most of the objects were seen to be standing on their places and appeared to be undamaged. Display cabinets having glass windows were intact. From the safety point of view, it is also referred that the floor did not appear to have unsafe deformations when people walked on top of it. In order to illustrate these findings, Figs. 64 to 75 present several photos of area B2 taken during the visit.

Area B4 corresponds to a long exhibition wing room on the east part of the floor (Fig. 60 ) which includes several movable heritage items on display. Due to the size of the wing and to the fact that part of the walls and ceiling in the southern part exhibited important cracks which appeared to be structural, only part of the wing was visited for safety reasons. On the part that was visited, most of the objects were seen to be standing on their places and appeared to be undamaged. Display cabinets having glass windows were intact. From the safety point of view, it is also referred that the floor did not appear to have unsafe deformations when people walked on top of it, although it exhibited a visible deformation. In order to illustrate these findings, Figs. 80 to 85 present several photos of area B4 taken during the visit.

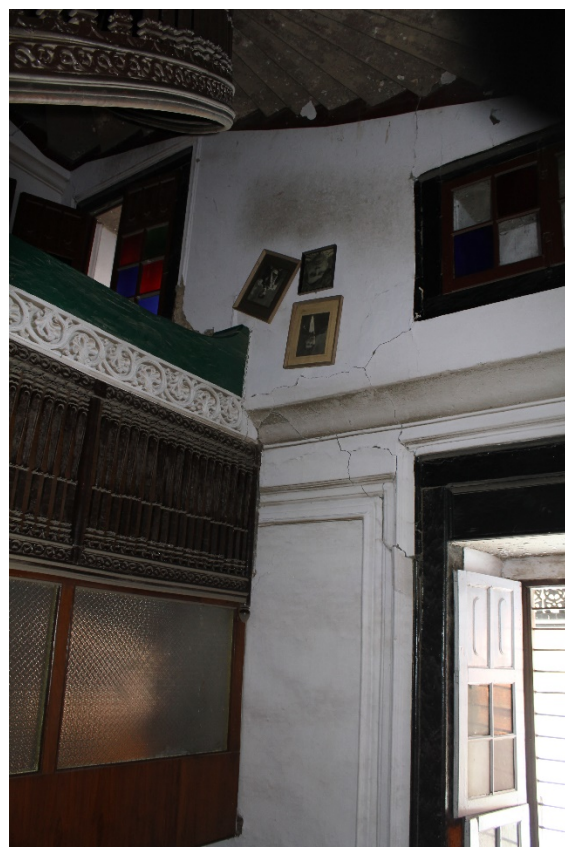
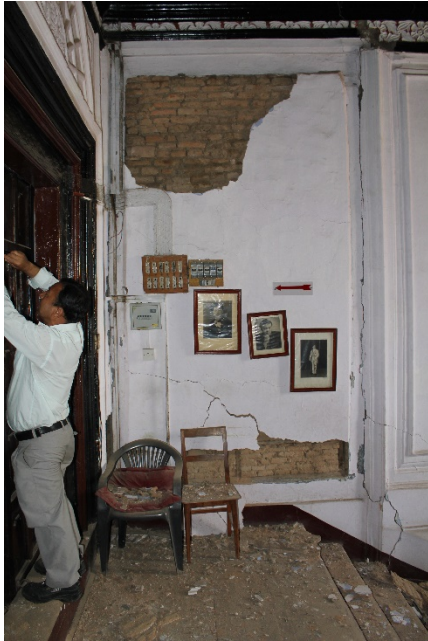
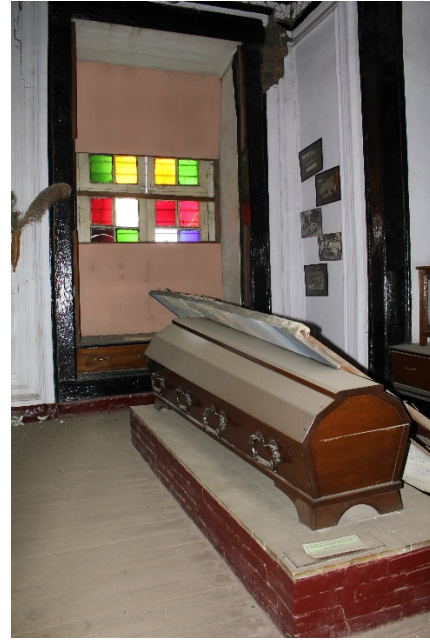
Area B1 corresponds to a lobby area (Figs. 61 and 62) and also includes a small exhibition room (Fig. 63). From the safety point of view, it is referred that the floor did not appear to have unsafe deformations when people walked on top of it. Furthermore, the walls and ceiling exhibited a few cracks but it was not possible to determine if they were structural or non-structural cracks.

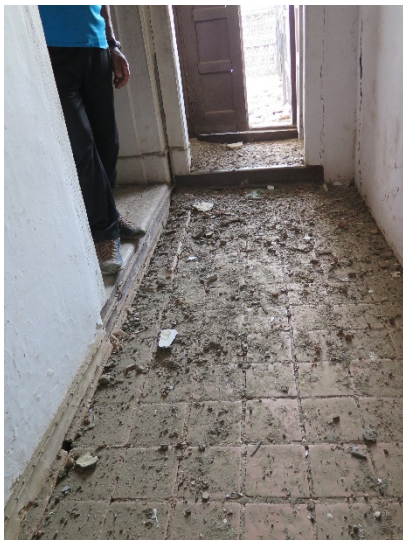
Figure 76 – 2<sup>nd</sup> floor plan from B1 area to B3 area

On the way to area B3, the corridor connecting areas B1 and B3 was seen to exhibit cracks on the floor, near the walls (Figs. 76 and 77). Area B3 corresponds to a lobby area giving access to an office and to staircase to the 3<sup>rd</sup> floor. From the safety point of view, the area close to the staircase (Figs.

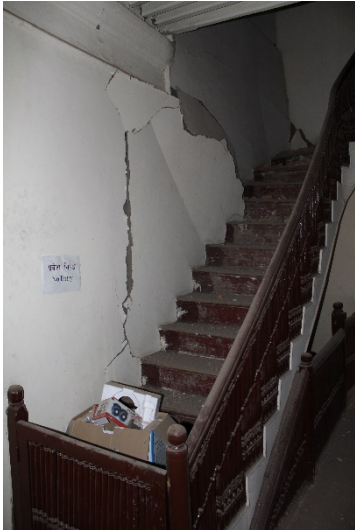
Figure 78 – 2<sup>nd</sup> floor plan B3 area

78 and 79) exhibited important cracks in the wall. Still, the floor did not appear to have unsafe deformations when people walked on top of it and the ceiling exhibited a few cracks whose severity was not possible to determine.
