Delamination analysis after carbon/epoxy plate drilling

SUMMARY

Drilling of carbon fibre reinforced plates – CFRP – causes typical damages such as delamination and others. These damages, that cannot be visually detected, can cause the premature collapse of structures. Damage assessment is usually carried out using non-destructive inspections like radiography and ultrasonic C-scan.

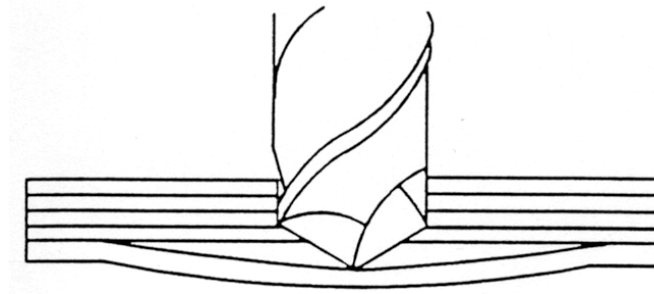
As composites are non-homogeneous and anisotropic, drilling raises specific problems that can affect parts strength and fatigue life [1, 2, 3]. Typical damages after drilling are push-out delamination, intralaminar cracking, fibre/matrix debonding and thermal damage. Due to their abrasiveness, composites drilling cause high tool wear, leading to the need of frequent tool changes that affect the production cycle. From all these problems, delamination is the most serious as it reduces severely the load carrying capacity of laminated composite structures and must be avoided. Delamination is a defect that occurs in interlaminar regions, that is to say, in the contact plan between adjacent layers. Delamination mechanisms are classified in push-out and peel-up, according to the laminate region where they occur, exit or entry side, respectively. Push-out delamination (figure 1) is a consequence of the compressive thrust force that the drill always exerts on the workpiece. The laminate under the drill tends to be drawn away from the upper plies, breaking the interlaminar bond in the region around the hole. When the loading exceeds the interlaminar bond strength delamination occurs, before the laminate is totally penetrated by the drill.

Figure 1 – Push-out delamination at exit.

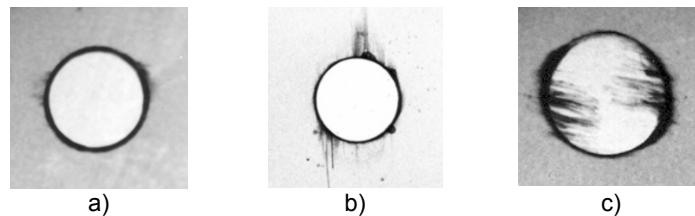
Developed films were used for the measurement of delaminations around the hole. Figure 2 shows some radiographies from holes made with twist, c-shape and dagger drills.

Figure 2 – Radiographies of drilled parts: a) twist drill; b) c-shape drill; c) Dagger drill.

The results of the damage criteria referred, equations (1) and (2), can be seen in figure 5. For every criteria the best result, that is to say, with less delamination around the hole was obtained with c-shape drill. This effect shows that the drill geometry has an influence on the delamination value. The peculiar geometry of c-shape drill, pre-tensioning the fibre prior to cut, has enabled the achievement of delamination values around 1.1, for every criteria used. The delamination results of dagger drill were better when considering the damage ratio than when considering the delamination factor. That can be the result of the existence of a main direction for delamination when drilling with dagger drill, but with less extent when the damaged area is to be considered. In fact, for twist and c-shape drills, the damage was more regularly distributed around the hole (figure 2).

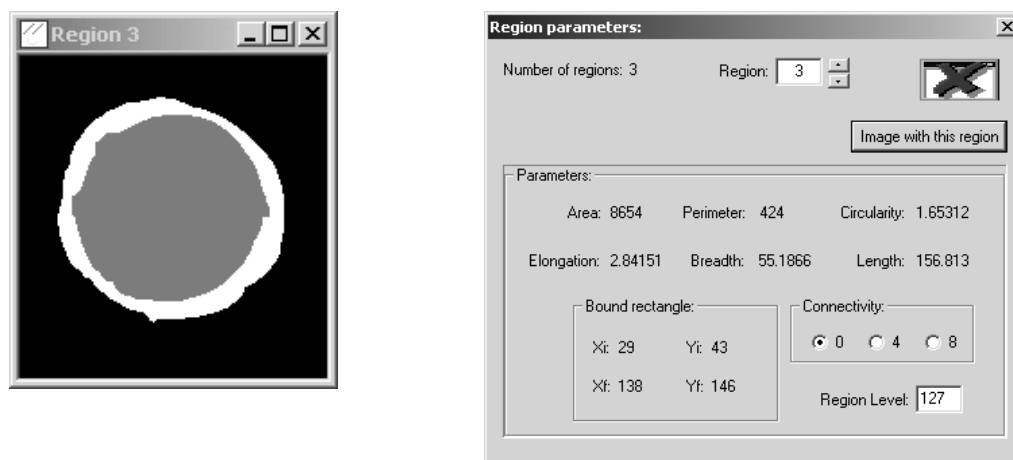
According to the kind of image considered, different processing and analysis sequences need to be established. For radiographic images, the first step was the selection of the interest zone. This step was manually executed and has just the objective of reducing computational time involved in the following steps. The second step was the pre-processing of the sub image by a smoothing filter to reduce sudden changes of intensity thus reducing existing noise. Next step on the smoothed image was the segmentation of the interest areas. In many cases, this step results in a large number of segmented areas, so it is needed to eliminate those who were not relevant. Noise areas were eliminated by the application of erosion and dilation morphologic filters. After this processing step, each image is mainly the concern damaged area plus its background. In the final step, a region processing and analysis algorithm is applied to differentiate the several regions in each image, and for each region a certain number of measurements is presented. In figure 3 an example of area identification and measurement results for a radiographic image is shown.

Figure 3 – Example of area identification and measurement results in an image obtained by radiography using Computational Vision techniques.

Images obtained by radiography were processed using appropriate Computational Vision techniques to give information that allows the determination of delamination factor and damage ratio. Departing from the shape of a radiographic image, that is nearly circular, and using the processing steps described before, it is possible to have a number of results including drilled area (dark grey in figure 3), damaged area (light grey in figure 3) and maximum damaged diameter.

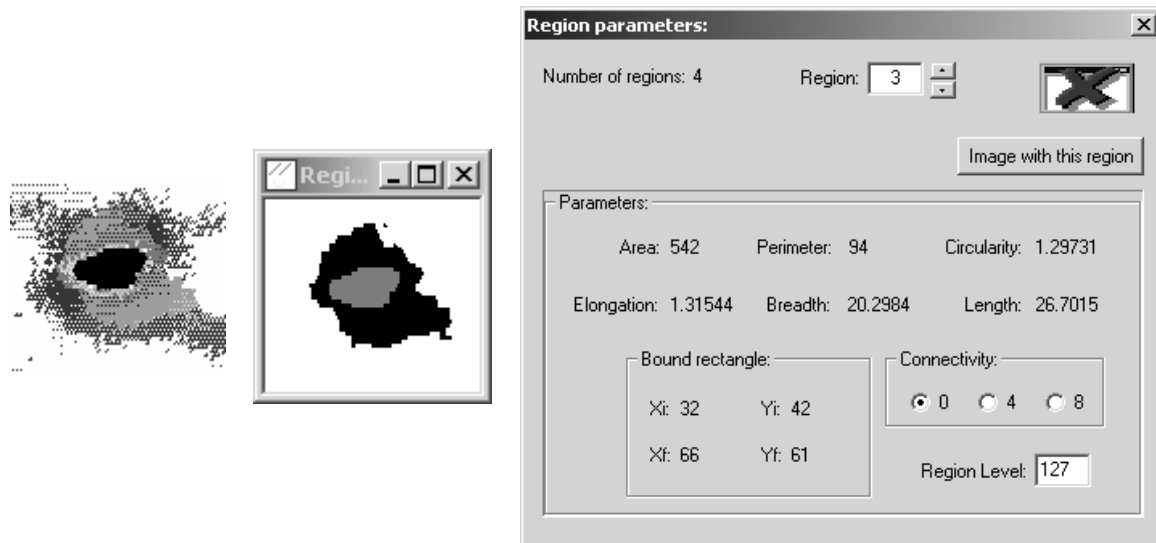
For C-Scan images the processing and analysis sequence was slightly different. The first step was, as before, the selection of the interest zone. Each colour image was then converted into grey levels. After this conversion was done, the pixels that were not included in the interest zones were removed. For this operation a segmentation operation was used by selecting an adequate threshold level of grey. So, pixels below that level are classified as noise and removed. After this operation was completed, the images were binarized and subjected to the application of morphological filters to get homogeneous regions. Final processing step is the same as for the radiography images, and consists in the application of the region processing and analysis algorithm to obtain the desired measurement. In figure 4 an example of interest zone, area identification and results is presented.

Figure 4 – Example of interest zone, area identification and measurement results in an image obtained by ultrasonic C-scan using Computational Vision techniques.

Images from ultrasonic inspections were only used for the determination of damage ratio using the processing and image analysis platform depicted. As can be seen in figure 4, the images obtained by C-scan are not circular. This can be a consequence of the beam diameter used, leading to the existence of noise regions.

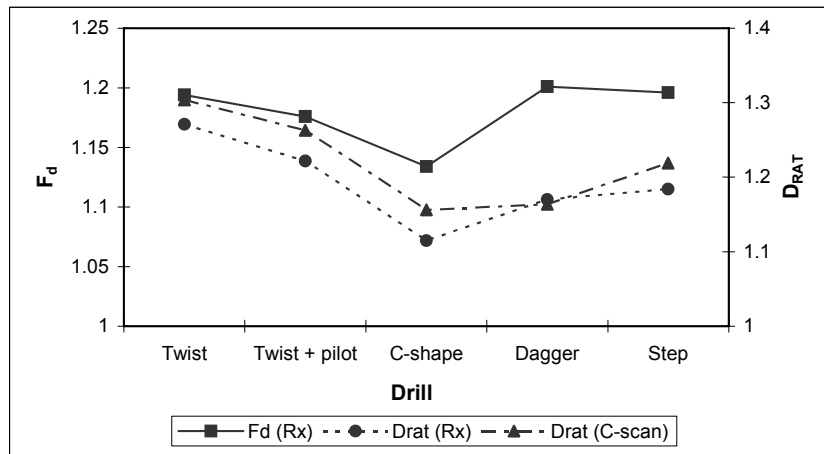
Figure 5 – Delamination factor (F_d) and damage ratio (D_{RAT}) results with radiography and C-scan images.

The use of a pilot hole has reduced the delamination in about 3%. For the step drill, the transition angle of 180° has caused the opposite effect, increasing delamination. The use of a step drill with a smoother transition angle (like 90°) could be helpful. Also, according to [9], a smaller pilot diameter than the one of the drill used – 3.4mm – would be preferable.
