Structures in Portugal: An Introduction

The initial idea was for a translucent building with a steel structure. Cost reasons and the loss of the transparency effect, which was the inevitable result of the structural elements' density, led to the choice of white concrete (Fig. 1). Although it clearly appealed to the architect, white concrete had not been proposed initially because it is not a common material in Northern European countries where it is difficult to find skilled labour to carry out top quality work in exposed concrete.

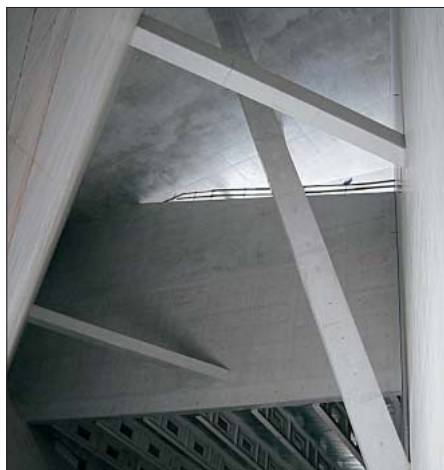
Fig. 2: Inclined column in South foyer

The external wall panels of the building act as a three dimensional shell with membrane forces and bending moments. The behaviour of each panel, as a plane stressed structure, contributes decisively to the overall stability of the building. The bending moments result from the action of their self weight and from the loads transmitted by the slabs which are supported on the shell. Sometimes these bending effects would be unacceptable if some auxiliary elements, called "interventions", had not been provided. The major "interventions" are the two large inclined columns which cross the South and North sides and give support to the roof panels (Fig. 2).

At a higher level spanning over the space between the exterior shell and the South longitudinal wall, is the small auditorium. Its main structural elements are two wall-beams 0,45 m thick and variable height. The small auditorium ceiling and floor layers are composite slabs supported on steel beams (Fig. 2).

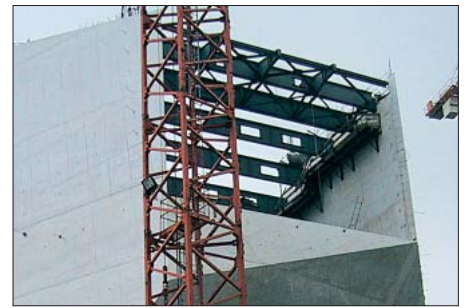
Fig. 3: East edge of main auditorium roof

ers or beams in a welded, variable cross section construction (Fig. 3). The stiffness of these edges is crucial in the situations where they support the large glass panels.

In the rest of the area, there is a composite steel-concrete slab, 0,20 m thick, supported by built-up welded steel beams with 1,9 m height and spaced 3 m apart. These beams have openings in their webs to allow the passage of the technical installation pipes (Fig. 3).

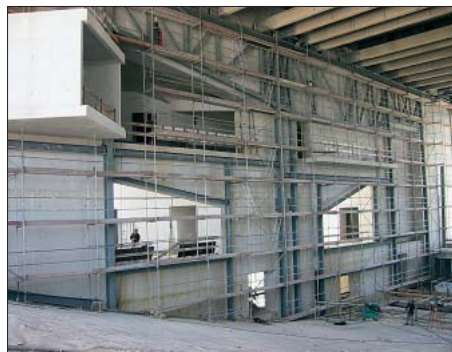
Fig. 5: “Inner box” under construction

The acoustic isolation of the main auditorium is assured by separating the auditorium structure from the rest of the building. This separation is referred to as being a “box in a box” (Fig. 5). In this separation the “inner box” floor, walls and ceiling only come into contact with the building’s structure through resilient supports.

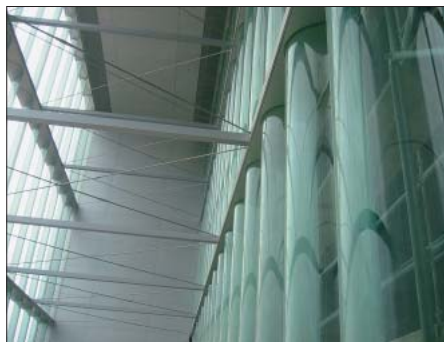
Fig. 6: Main auditorium West window

For acoustic reasons each of the main auditorium extreme windows is made of two glass walls 6,5 m apart. These windows are 23,2 m wide and approximately 14 m high. The glass walls consist of three stacked panels in an “s” shape. The upper two are suspended from the roof while the lower one is supported on the base. Wind load resistance is achieved by the wavy glass section spanning between two discreet horizontal trusses, located at the lower and upper thirds of the height between the two glass planes (Fig. 6).

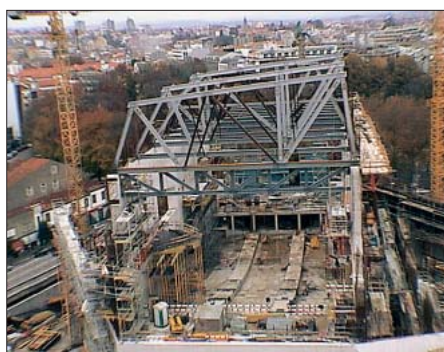
Fig. 7: Steel trusses in restaurant area

In the restaurant area, where between this slab and the roof there is sufficient height, there is a solid slab supported on the lower flange of steel trusses spaced 6 m apart. These steel trusses go up to the roof and have different geometries imposed by the irregular form of the roof (Fig. 7). These trusses also give support to the roof panels of the exterior shell.

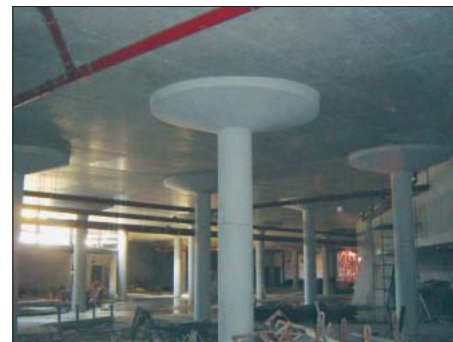
Fig. 8: General view of the parking garage

columns are circular with truncated conical shear heads and are generally set out in a 7,8 m by 7,8 m grid (Fig. 8).

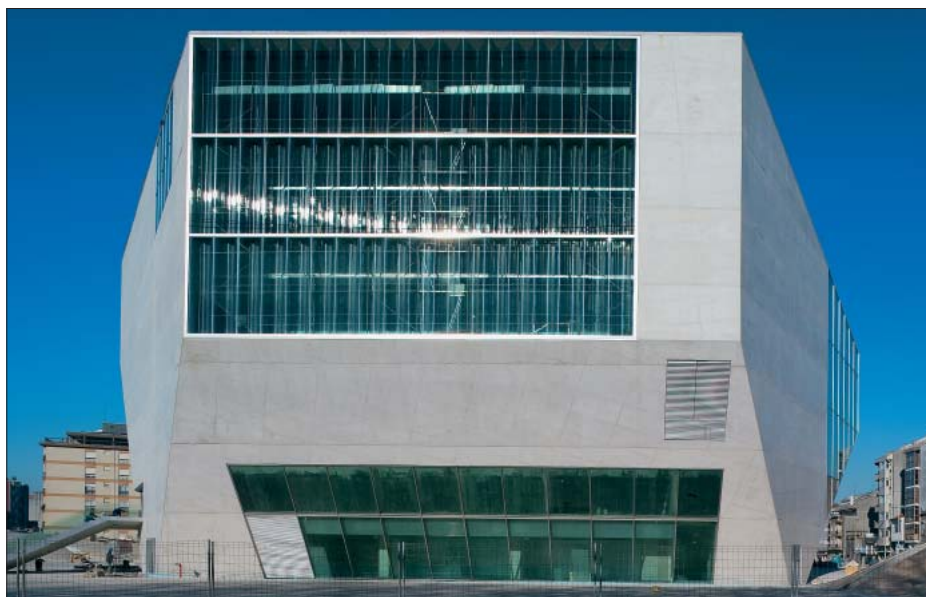
Fig. 12: East elevation – February 2005

The constructability of the auditorium building of the “Casa da Música” was one of the main challenges facing the entire team involved in the project and construction. The stability of the sloped walls during construction and the fact that the structure would only be stable as a unit, after the conclusion of the entire exterior shell, required a specific study for the phasing of the construction of the structure (Figs. 10, 11, 12).

minimising the time that formwork and its temporary structures remained in place in order to free up the underlying areas and to carry out other necessary finishing work (Fig. 12). Accordingly, based on the contractor's initial work plan, which defined the sequence of concreting, 88 construction phases were defined for the building and the stability of all these phases was studied individually.

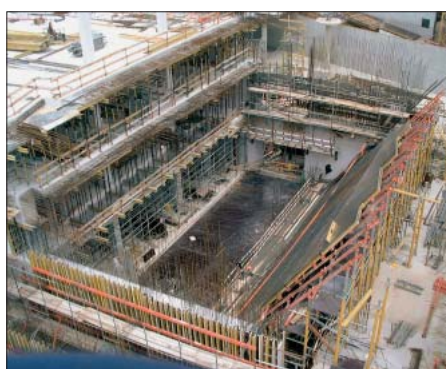
Fig. 10: Construction work – May 2002

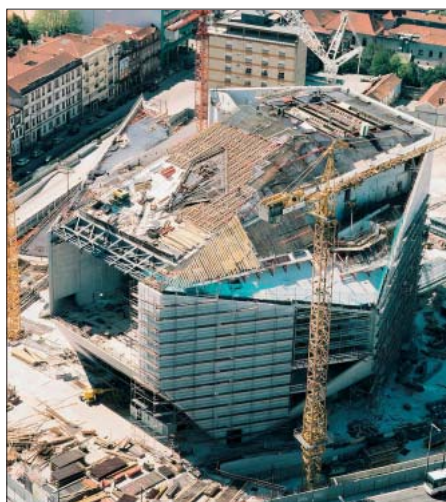
Fig. 11: Construction work – May 2003
