# Use of Incinerator Bottom Ash as a Recycled Aggregate in Contact with Nonwoven Geotextiles: Evaluation of Mechanical Damage Upon Installation

**Abstract:** The recycling and reuse of materials is crucial to reducing the amount of generated waste and the exploitation of natural resources, contributing to achieving environmental sustainability. During the incineration process of municipal solid waste, a residue known as incinerator bottom ash is generated in considerable amounts, being important the development of solutions for its valorization. In this work, three nonwoven geotextiles were submitted to mechanical damage under repeated loading tests with incinerator bottom ash and, for comparison purposes, with three natural aggregates (sand 0/4, gravel 4/8 and *tout-venant*) and a standard aggregate (*corundum*). Damage assessment was carried out by monitoring the changes that occurred in the short-term tensile and puncture behaviors of the geotextiles. Results showed that the damage induced by incinerator bottom ash on the short-term mechanical behavior of the geotextiles tended to be lower than the damage induced by the natural aggregates or by the standard aggregate. Therefore

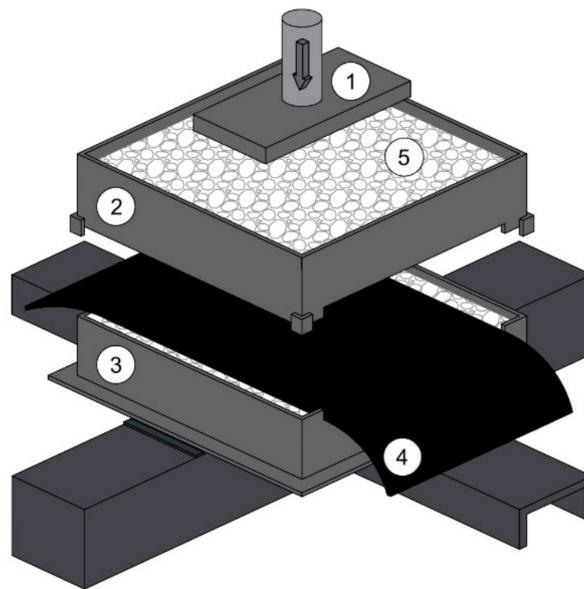
**Figure 1.** Schematic representation of equipment used for the MD tests: (1) loading plate, (2) upper box, (3) lower box, (4) test-specimen, (5) aggregate.

The equipment used in the MD tests was a laboratory prototype developed at the Faculty of Engineering of the University of Porto in accordance with the specifications of EN ISO 10722 [15]. The equipment included a test-container (a rigid metal box where the geotextiles and aggregates were placed), a loading plate (with dimensions of 200 mm × 100 mm) and a compression machine. The test-container, having a square base with a side of 300 mm, was divided into two parts: a lower box and an upper box, each with a height of 87.5 mm. A schematic representation of the equipment is illustrated in Figure 1. In this outline, the upper box is represented in a distinct plane to provide a better understanding of the elements of the equipment.

The MD tests comprised of several steps. First, a sublayer of aggregate (five different aggregates were used) with a height of 37.5 mm was placed in the lower box and submitted to compaction. Then, the remaining half of the box was filled with another sublayer of aggregate (with a height of 37.5 mm), followed again by compaction. Each compaction process consisted of placing a flat plate over the sublayers of aggregate and applying a pressure of  $(200 \pm 2)$  kPa for 60 s (pressure was applied over the whole area of the box).

The next step was the placement of a test-specimen (with a width and length of 250 and 500 mm, respectively) over the compacted layer of aggregate, followed by the installation of the upper box. A single layer of loose aggregate with a height of 75 mm was afterwards introduced into the upper box (it is important to stress that this layer was not submitted to a compaction process). Damaging actions were induced in the test-specimen by applying a vertical dynamic loading between  $(5.0 \pm 0.5)$  kPa and  $(500 \pm 10)$  kPa at a frequency of 1 Hz for 200 cycles. At the end of the MD test, the test-specimen was carefully removed, avoiding additional damage.

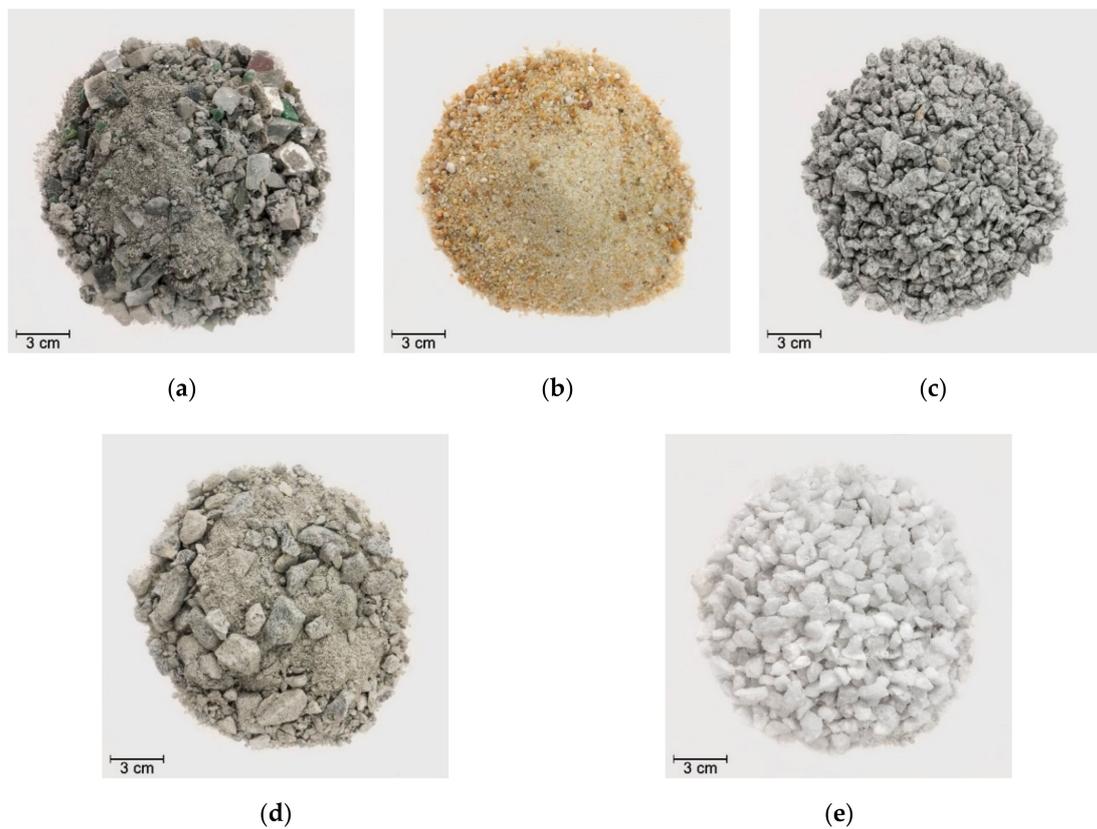
**Figure 2.** Aggregates used in the MD tests: (a) IBA, (b) sand 0/4, (c) gravel 4/8, (d) *tout-venant*, (e) *corundum*.

The aggregates used in the MD tests included IBA and, for comparison purposes, *corundum* (a synthetic aggregate of aluminum oxide used in the procedure described in EN ISO 10722 [15]) and three natural aggregates: sand 0/4 (river sand), gravel 4/8 and *tout-venant* (well graded untreated mixed aggregate) (Figure 2). IBA was supplied by a Portuguese incineration plant (Lipor II-Maia) and resulted from the incineration of municipal solid waste. This recycled aggregate was used as provided by the supplier, without further treatment other than drying. Both IBA and the other aggregates were dried to constant mass in a ventilated oven at 110 °C.

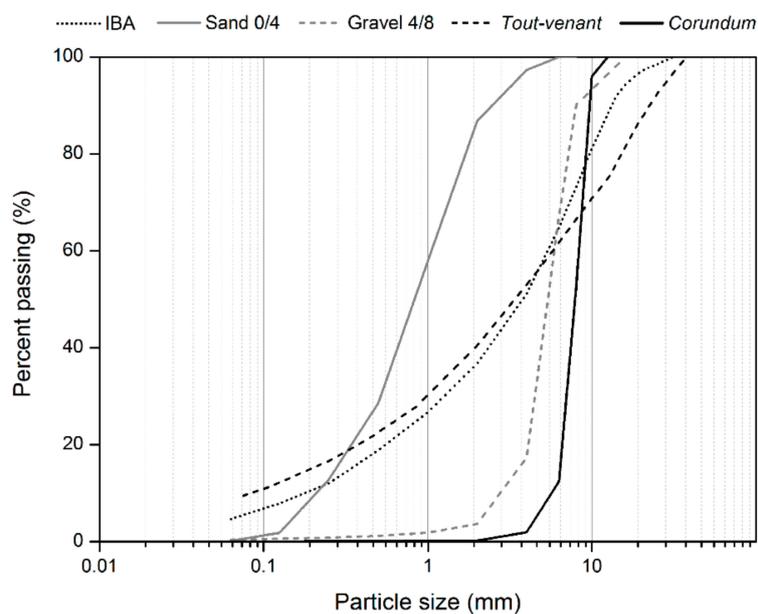
The particle size distribution of the aggregates was determined by sieving (tests carried out according to EN 933-1 [32]) and can be found in Figure 3. The main parameters for the characterization of the particle size distributions ( $D_{10}$ —effective 10% particle size,  $D_X$ —particle size corresponding to X% passing, and  $D_{Max}$ —maximum particle size) are summarized in Table 2.

Finally, the effects of IBA were identical to the effects of sand 0/4 and slightly less pronounced compared with *tout-venant*. The particle size distribution of IBA and *tout-venant* were much identical (Figure 3), which explains the similarities between the effects of these aggregates on the mechanical properties of the geotextiles. Indeed, despite having different  $D_{Max}$  (higher for *tout-venant*), the  $D_{30}$ ,  $D_{50}$  and  $D_{60}$  of IBA and *tout-venant* were not significantly different. As *tout-venant*, IBA also had a relatively high number of fine particles (when compared with sand 0/4, gravel 4/8 or *corundum*), which surrounded the larger particles and originated a relatively plane and regular surface for the transference of stresses during the MD tests. Although IBA had a higher  $D_{Max}$  than gravel 4/8 and *corundum* (14.0 mm for IBA and, respectively, 8.0 and 10.0 mm for gravel 4/8 and *corundum*),  $D_{60}$ ,  $D_{50}$ ,  $D_{30}$  and  $D_{10}$  were lower compared with those aggregates. This circumstance also contributes to the lower degradation induced by IBA to the geotextiles when compared with gravel 4/8 or *corundum*. The damaging effect of IBA may be ascribed to the presence of some cutting materials in its composition (such as glass, metals and ceramic waste), which may have induced some cuts (not detected by naked eye) on the geotextiles.

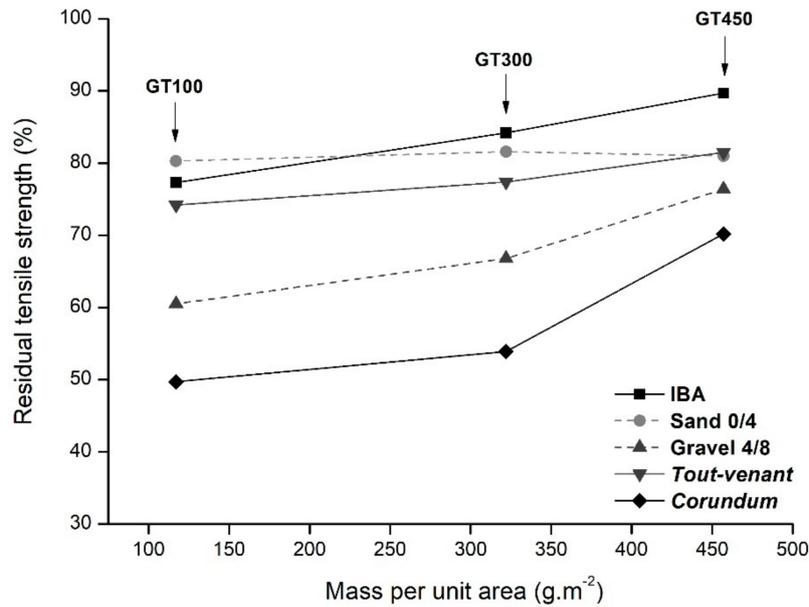
Figure 4. Comparison of the residual tensile strengths of the geotextiles after the MD tests.

The effect of the different aggregates was compared by the impact that they caused on the tensile and puncture properties of the geotextiles. Comparison of the  $T_{Residual}$  of the geotextiles after MD tests can be found in Figure 4. Figure 5 illustrates a similar comparison for  $F_P Residual$ . It is worth mentioning that the points representing the residual strengths of the geotextiles in Figures 4 and 5 were joined by lines in order to highlight the effect of mass per unit area on the resistance of the geotextiles against mechanical damage.

The MD tests with sand 0/4 led to some reductions in the  $T$  of the geotextiles (the  $T_{Residual}$  was between 80.3% and 81.6%). Regarding the effect on  $F_p$ , GT100 was slightly more affected (there was a reduction of 25.9%) than GT300 and GT450 (with reductions of 16.0% and 16.9%, respectively). Compared with the other aggregates, sand 0/4 was one of the less damaging. The geometry and dimensions of this aggregate ( $D_{10}$ ,  $D_{50}$  and  $D_{60}$  of, respectively, 0.20, 0.86 and 1.07 mm) fostered the formation of a plane and regular surface after compaction. Therefore, there was a high contact surface area between sand 0/4 and the geotextiles, which could have contributed to a good distribution of the applied loads (and, thus, would have minimized the occurrence of damage). However, as a consequence of the non-cohesive nature of sand 0/4, considerable settlements occurred during the MD tests, which affected the aforementioned good distribution of the applied loads. Even though the particles were of low dimensions, they had a rough texture, which may have induced some damage

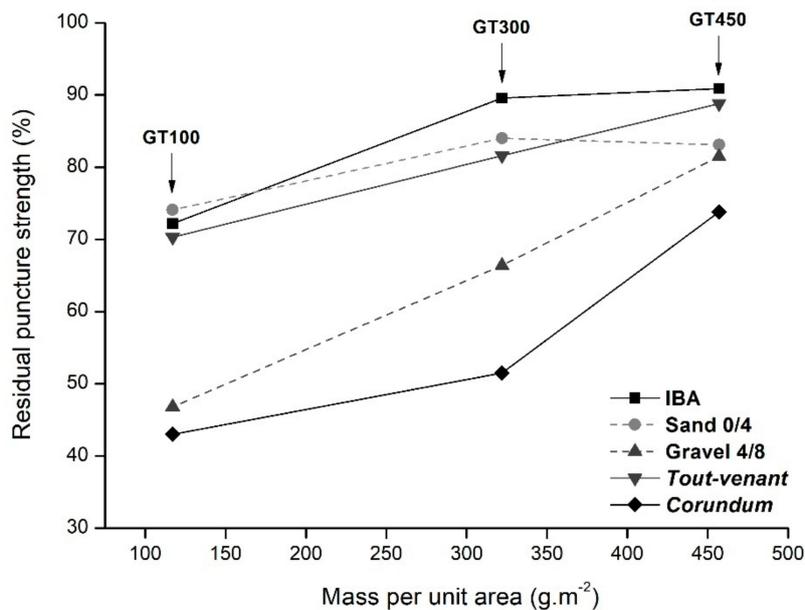
Figure 5. Comparison of the residual puncture strengths of the geotextiles after the MD tests.
