Identification of gear wear damage using topography analysis

Gear failure modes and their underlying mechanisms are usually identified by visual inspection, which relies on the skills and experience of the human observer and hence is prone to subjectivity and bias. Therefore, it is essential to design and implement objective methods to improve the identification of gear failure modes. In the present study, the 3D topography of gear surfaces affected by different types of wear modes, i.e., micropitting, pitting, and scuffing, was measured by means of white light interferometry. The surfaces were evaluated in terms of height, spatial, and function roughness parameters, according to ISO 25178-2. Besides, a new roughness parameter, named surface motion orientation (S_{mo}), was proposed. Three features were found relevant to identify the differences between the gear surfaces affected by different failure modes: the shape of asperities distribution, the severity of damage, and the surface texture orientation with respect to the motion direction. The combination of the roughness parameters selected to quantify each of these features (S_{sk} , S_q , S_{mo}) resulted in an objective class

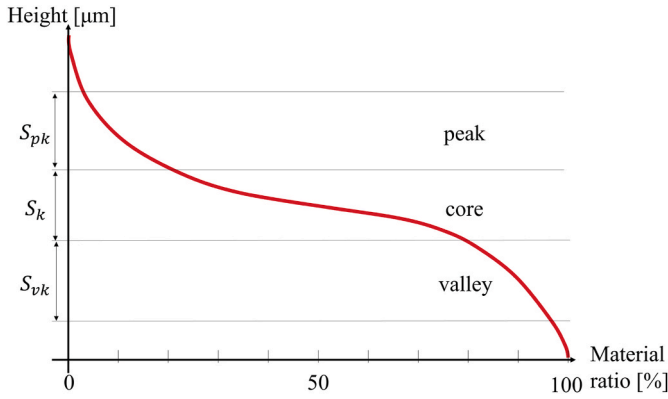
Fig. 5. Graphical representation of the CDF of an asperity distribution and the derived function parameters S_{pk} , S_k and S_{vk} .

ISO 25178-2 [26], splits the CDF into three zones: peaks, core, and valleys. Each one of these zones is then associated with a roughness parameter: reduced peak height (S_{pk}), core height (S_k) and reduced valley height (S_{vk}), respectively. These parameters are graphically described in Fig. 5. Thereafter, these function parameters can indicate the scale of the asperities height in each specific portion of the surface: peaks (S_{pk}), core (S_k) or valleys (S_{vk}).

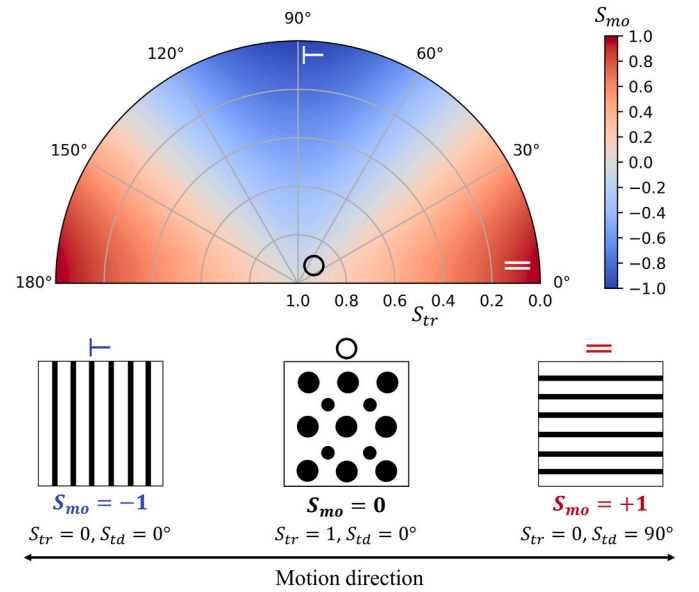
Fig. 6. Graphical representation of the surface motion orientation (S_{mo}) parameter according to the S_{tr} and S_{td} parameters and including three surface conditions.

A schematic representation of the S_{mo} for different surface conditions is shown in Fig. 6. The half-polar plot exhibits the values assumed by the proposed S_{mo} parameter for all possible combinations of the S_{tr} and S_{td} parameters. In the outer radius of the graph, which corresponds to anisotropic surfaces ($S_{tr} = 0$), the S_{mo} with higher absolute magnitudes can be found. Meanwhile, the sign of the S_{mo} parameter varies according to the S_{td} parameter. When the surface texture is parallel to the motion direction, the S_{mo} assumes positive sign ($S_{mo} > 0$). On the other hand, when the surface texture is perpendicular to the motion direction, the S_{mo} assumes negative sign ($S_{mo} < 0$). Besides, as the surface becomes more isotropic, the S_{tr} move towards the center of the polar plot and the S_{mo} assumes values close to zero. To better visualize these effects, three key surface conditions are highlighted with geometric indicators (\perp , \circ , \parallel) in Fig. 6. In the mostly negative condition (\perp), the surface is highly

anisotropic ($S_{tr} = 0$) and perpendicular to the motion direction ($S_{td} = 90^\circ$), resulting in $S_{mo} = -1$. When the surface is isotropic ($S_{tr} = 1$), represented by the “O” indicator, the orientation of the surface texture can be neglected as the value of the proposed parameter tends to zero ($S_{mo} = 0$). Finally, for the mostly positive condition (\parallel), the surface is highly anisotropic ($S_{tr} = 0$) and parallel to the motion direction ($S_{td} = 0^\circ$ or 180°), resulting in $S_{mo} = +1$.

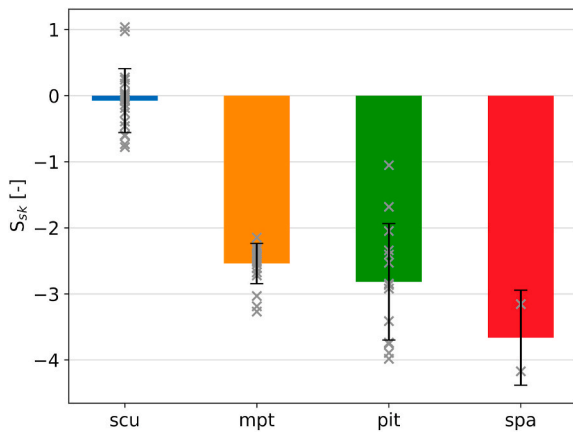
Fig. 9. Result of skewness (S_{sk}) indicating the shape of the asperity distribution for each gear failure mode.

The average and standard deviation of the skewness parameter (S_{sk}) for each failure mode are shown in Fig. 9. In the bar plots, the error bars exhibited are equivalent to one standard deviation ($\pm 1\sigma$). Besides, light-grey 'x' markers were added to show the single measurements that resulted in the average and deviation values. Within the markers, it is

possible to have a better idea about the distribution of the data. In Fig. 9, a clear difference is observed between scuffing and the pitting-type failures (*mpt*, *pit*, *spa*). The gear samples with scuffing failure exhibited skewness close to zero, which indicates a symmetrical distribution. This relationship of the adhesive wear leads to symmetrically distributed surfaces ($S_{sk} \cong 0$) was also reported by Gehlen et al. [43], in their investigation of the worn surfaces of polymers. In this case, the adhesive wear triggered several phenomena that can explain the current aspect of these surfaces. Due to welding, material accumulated on top of the surface, establishing the peaks. Besides, material pullout contributed to the formation of the valleys. Finally, plastic deformation may happened on top of these phenomena, contributing to the development of both peaks and valleys.

On the other hand, all fatigue-related failure modes (*mpt*, *pit*, and *spa*) exhibited negatively skewed asperity distributions ($S_{sk} < 0$). This can be attributed to the contact fatigue wear mechanism, which triggered the faults in the shape of pits, and consequently, established the valleys of the surfaces. Surface profiles with asymmetric distributions towards the valleys can also be seen in literature [8,13,14] in works that evaluated micropitting and pitting failures. Additionally, no significant difference was observed in the shape of the asperity distribution between these failure modes (*mpt*, *pit*, *spa*). Therefore, the shape of the asperity distribution, quantified through the skewness (S_{sk}) parameter, can differentiate the nature of the wear mechanism between adhesive or contact fatigue.

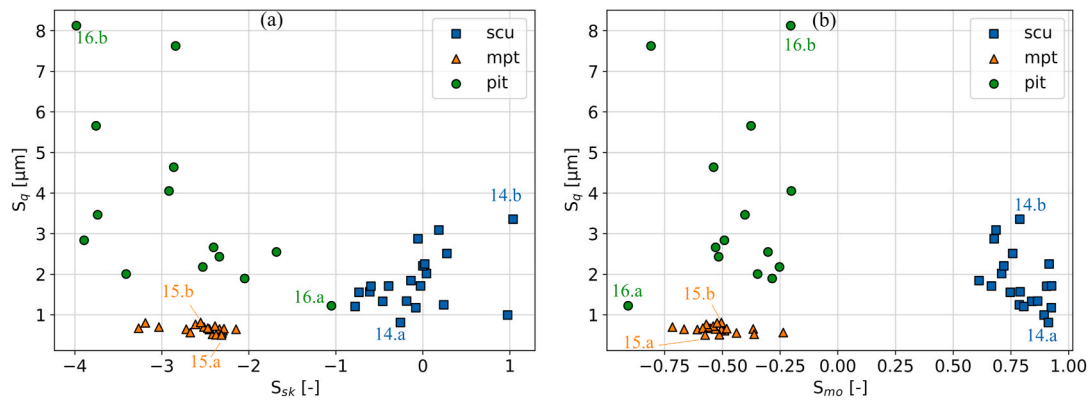
Fig. 16. Distribution of the severity of damage (S_q) parameter against the S_{sk} (a) and the S_{mo} (b) parameters for the surfaces of the *mpt*, *pit*, and *scu* failure modes, the colored numbers indicate the figure with the image of respective the surface.

The severity of damage is a third feature required to further differentiate the gear failure modes. Hence, the behavior of the S_q parameter against the S_{sk} and S_{mo} parameters is shown in Fig. 16. Since only two spalling instances were found, they were omitted from Fig. 16 to provide better visual discrimination between the other surface phenomena. In fact, these spalling surfaces exhibited S_q values at least twice as higher as of any other surface in the dataset. To support the analysis from Fig. 16, top-view images of the surfaces with the lowest and the highest S_q values are shown in Figs. 17, 18 and 19, for the scuffing, micropitting, and macropitting failure modes, respectively. The numbers of these figures were added to the respective point in Fig. 16 to indicate the addressed surface.

In Fig. 16, the surfaces from scuffing failure are relatively gathered on the right side of the graphs, especially in Fig. 16b, where a more compacted group can be seen. Additionally, it can be noted that the surfaces from this gear set cover different severities of the scuffing failure. First, the scuffing surface of the smaller value of S_q (Fig. 17a) exhibits a mild form of scuffing wear. On the other hand, the surface with the larger S_q value of this set (Fig. 17b) exhibits a more severe failure mode, with formation of patches on the surface, which is a typical

Regarding the micropitted surfaces in Fig. 16, they are located in a tight group at negative values of S_{mo} and S_{sk} , and small values of S_q . This implies that there is not much variation in the roughness amplitude and hence the severity of this failure mode. This was confirmed by the similarities in the amplitude ranges of the surfaces exhibited in Fig. 18a and Fig. 18b, corresponding to the smallest and the largest S_q values obtained for this failure mode. In contrast to the micropitted surfaces, the macropitted surfaces, although also located at negative values of S_{mo} and S_{sk} in Fig. 16, presented much larger values of S_q and with a larger variation. Indeed, as shown in Fig. 19, the pitting set includes surfaces with small pits (Fig. 19a), to surfaces with large and deep pits (Fig. 19b).

Moreover, Fig. 16 shows that micropitted surfaces typically display $S_q \leq 1\mu m$. This suggests the existence of a threshold of $S_q = 1\mu m$, that potentially serves as a differentiator between micropitting and macropitting. From the literature [12–14,16], a single micropit is defined as having a few micrometers wide and up to 20 μm deep, which requires the prior identification of each pit in order to evaluate its size. Therefore, the use of an overall metric of the surface roughness, such as the S_q parameter, can facilitate the differentiation between micropitting and other failure modes, like macropitting. However, three limitations have to be considered regarding this result. First, the micropitting set evaluated in this work exhibited pit depths of 5 μm , without larger variations, as seen mentioned in the analysis of Fig. 18, which suggests that the threshold ($S_q = 1\mu m$) can be higher if deeper micropits (up to 20 μm deep) are measured. Second, it cannot be implied that gears subjected to pitting tests cannot develop micropitting besides macropitting. For instance, on the damaged gear surface that exhibited the smallest S_q , as shown in Fig. 19a, it is possible to identify small pits consistent with the definition of micropitting. Third, it is more reasonable to consider that there is a range of S_q values with overlapping of the micropitting and the macropitting phenomena. Above this range, the surfaces predominantly exhibit macropitting and the effects of micropitting can be safely neglected, as seen in the surface of Fig. 19b. Therefore, further investigations have to be conducted to fully determine this range.

Additionally, due to the similarity between the graphs of $S_q \times S_{sk}$ (Fig. 16a) and $S_q \times S_{mo}$ (Fig. 16b), it may raise a valid claim that using the severity of damage parameter (S_q) associated to only one of the other parameters (S_{sk} or S_{mo}) is enough to distinguish between the gear failure modes. Indeed, this is valid for the surfaces evaluated in this study, especially if it is considered the parameters S_q and S_{mo} , exhibited in Fig. 16b. Nevertheless, the skewness (S_{sk}) and the surface motion orientation (S_{mo}) parameters hold completely different physical meanings. The first (S_{sk}) indicates how the surface is distributed alongside the height, without considering the spatial orientation. The second (S_{mo}), on the other hand, only shows how the damage defects are oriented over the surface. For instance, the collective consideration of these three features should be relevant for the identification of failure modes not included in this investigation, such as abrasion. Therefore, the authors herein support the argument that all three indicators (S_q , S_{sk} , S_{mo}) are equally important for the identification of gear failure modes.
