Experimental assessment of post-fire retrofitted RC columns tested under cyclic loading

Abstract: Multiple combined hazards can affect the structures during their live span and may conditionate the future structural behaviour for some types of loading. That is the case of a structure previously damaged by fire and then loaded under seismic loading. For seismic hazard zones it is important assess the seismic performance of existing reinforced concrete (RC) structures designed according to old codes and without seismic detailing. This structural seismic assessment is even more important for buildings that were previously damaged by fire. Therefore, it is critical develop and validate fire retrofitting methods that can also improve the seismic behaviour. This paper presents the results of a novel experimental campaign carried out on four (two of them repaired and strengthened with CFRP wrapping after fire exposure) full-scale reinforced concrete columns previously damaged by a 30 or 90 minutes standard fire and then tested under uniaxial cyclic lateral loading up to failure. Moreover, two additional control columns, one as-built and another strengthened, were cyclically tested for co

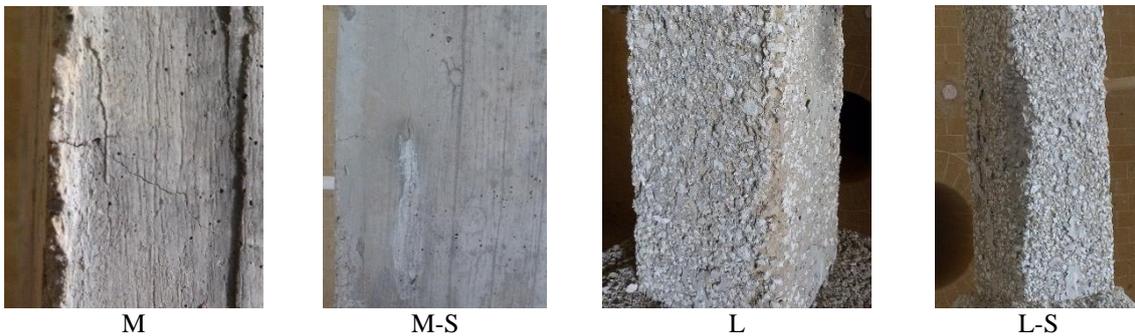
Fig. 5 – Damages observed after fire test.

The damage observed after the fire exposure are presented in Fig. 5. After the medium fire were only observed transversal concrete cracks in the corners of the column. After the long fire spalling and cracks on the concrete cover were observed. The large concrete aggregates are limestone and the sand is quartz and therefore larger aggregates were more

affected by the long fire. After the long fire, the concrete surface was observed to become irregular and rough, and consequently it was not possible to identify the crack pattern.
