## Acoustics of Modern and Old Museums

António P.O. Carvalho  
Hélder J.S. Gonçalves  
Luísa M.M. Garcia  
Laboratory of Acoustics, College of Engineering, University of Porto  
4200-465 Porto, Portugal  
carvalho@fe.up.pt

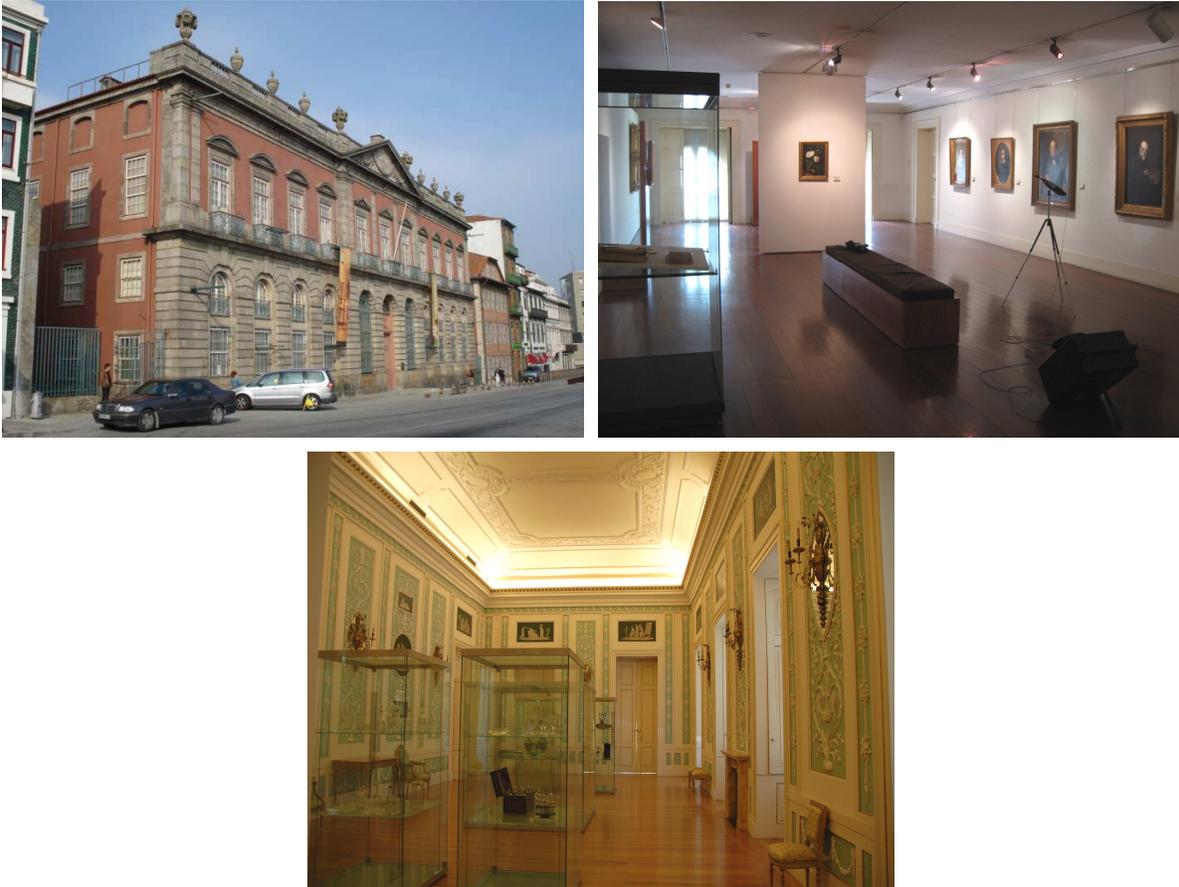
**Figures 1 to 3:** National Museum of Soares dos Reis (exterior view and tested rooms n° 2 and 16).<sup>1</sup>

The National Museum Soares dos Reis (NMSR) is installed in the *Palace of the Carrancas* (Porto, Portugal) in a neoclassical building built in 1800 (Figures 1 to 3). In 1934 works begin to adapt it to a museum. In 1992 it is again renovated, by architect Fernando Távora.

Three representative rooms were selected in each museum (n. 11, 12 and 14 in CAMS and n. 2, 5 and 16 in NMSR) whose dimensions are shown in Table 2. In the NMSR only the rooms in the old palace (not in the new annex) are used to represent typical situations of an "old" museum (Figures 2 and 3).

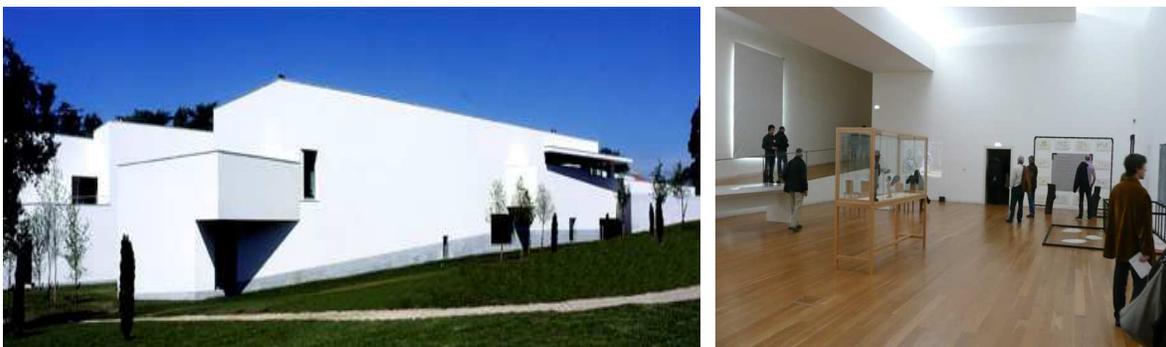
**Figures 4 and 5:** Museum of Contemporary Art (Serralves), Exterior view and tested room n. 11.<sup>2</sup>

The Contemporary Art Museum of Serralves (CAMS), also located in Porto, is a typical example of a “modern” museum. The building (1999) designed by the architect Siza Vieira, has three floors (total area 12,670 m<sup>2</sup>) with 14 exhibition rooms (occupying 4,485 m<sup>2</sup>), almost  
*Noise-Con 2013, Denver, Colorado, August 26-28, 2013*

entirely with double floor height (Figures 4 and 5). The exhibition halls are wide and free of partitions inside. The walls are lined with plasterboard; floors are in hardwood except for two rooms (# 12 and 13) with a marble floor. The ceilings are mostly plasterboard coated, having some areas with the acoustic material *Wilhelmi Alvaro*, both with a reduced air space ( $\approx 5$  cm).

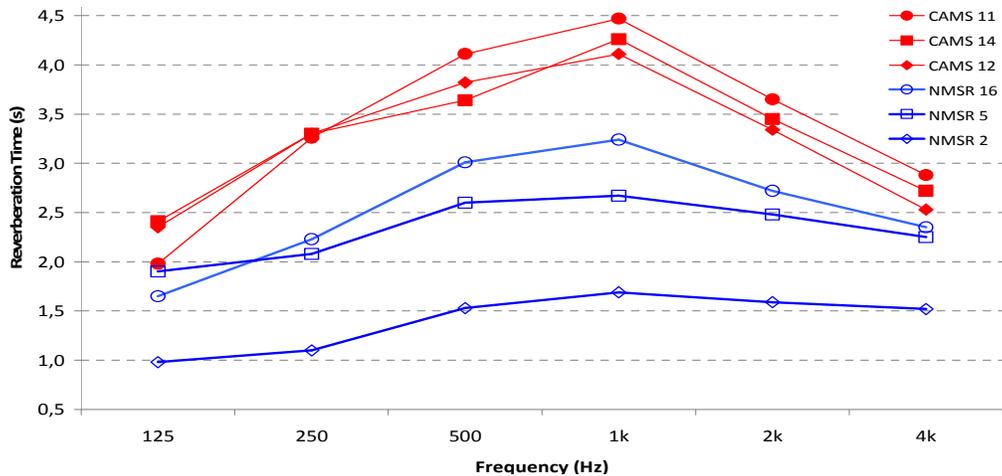
The Reverberation Time values were measured at three positions in each room, per octave band from 125 to 4k Hz and resulted in the values seen in Figure 6 and Table 3.

Figure 6: Reverberation Times at the six rooms at both museums (above red CAMS, below blue NMSR).<sup>1,2</sup>

The CAMS has the rooms with the highest RT values, nearly 1.5 s superior to the traditional NMSR rooms. Room 11 showed the worse reverberation. Those high reverberation time values are justified by the characteristics of the CAMS rooms (large volumes, very high ceilings and very reflective surfaces).

In NMSR is room 16 that has the largest RT value (3.0 s) almost doubles room 2 values due to the large difference in volumes.

Analyzing the average RT values with the ideal range for museums (0.8 to 1.4 s) only room n. 2 of NMSR approaches this recommendation.

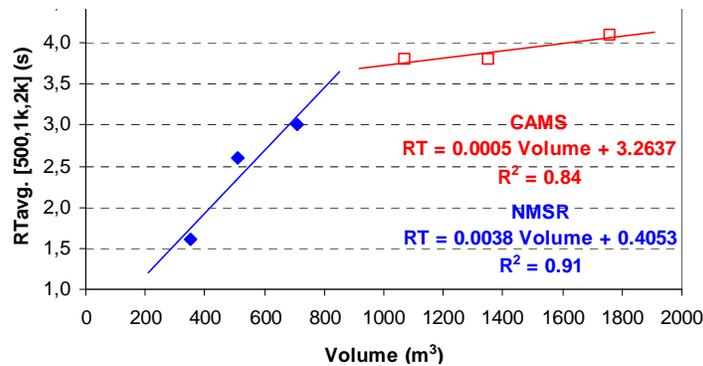
The figure 7 compares the evolution of average RT values concerning the room volumes in both museums. The "old" museum RTs show a step increase with volume as the "modern" museum has it more softly (but much higher values).

Figure 7: Average RT values related with room volumes, in both museums (above red CAMS, left blue NMSR).

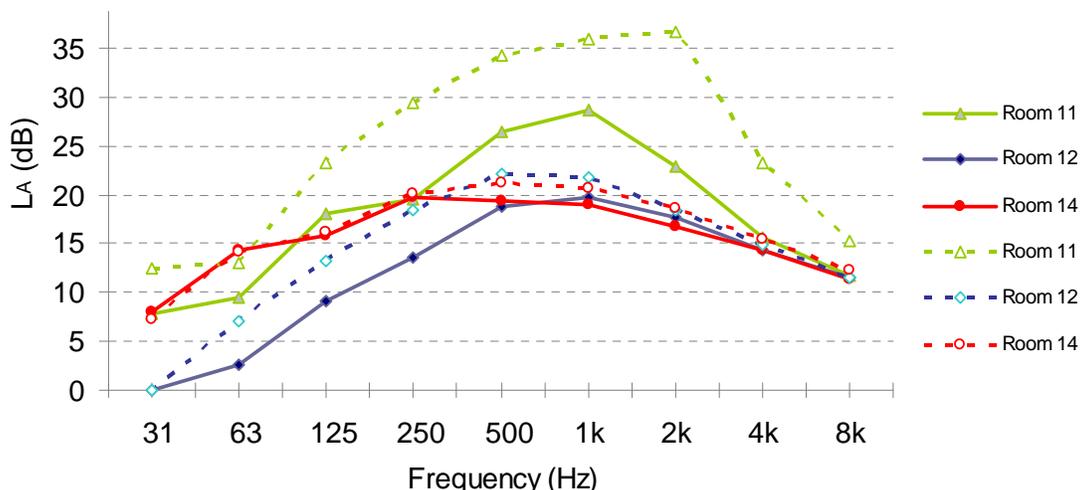
In CAMS the measured values of the A weighted sound pressure levels of background noise without visitors (with and without HVAC) show that the noise in the rooms is very variable in frequency, with a major importance in the middle frequencies (Figure 8). The HVAC operation revealed a noise increase in rooms 11, 12 and 14 (CAMS) respectively for 9.0 / 2.2 / 1.3 dB(A), presenting room 11 the maximum background noise.

**Figure 8:** Background sound pressure levels (A weighted), with (-) and without (---) HVAC at CAMS.<sup>2</sup>

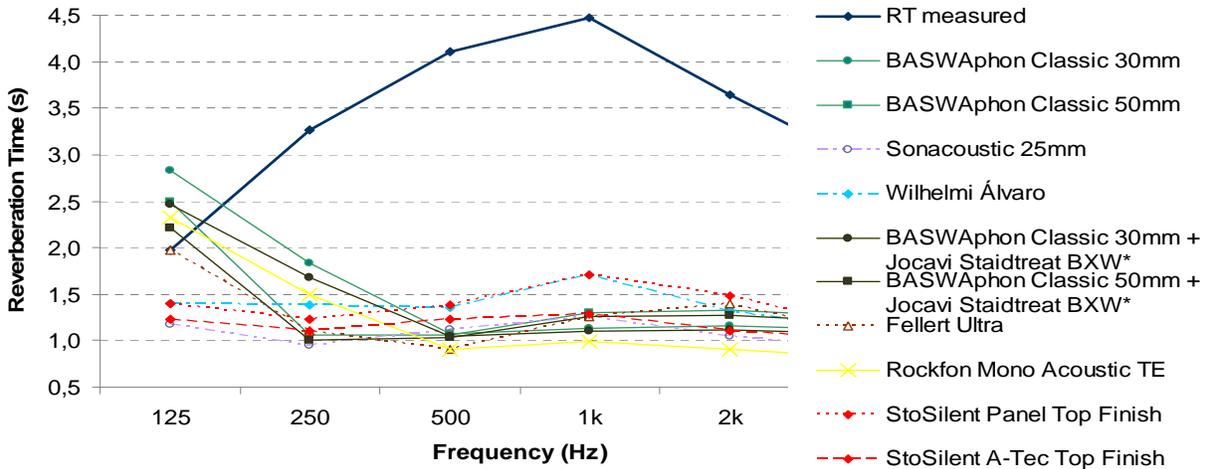
Based on those problems, some suggestions are presented to reduce the RT values closer to the ideal, by an increase of sound absorption. The ceiling systems selected were: *BASWaphon Classic*, *Sonacoustic*, *Fellert Ultra*, *Rockfon Mono Acoustic TE*, *StoSilent Top Finish* and *Wilhelmi Álvaro* (Figure 9).

Only the conclusions for room 11 are presented because it has the worst conditions (see others in [2]). It was chosen only to intervene on the ceiling (268 m<sup>2</sup>) by replacing the existing plasterboard by the various proposals achieving a significant RT reduction (Figure 9). Most materials present a worse performance at the 125 Hz frequency band than the existing material. In the remaining frequencies there is only a slight variation of RT values among proposals.

**Figure 9:** Measured and predicted RT in Room 11 (CAMS) for the suggested acoustical corrections.<sup>2</sup>

Two additional proposals are also presented that jointly use *BASWaphon* and *Jocavi* panels for a correction in the 125 Hz band to fix a *BASWaphon* deficit absorption at that frequency.

The best solutions for room 11 are *Sonacoustic* or *StoSilent A-Tec Top Finish*, with a predicted RT [500, 1k, 2k Hz] reduction of about 3 s for about 25,000 € (\$33,000) but it can double with a correction at low frequencies.
