# FATIGUE BEHAVIOUR OF REINFORCED CONCRET BEAM STRENGTHENED WITH A CFRP REINFORCED SYSTEM

J.L. Esteves<sup>1</sup>, P. Vieira<sup>2</sup>, A.T. Marques<sup>1</sup>

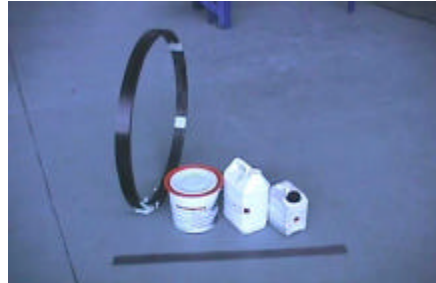
The reinforcement system is made using a CFRP unidirectional laminate made by pultrusion in our installations [2-4]. The Epoxide/Carbon laminate made is 50 mm width and 1.4 mm thick.

Fig. 2. The reinforcing material

- Fibre mass percentage:  $m_f = 70 \%$
- Young modulus:  $E = 160 \text{ GPa}$
- Tensile strength:  $\sigma \geq 2400 \text{ MPa}$

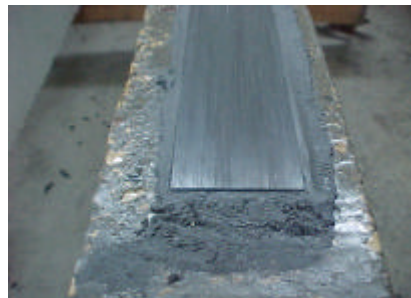
The beam had to be cleaned and prepared for the resin application [5-6]. An abrasive millstone was used to clean the surface. Cleaning the dust was the next step before applying the epoxy resin. After a 24 hours cure, we applied the adhesive past in the beam and in the reinforcement. After the reinforcement application, and a 7 days curing at ambient temperature (more or less 20 °C) the beam was then ready [7].

Fig. 3. Beam with the reinforcement

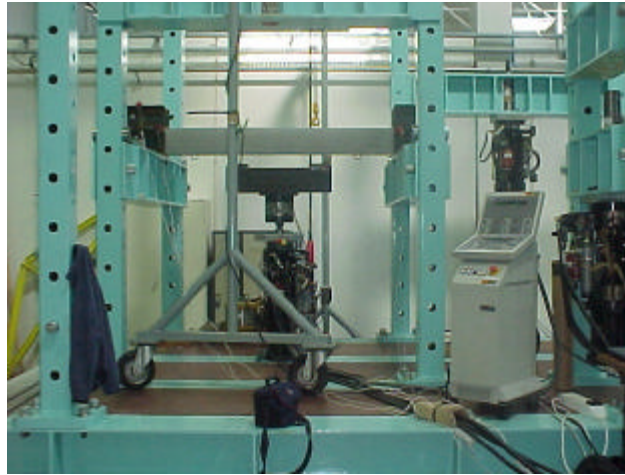
For our tests we used a modular structure for multiaxial fatigue tests. This structure is equipped with servo hydraulic Instron actuators with capacities of 100 kN, 250 kN and 500 kN (Fig. 4).

Fig. 4. Test equipment

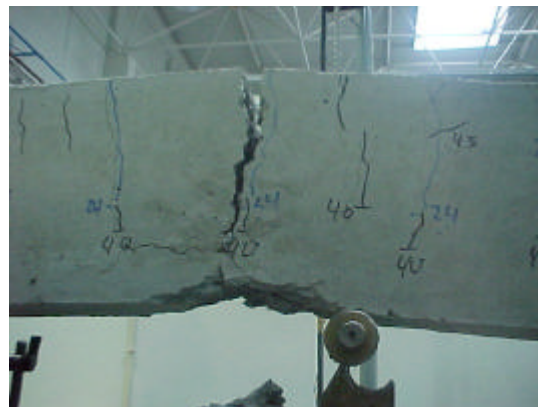
**Fig. 7.** Rupture of a reference beam.

In Fig. 7 we can see the rupture of the second reference beam. The crack happened close to one of the loading points and the rupture occurred when the tension steel rebars cracked.

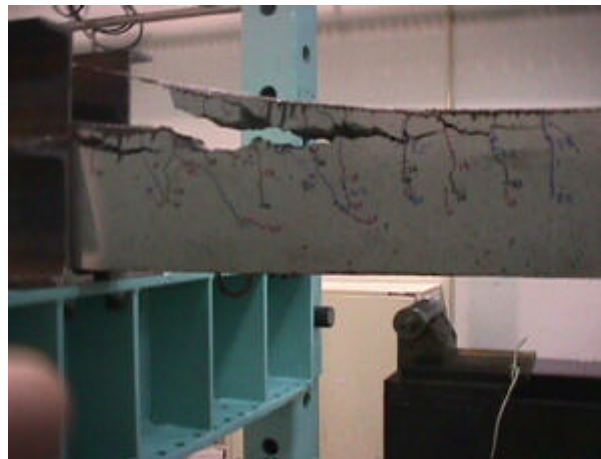
**Fig. 9.** Rupture of the reinforced beam

The 25 mm covering is too much and is possibly the cause of this kind of rupture. In fig. 10 we can see the failure mode.

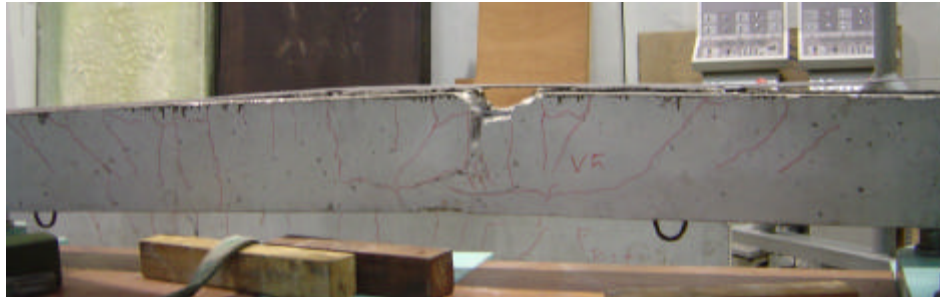
**Fig. 10.** Fatigue rupture of the reinforced beam (20%-70% máx load)

Reinforced beam with CFRP reinforcement 20% (13 kN) and 70% (45 kN) – 648 480 cycles
