COMPDYN 2021 8<sup>th</sup> ECCOMAS Thematic Conference on Computational Methods in Structural Dynamics and Earthquake Engineering M. Papadrakakis, M. Fragiadakis (eds.) Streamed from Athens, Greece, 28-30 June 2021

# ASSESSMENT OF RC HOLLOW-PIERS FOR SEISMIC LIMIT STATE OF DAMAGE - DIRECT REPAIR COSTS

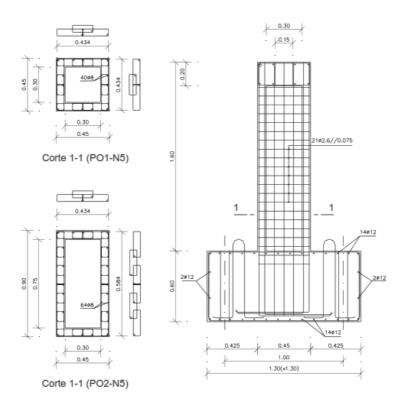
Figure 1: Piers PO1-N5 and PO2-N5 reinforcement details [1].

This experimental test campaign consisted of 12 piers, 6 with a squares cross section (PO1) and 6 with a rectangular section (PO2). The square piers have a section of 0.45x0.45m and a wall thickness of 7.5cm. The rectangular piers have a section of 0.90x0.45m also with a wall thickness of 7.5cm. All piers are 1.40m tall and were built with ½ scale from the original size. All the piers have different characteristics of materials, arrangement of shear reinforcement or cross areas of reinforcement. Table 1 shows these characteristics of the piers [1-3] and Figure 1 illustrate the reinforcement details. An axial load of 250 kN was considered, that corresponds to a normalized axial force of 0.08.

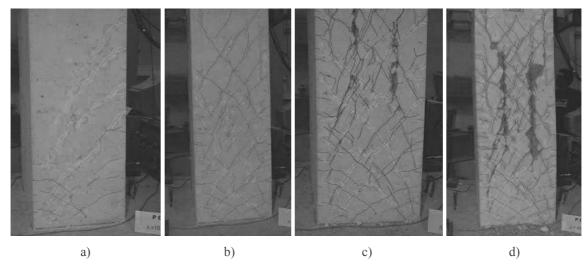
Figure 2: a) Slight damage, b) Moderate damage, c) Extensive damage, d) Collapse.

The methodology proposed by Delgado et al. [4] defines a total of four damage limit states. The first state of damage corresponds to slight damage. In this state, the damage is barely visible and does not compromise the structural stability. The visible damages are essentially the beginning of cracking, in a small extension and density, concentrated on the lower third of the columns. The second state of damage, referred to as moderate damage, is distinguished from the previous state limit by the increase in cracking. The cracks have reduced openings, smaller than 1mm, being a large part of the typical cracks, shear cracking, which reach a maximum of 1mm of opening. The third state of damage is the state of extensive damage. When a pier reaches this level of damage the element already requires attention and a significant repair. The most visible damages in the piers are the appearance of cracks openings of up to 3 mm and with a high density. In this state of damage the cracks are essentially due to shear in the webs and to bending in the flanges also noting the effect of "shear lag effect". The cracks are evenly distributed over the entire section of the pier. It is also possible to observe some concrete spalling. The ultimate damage state is the collapse. When damage to the pier reaches this level, it is no longer economically and feasible to repair the structural element and its structural safety is seriously compromised. Between this state and the state of extensive damage, there is a significant evolution of damages, with emphasis on the concrete

crushing and an increase of the detachment of the concrete cover. Numerically, this state is defined when the shear stress is higher than the theoretical resistant value or the conventional shear occurs. Figure 2 illustrates the evolution of damage, in the various limit states of damage.

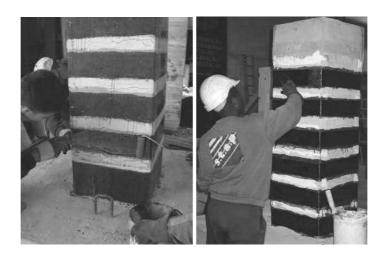
Figure 3: Pier reinforced with CFRP.

One of the most used strengthening techniques is the jacketing with carbon fibre blankets (CFRP). This technique has the advantage of causing a minimal increase of the section and greatly increasing the strength. This technique consists of bonding carbon fibre blankets using epoxy resins and then finishing with a self-adhesive mortar. In this type of strengthening, it is necessary to ensure that the ends are well bonded. Figure 3 illustrates the result of a CFRP-reinforced piers. All of these glues referred to in the previous reinforcements must comply with EN 1504-4 [10].

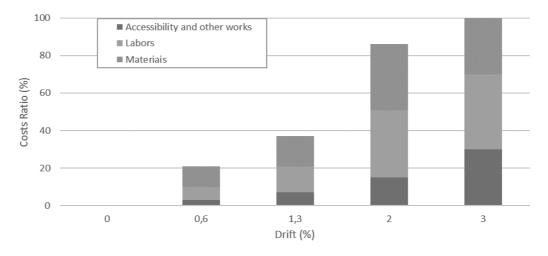
Figure 4: Evolution of the repair cost ratio (%) for each LSD/drift.

In order to make this analysis more global, it was adopted to represent the evolution of the ratio between the cost of repair and the cost of replacing the pier as a function of the drift, as illustrated in Figure 4, for each Limit State of Damage (LSD). This transfer evolution of damage into costs, provides an important indicator for any cost estimate in hollow section reinforced concrete piers. Additionally, it also allows to assess the impact and efficiency of each repair or strengthening technique. Figure 4 reveals that the repair costs associated with the extensive and collapse damage levels mean that the repair of the structural element is not viable. However, even in the case of slight and moderate damages the respective costs are already quite significant.
